Lot 162: 249
Tarleton Drive

ATTACH 2x_ SCAB OF THE SAME SIZE AND GRADE AS THE BROKEN MEMBER TO EACH FACE OF THE TRUSS (CENTER ON BREAK OR SPLICE) WITH 10d (0.131" X 3") NAILS (TWO ROWS FOR 2x4, THREE ROWS FOR 2x6) SPACED 4" O.C. AS SHOWN. STAGGER NAIL SPACING FROM FRONT FACE AND BACK FACE FOR A NET 0-2-0 O.C. SPACING IN THE MAIN MEMBER. USE A MIN. 0-3-0 MEMBER END DISTANCE.

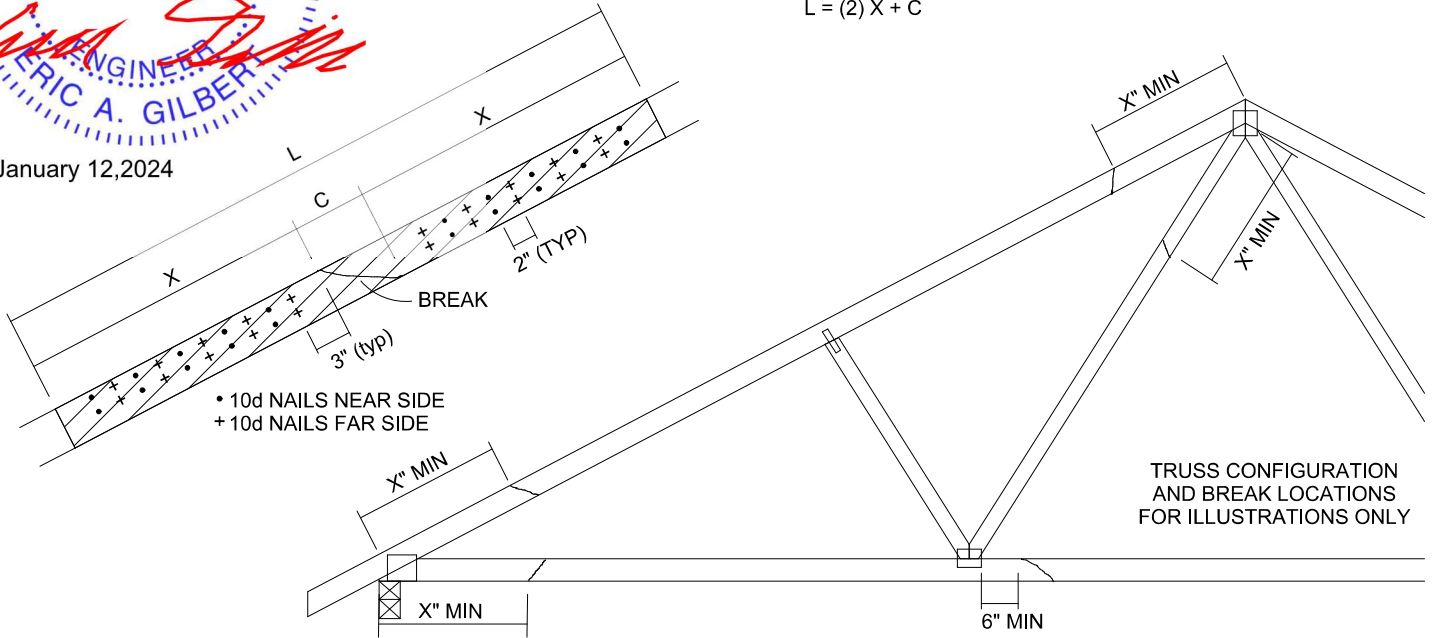
THE LENGTH OF THE BREAK (C) SHALL NOT EXCEED 12". (C=PLATE LENGTH FOR SPLICE REPAIRS)
THE MINIMUM OVERALL SCAB LENGTH REQUIRED (L) IS CALCULATED AS FOLLOWS:
 $L = (2) X + C$

THE LOCATION OF THE BREAK MUST BE GREATER THAN OR EQUAL TO THE REQUIRED X DIMENSION FROM ANY PERIMETER BREAK OR HEEL JOINT AND A MINIMUM OF 6" FROM ANY INTERIOR JOINT (SEE SKETCH ABOVE)

TOTAL NUMBER OF NAILS EACH SIDE OF BREAK *		X INCHES	MAXIMUM FORCE (lbs) 15% LOAD DURATION							
			SP		DF		SPF		HF	
2x4	2x6		2x4	2x6	2x4	2x6	2x4	2x6	2x4	2x6
20	30	24"	1706	2559	1561	2342	1320	1980	1352	2028
26	39	30"	2194	3291	2007	3011	1697	2546	1738	2608
32	48	36"	2681	4022	2454	3681	2074	3111	2125	3187
38	57	42"	3169	4754	2900	4350	2451	3677	2511	3767
44	66	48"	3657	5485	3346	5019	2829	4243	2898	4347

* DIVIDE EQUALLY FRONT AND BACK

DO NOT USE REPAIR FOR JOINT SPLICES
