Reference: Engineering Services
2402 South River Road
Lillington, NC 27577
TE&D Project No.: 2401-020635

As requested by the client, a representative of Tyndall Engineering & Design, PA (TE&D) was on-site to observe the following items per the home inspection report:

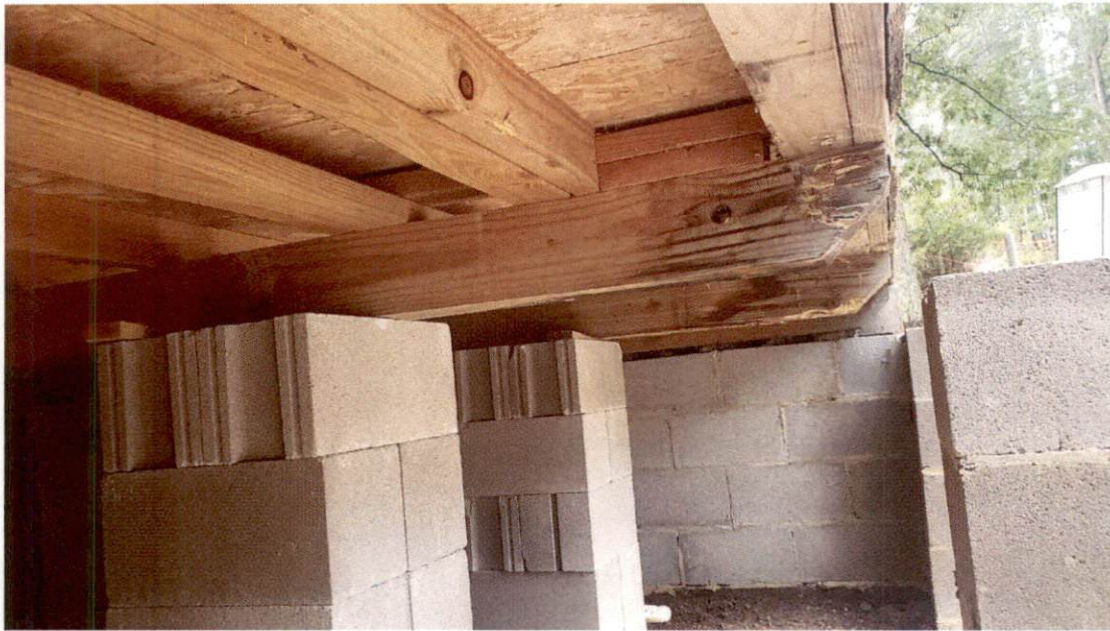
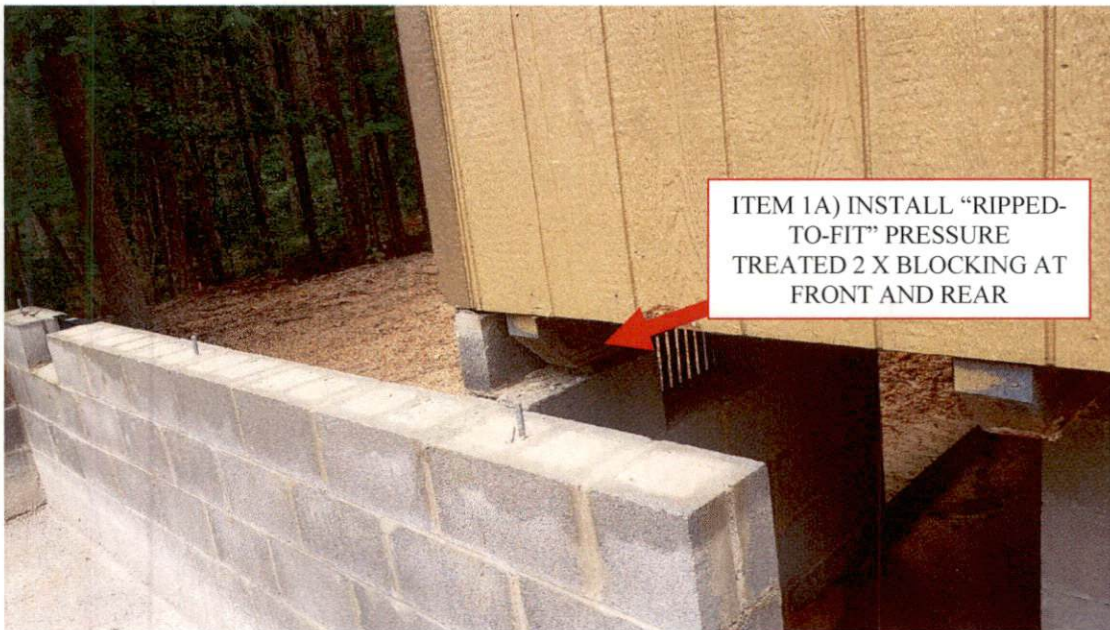
1. We observed the existing 4 x 6 girders as being cantilevered approximately 3'-3". Based on our observations and analysis, the cantilevered girders are inadequate to support the anticipated loading conditions. We recommend the following:

Item 1) Examples of cantilevered girders

- a. The front and rear exterior girders/rimjoists are inadequate to support the anticipated loading conditions. We recommend that these girders be blocked solid to the existing foundation wall below with "ripped-to-fit" pressure treated 2 x blocking. Wood or steel shims may be used to ensure a tighter fit; however, angled shims may not be used.

- b. While the (3) center girders remain adequate, this is under the assumption that the the proposed addition is self-supporting and will not bear on the existing structure. Therefore, provided that the aforementioned criteria are met, the (3) cantilevered center girders will remain adequate to support the anticipated loading conditions.

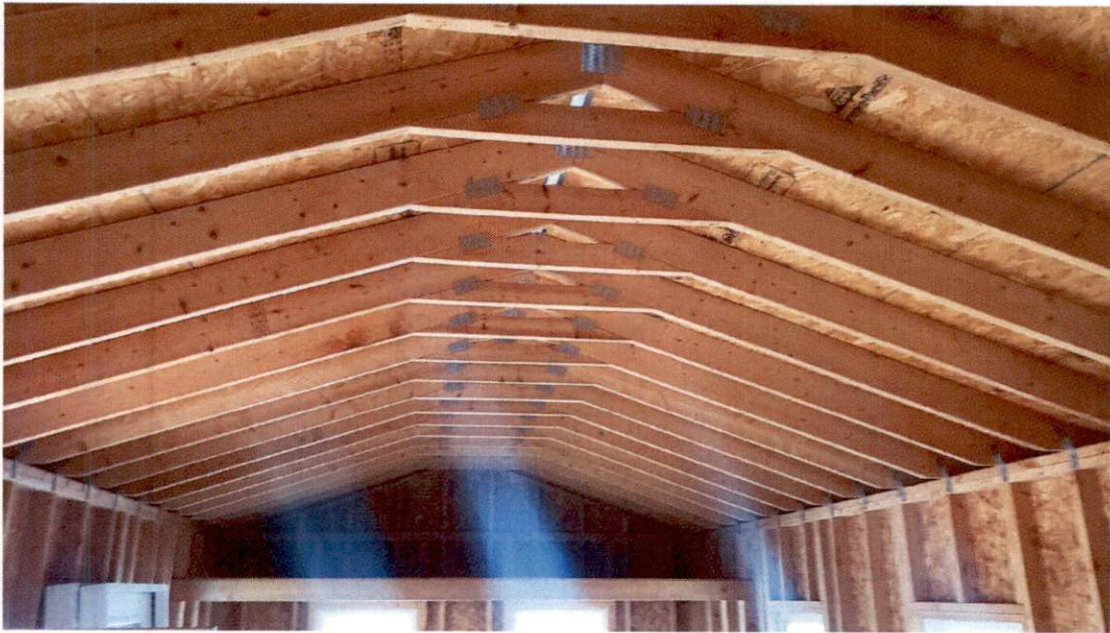
2. We observed the roof of the existing structure as consisting of roof trusses at 16" o.c. TE&D was not provided with the roof truss drawings for the home; however, we did not visually observe any defects (i.e. cracks, damage, rot, deterioration) within the existing roof trusses during our inspection.

Item 2) Example of existing roof trusses
