ATTACH 2x_ SCAB OF THE SAME SIZE AND GRADE AS THE BROKEN MEMBER TO EACH FACE OF THE TRUSS (CENTER ON BREAK OR SPLICE) WITH 10d (0.131" X 3") NAILS (TWO ROWS FOR 2x4, THREE ROWS FOR 2x6) SPACED 4" O.C. AS SHOWN. STAGGER NAIL SPACING FROM FRONT FACE AND BACK FACE FOR A NET 0-2-0 O.C. SPACING IN THE MAIN MEMBER. USE A MIN. 0-3-0 MEMBER END DISTANCE.

WARNING - Verify design parameters and READ NOTES ON THIS AND INCLUDED MITEK REFERENCE PAGE MII-7473 rev. 5/19/2020 BEFORE USE.

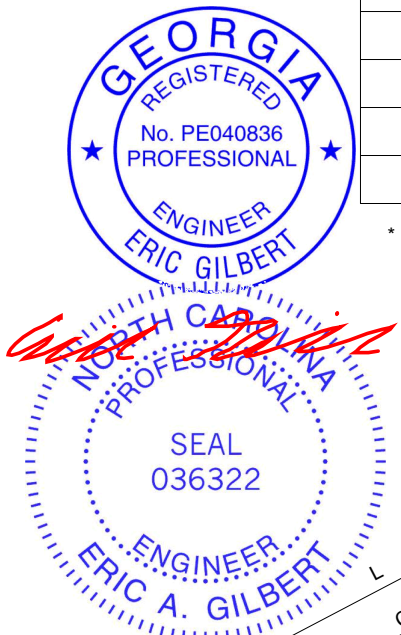
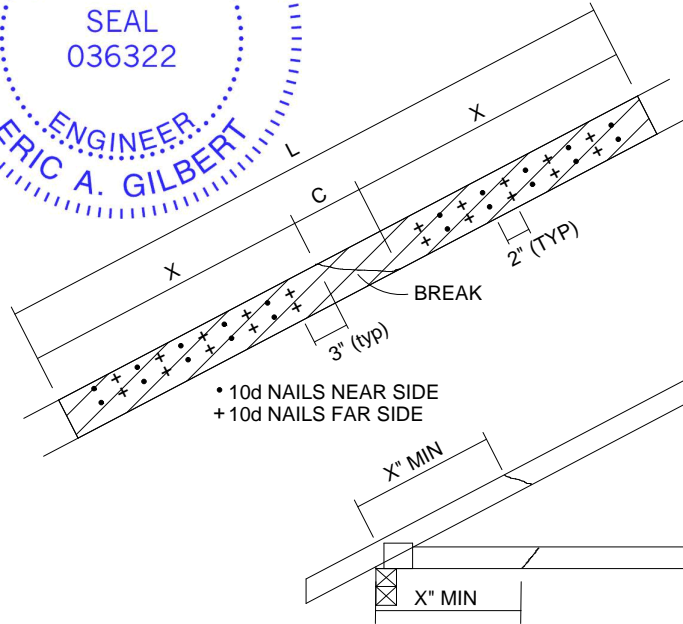
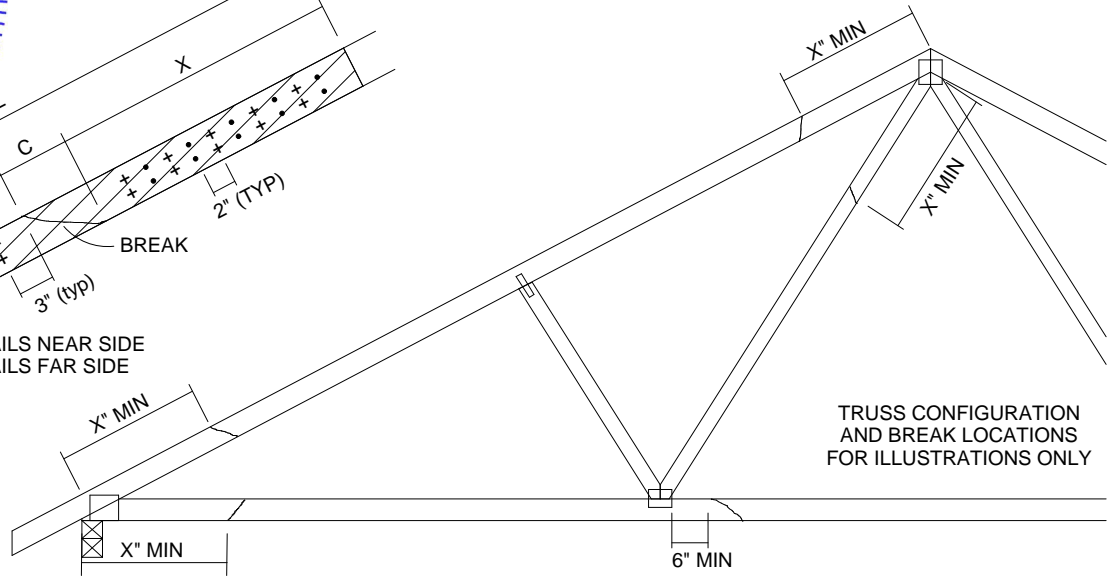
THE LENGTH OF THE BREAK (C) SHALL NOT EXCEED 12". (C=PLATE LENGTH FOR SPLICE REPAIRS)
THE MINIMUM OVERALL SCAB LENGTH REQUIRED (L) IS CALCULATED AS FOLLOWS:
 $L = (2) X + C$

THE LOCATION OF THE BREAK MUST BE GREATER THAN OR EQUAL TO THE REQUIRED X DIMENSION FROM ANY PERIMETER BREAK OR HEEL JOINT AND A MINIMUM OF 6" FROM ANY INTERIOR JOINT (SEE SKETCH ABOVE)

TOTAL NUMBER OF NAILS EACH SIDE OF BREAK *		X INCHES	MAXIMUM FORCE (lbs) 15% LOAD DURATION							
			SP		DF		SPF		HF	
2x4	2x6		2x4	2x6	2x4	2x6	2x4	2x6	2x4	2x6
20	30	24"	1706	2559	1561	2342	1320	1980	1352	2028
26	39	30"	2194	3291	2007	3011	1697	2546	1738	2608
32	48	36"	2681	4022	2454	3681	2074	3111	2125	3187
38	57	42"	3169	4754	2900	4350	2451	3677	2511	3767
44	66	48"	3657	5485	3346	5019	2829	4243	2898	4347

* DIVIDE EQUALLY FRONT AND BACK

DO NOT USE REPAIR FOR JOINT SPLICES
