RE: Daily Field Report for 10/21/2024
Lot 601 Colony at Lexington (CMT) Cameron, NC
Building & Earth Project No : RD240866

Field Observations Report

Project Name:	Lot 601 Colony at Lexington (CMT) Cameron, NC	Project Number:	RD240866
Client Name:	Dream Finders Homes-Carolinas	Placement#:	FO-1
Contractor:	Dream Finders Homes-Carolinas	Technician:	German Castro
Monitoring:	DCP

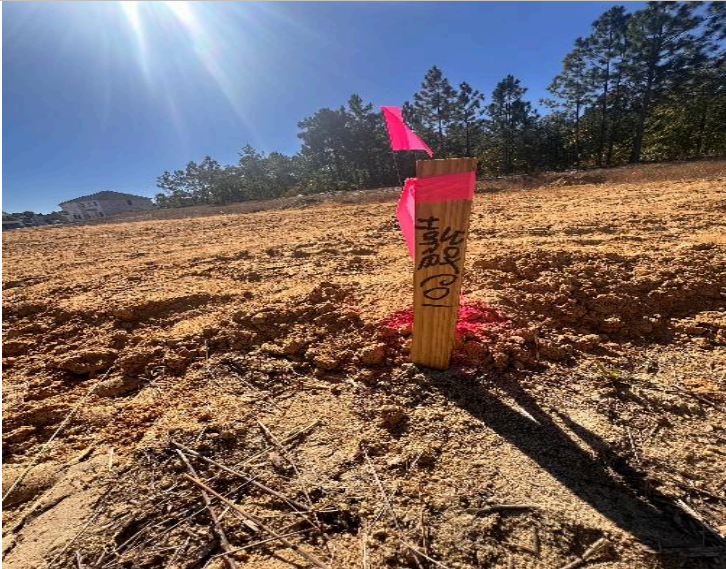
Picture ID	Lot
95263

The lot is relatively flat. Building locations are referenced from the street looking at the front of the residence. Surface water runoff appears to drain rear sides.

The site has been stripped of surface cover and topsoil.

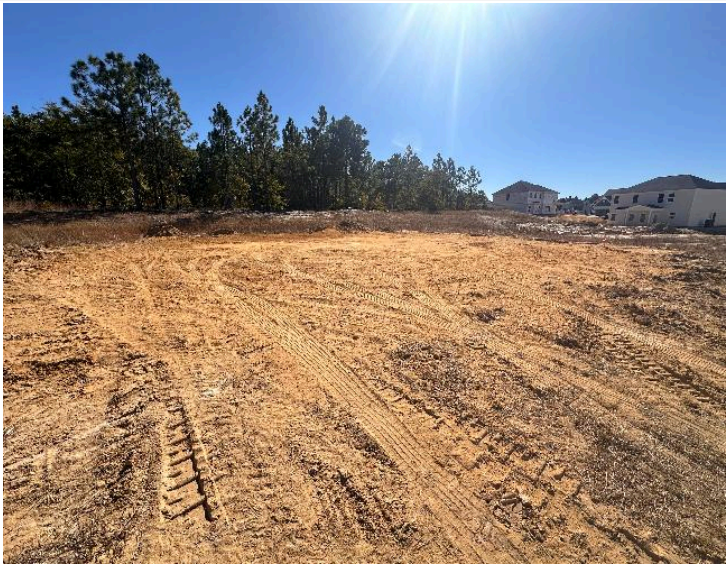
Picture ID	Observation area
95264

Hand Rod Probing: Our representative performed hand rod probing of the surface of the building pad. Hand rod probing of the bearing material generally showed an average penetration of approximately 0.5 inch.

Based on our observations and test results, the newly placed fill/existing soils appear to be suitable to provide support for the floor slab and footings, provided the floor slab has a loading of less than 150 pounds per square foot, and the footings have a design bearing capacity of 2,000, or less.

To minimize the potential for future softening of the bearing materials due to water infiltration, the surface soils should be protected from construction traffic and inclement weather. The construction of the footings and structure should commence without delay. In the event that the subgrade soils become wet, or otherwise compromised from their current condition, should be observed and retested as necessary by Building and Earth Sciences.
