**RE:** Daily Field Report for 11/08/2024  
Lot 48 Watson Ridge (CMT) Sanford, NC  
Building & Earth Project No : RD240917

## Field Observations Report

### 1 : Foundation Inspection

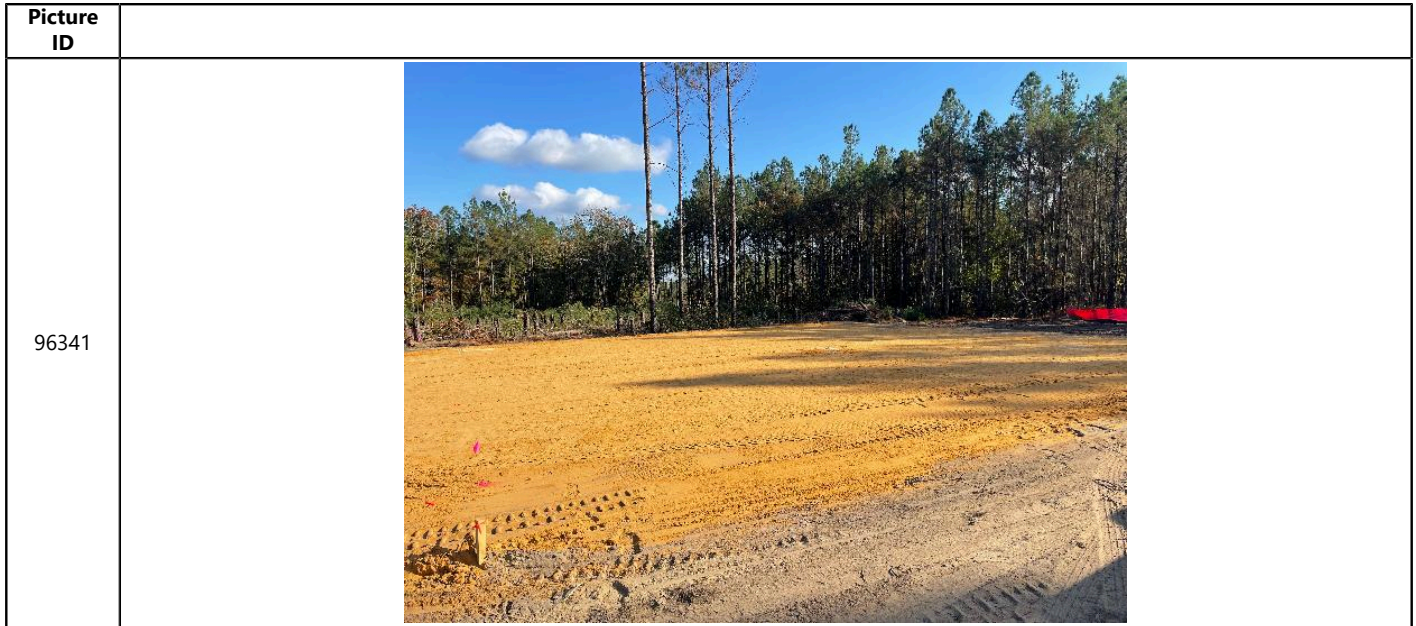
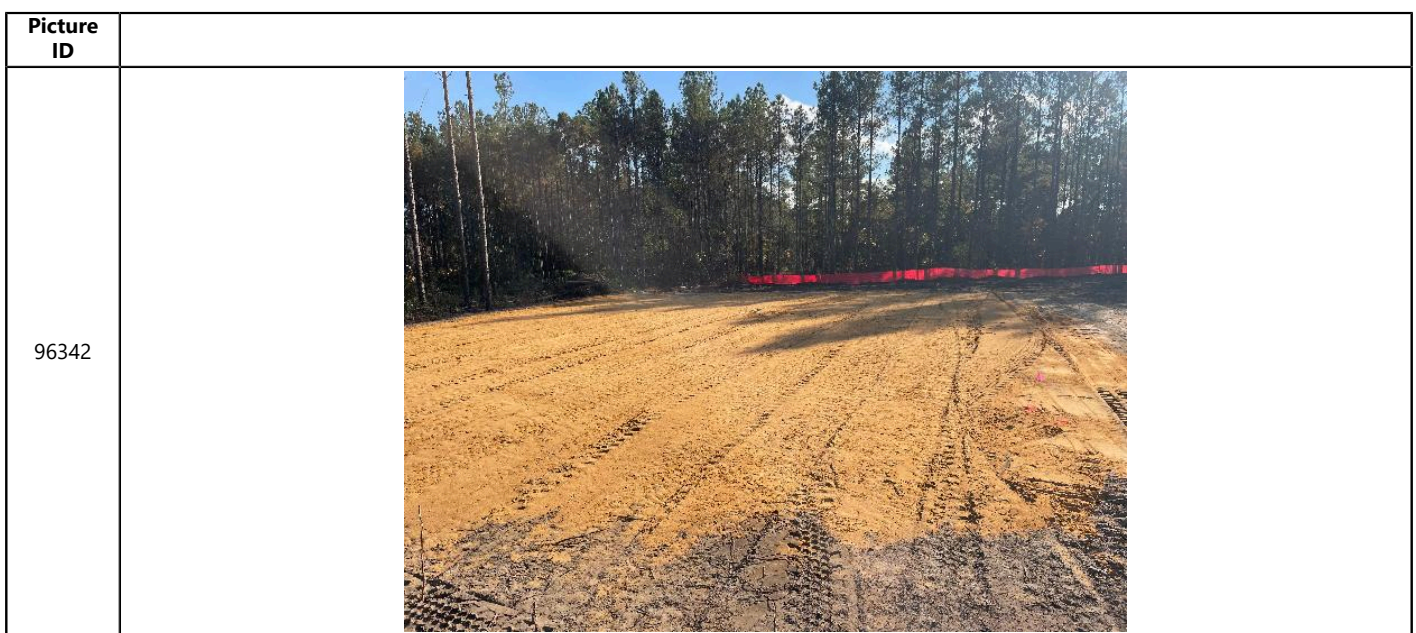
### Photographs

The lot is relatively flat. Building locations are referenced from the street looking at the front of the residence. Maximum relief across the lot is approximately 2 feet. Surface water runoff appears to drain towards the rear of the property.

The site has been stripped of surface cover and topsoil, has been undercut to remove excessive organic soils. It appears that 4 inches of topsoil has been removed from the building pad area.

Hand Rod Probing: Our representative performed hand rod probing of the surface of the building pad. Hand rod probing of the bearing material generally showed an average penetration of approximately 6 inches.

To minimize the potential for future softening of the bearing materials due to water infiltration, the surface soils should be protected from construction traffic and inclement weather. The construction of the footings and structure should commence without delay. In the event that the subgrade soils become wet, or otherwise compromised from their current condition, should be observed and retested as necessary by Building and Earth Sciences.
