RE: Daily Field Report for 01/08/2025
Lot 570 Creekside Oaks North (CMT) Lillington, NC
Building & Earth Project No : RD250002

Field Observations Report

1 : Foundation Inspection

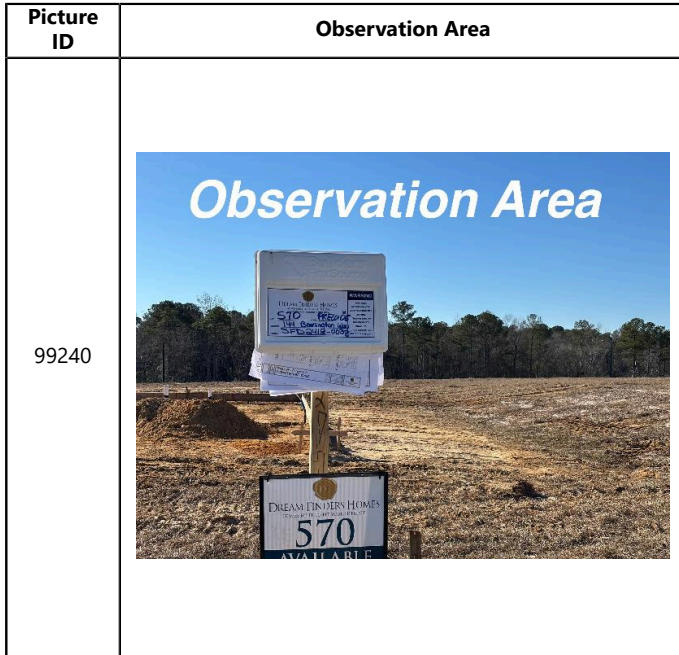
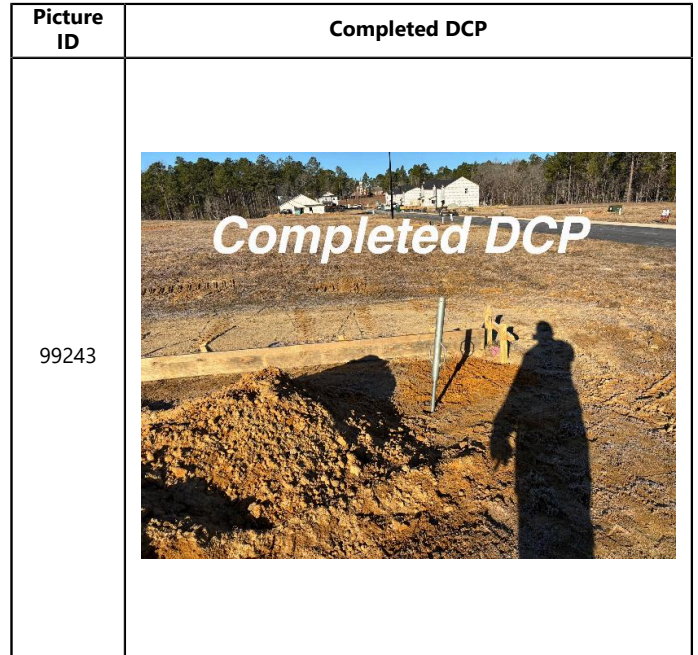
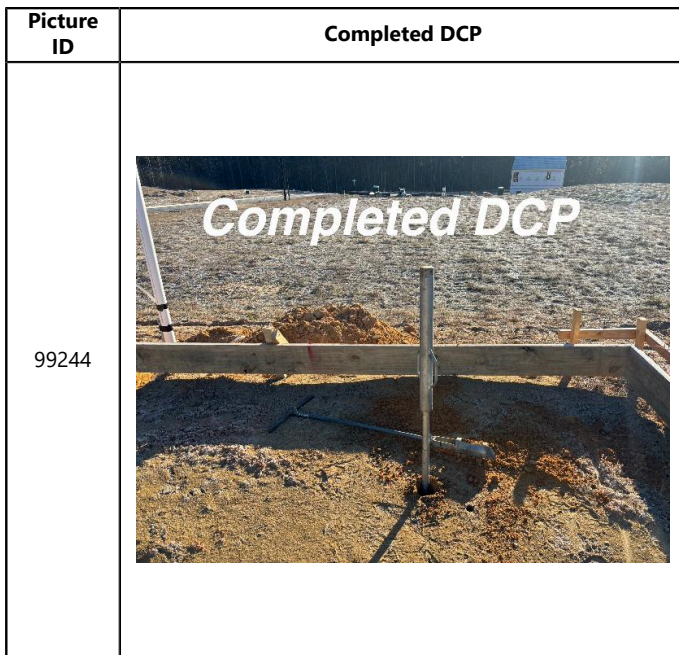
Photographs

Project Name: Lot 570 Creekside Oaks North (CMT) Lillington, NC	Project Number: RD250002
Client Name: Dream Finders Homes-Carolinas	Placement#: FO-1
Contractor: Dream Finders Homes-Carolinas	Technician: Ahmad Shelton
Monitoring: DCP

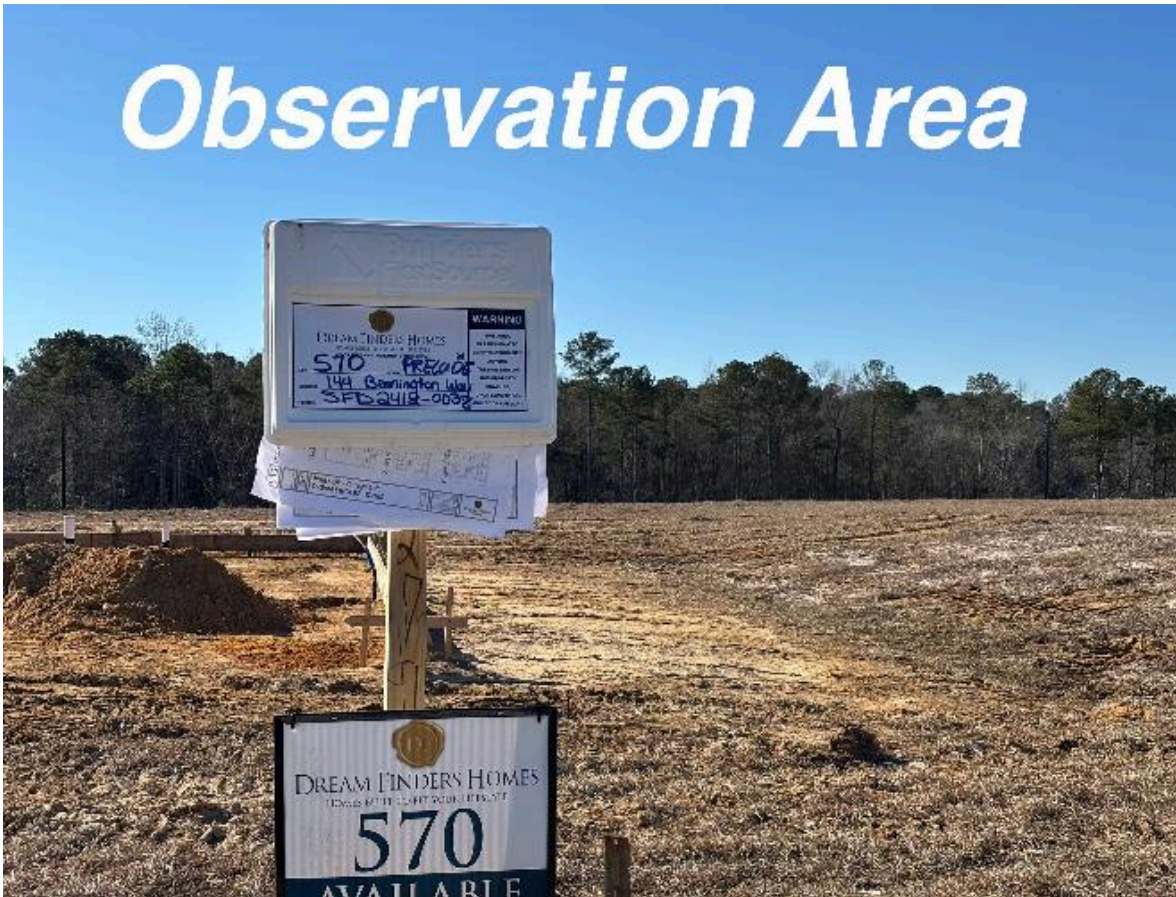
Picture ID	Observation Area
99236

<p>The photograph shows a cleared, brownish field under a clear blue sky. In the foreground, a wooden post holds two signs. The top sign is white with a 'WARNING' section and handwritten text: '570 PREVIOUSLY 144 Garlington Way SFD 2418-0000'. Below it is a smaller sign with a diagram. The bottom sign is black and white, reading 'DREAM FINDERS HOMES' and '570 AVAILABLE'. The background consists of a line of trees.</p>
