Reference: Engineering Services  
504 CC Byrd Ln.  
Linden, NC 28356  
TE&D Project No.: 2401-020053

1. Analysis of the existing basement foundation walls for proposed construction.

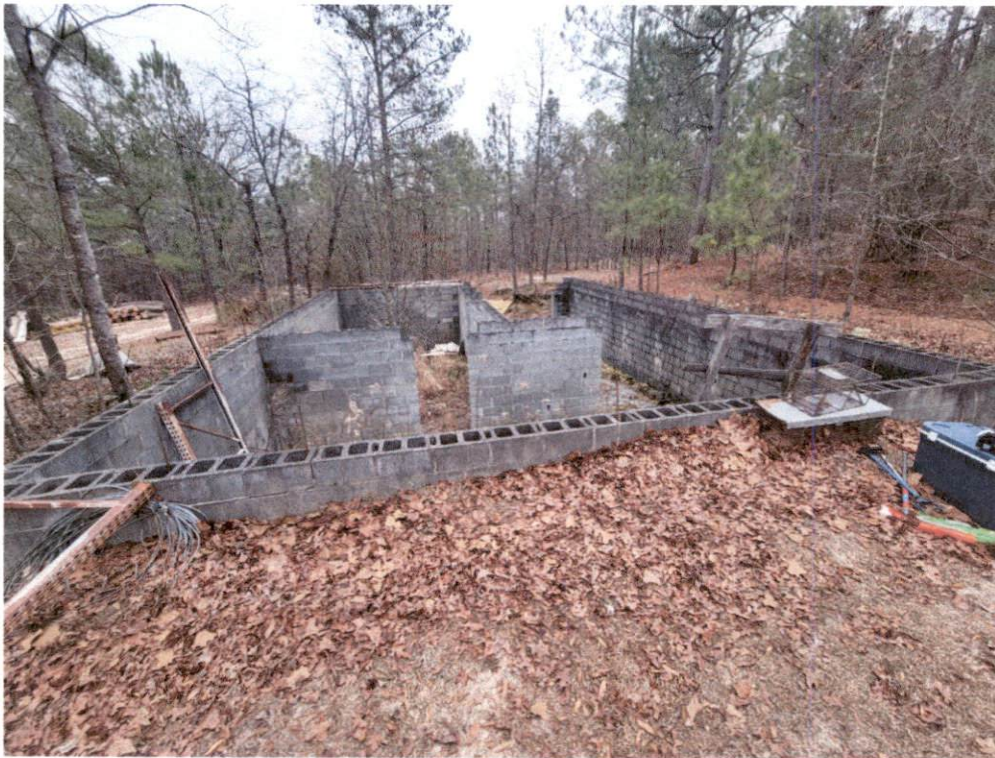
1. We observed an 8'-0" tall CMU basement foundation comprised of 10" wide CMU blocks at the exterior walls and 8" wide CMU blocks at the interior walls. The foundation wall was installed on an 18" wide by 8" deep continuous concrete footing. The exterior foundation was reinforced with #4 rebar installed vertically at 48" o.c. and with horizontal "H-wire" installed at 16" o.c. Based on our observations and analysis, the following modifications and repairs are to be installed:

Foundation Observed (rear view)

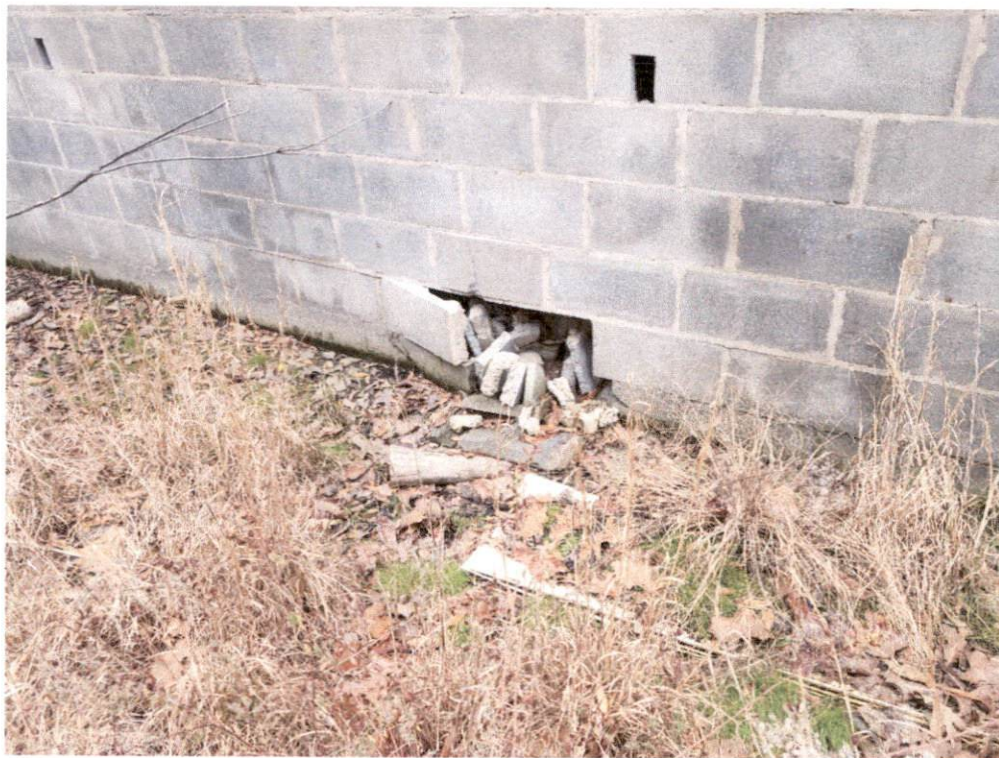
Damaged Right Foundation Wall

- A. Impact damage was observed at the right exterior foundation wall. All damaged CMU blocks are to be removed and the damaged section of the foundation wall is to be rebuilt per the 2018 North Carolina Residential Building Code by a certified mason.

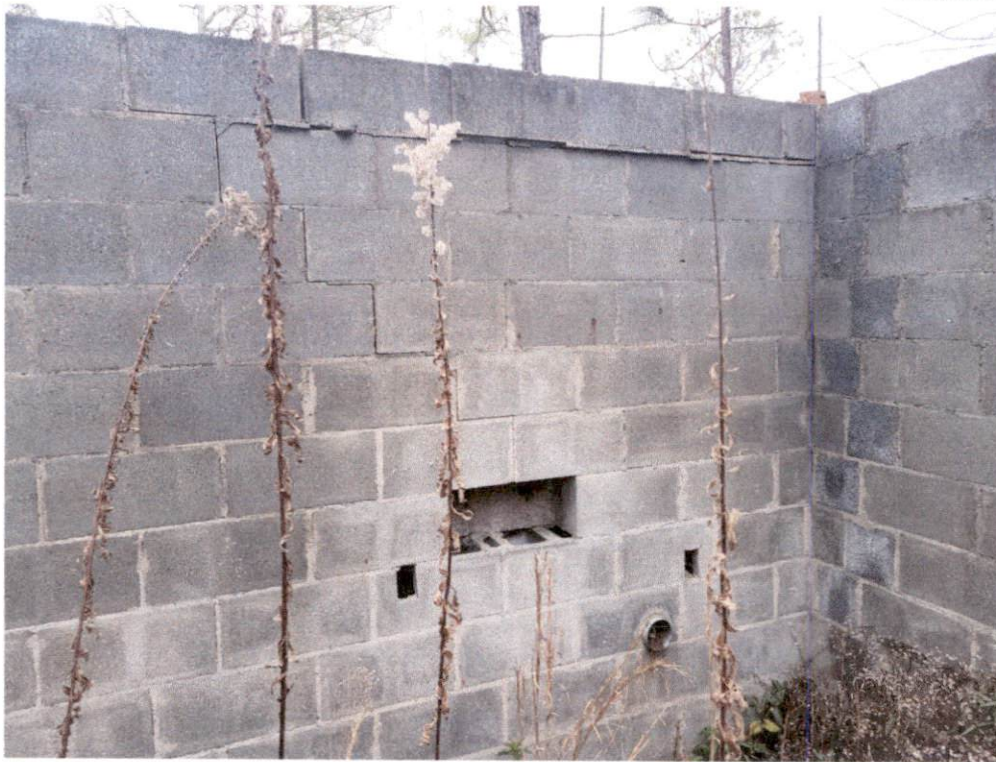
Damaged Back Foundation Wall

- B. Impact damage was observed at the back-exterior foundation wall. All damaged CMU blocks are to be removed and the damaged section of the foundation wall is to be rebuilt per the 2018 North Carolina Residential Building Code by a certified mason.

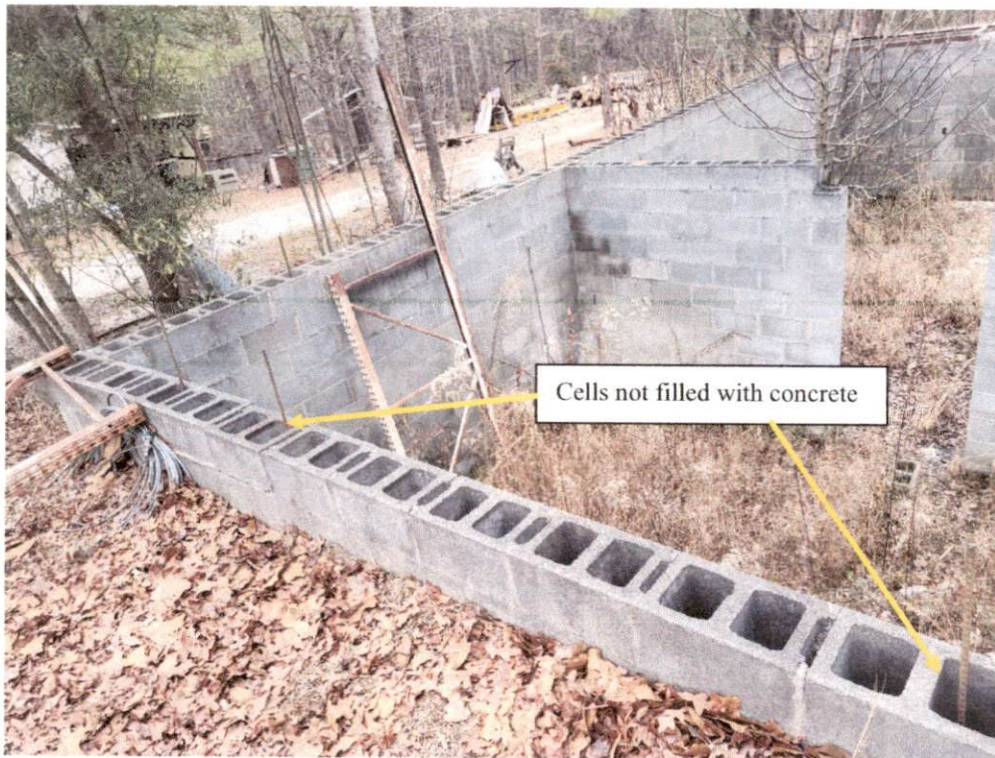
Section of missing Vertical Reinforcement

- C. Multiple vertical #4 rebar was missing from the back-exterior wall of the foundation. New vertical #4 rebar reinforcement is to be installed at 48" o.c. in the back wall per the 2018 North Carolina Residential Building Code.
