RE: Daily Field Report for 06/09/2025
Lot 29 Watson Ridge Garage (CMT) Sanford, NC
Building & Earth Project No : RD250558

Report of Field Density Testing

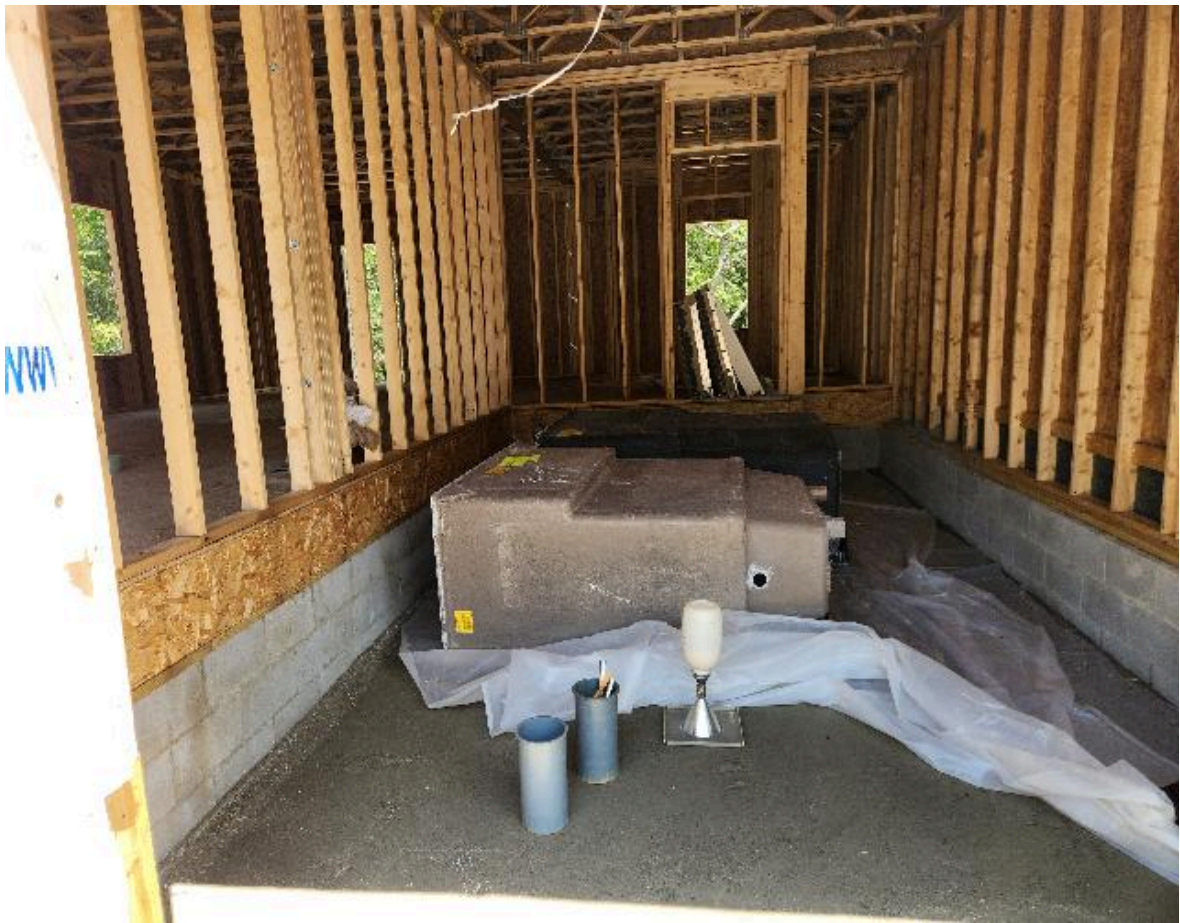
108417

Test #	IDs		Test Type	Location	Probe Depth (in)	Elev. (ft)	Dry Density(pcf)	% Moisture	% Compaction	Result
	Area	Proctor								
1	FSG-Bldg	1-point	ASTMD1556	Finished Subgrade Soils -Building : Lot 29 Front of garage :		FSG	122.2	8.2	99%	PASS

Lot 29 garage front
