**RE:** Daily Field Report for 06/10/2025  
3162 Cameron Hill Road (CMT) Cameron, NC  
Building & Earth Project No : RD250556

## Field Observations Report

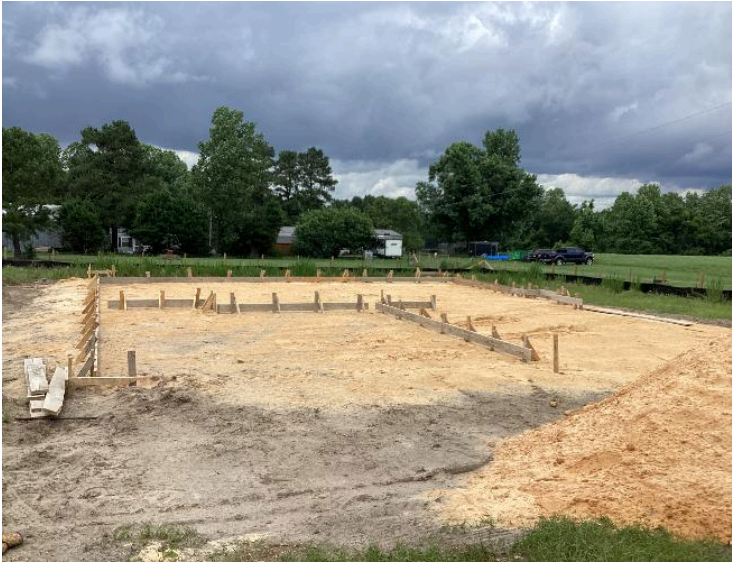
Picture ID	Front
108551

The lot sloped front to back. Building locations are referenced from the street looking at the front of the residence. Maximum relief across the lot is approximately 2 feet. Surface water runoff appears to drain to the rear.

The site has been stripped of surface cover and topsoil.

Structural fill has been placed at the site to level the building pad. Based on our observations, we understand the pad has been filled according to the following:
