MiTek USA, Inc.

ATTACH 2x SCAB OF THE SAME SIZE AND GRADE AS THE BROKEN MEMBER TO EACH FACE OF THE TRUSS (CENTER ON BREAK OR SPLICE) WITH 10d NAILS (TWO ROWS FOR 2x4, THREE ROWS FOR 2x6) SPACED 4" O.C. AS SHOWN. (.131" dia. x 3") STAGGER NAIL SPACING FROM FRONT FACE AND BACK FACE FOR A NET 0-2-0 O.C. SPACING IN THE MAIN MEMBER. USE A MIN. 0-3-0 MEMBER END DISTANCE.

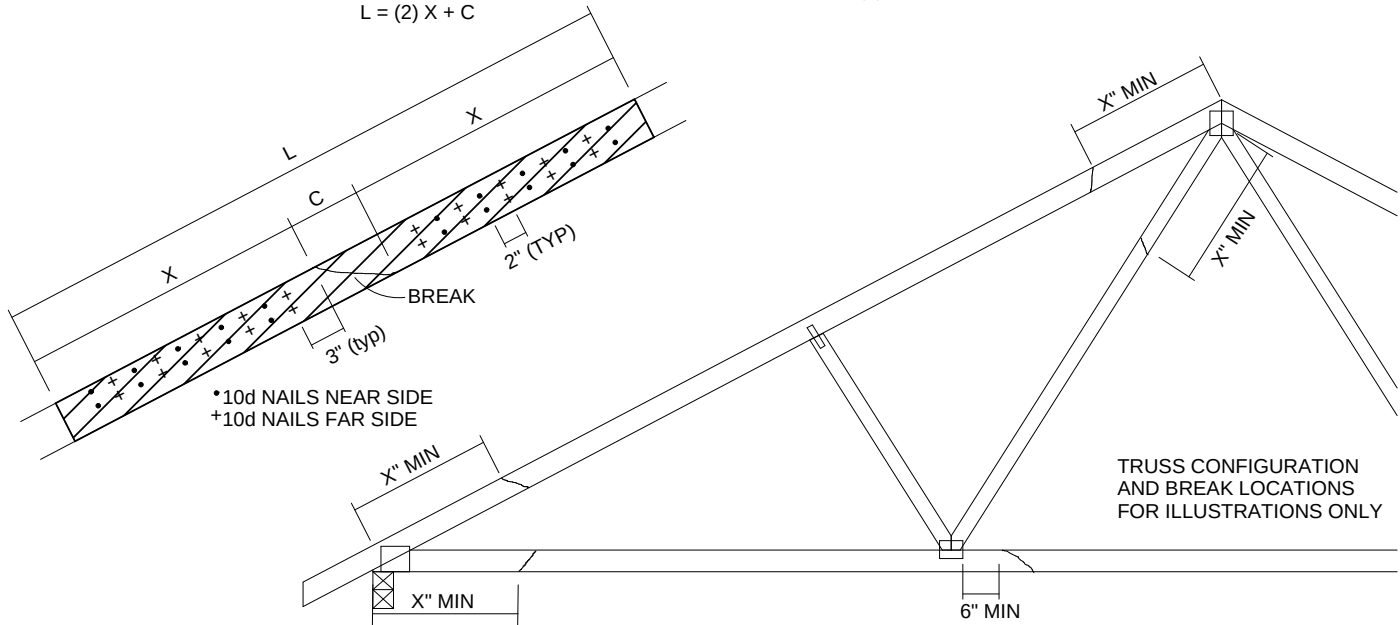
THE LENGTH OF THE BREAK (C) SHALL NOT EXCEED 12". (C=PLATE LENGTH FOR SPLICE REPAIRS)  
THE MINIMUM OVERALL SCAB LENGTH REQUIRED (L) IS CALCULATED AS FOLLOWS:

$$L = (2) X + C$$

THE LOCATION OF THE BREAK MUST BE GREATER THAN OR EQUAL TO THE REQUIRED X DIMENSION FROM ANY PERIMETER BREAK OR HEEL JOINT AND A MINIMUM OF 6" FROM ANY INTERIOR JOINT (SEE SKETCH ABOVE)

DO NOT USE REPAIR FOR JOINT SPLICES
