RE: Daily Field Report for 06/20/2025
Lot 546 Creekside Oaks North (CMT) Lillington, NC
Building & Earth Project No : RD250610

Field Observations Report

Project Name:	Lot 546 Creekside Oaks North (CMT) Lillington, NC	Project Number:	RD250610
Client Name:	Dream Finders Homes-Carolinas	Placement#:	FO-1
Contractor:	Dream Finders Homes-Carolinas	Technician:	Anthony Wisniewski
Monitoring:	DCP

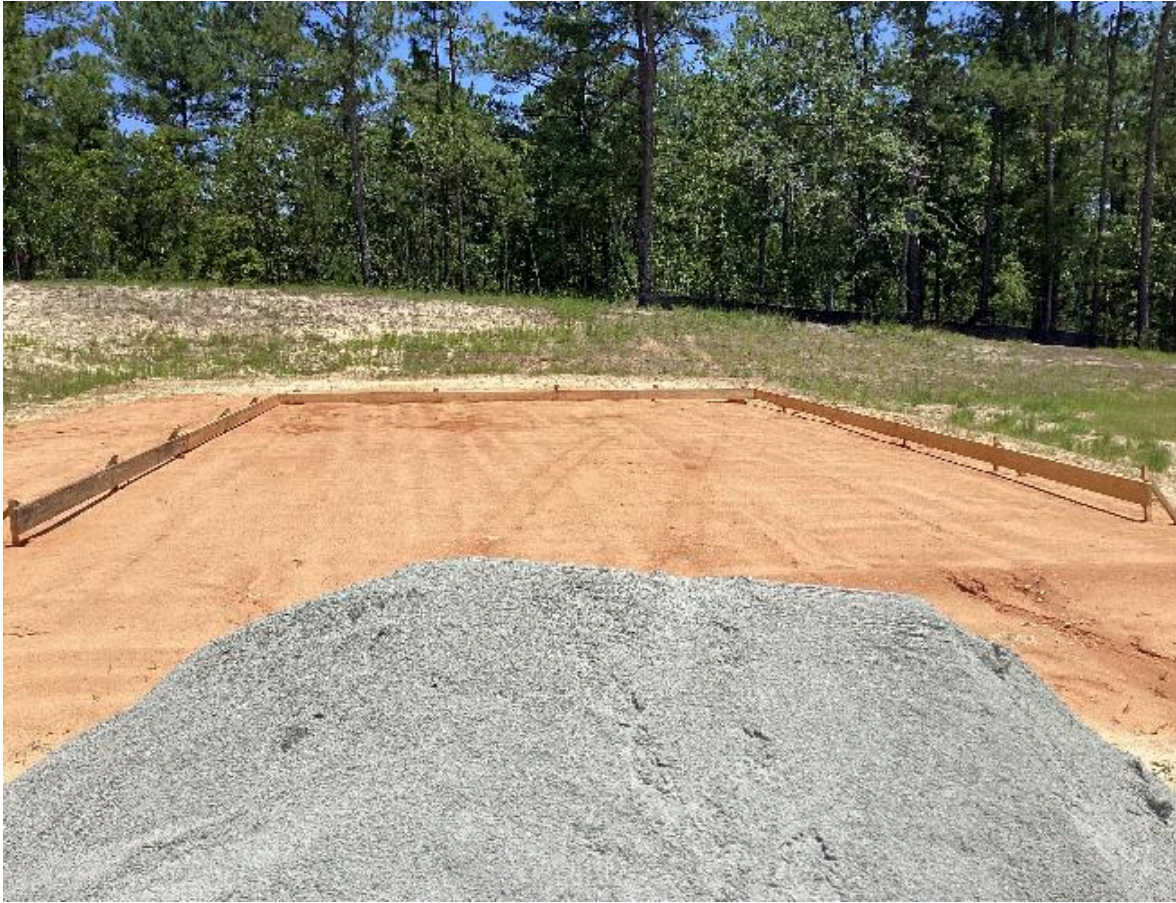
Picture ID	Front
109400

The site slopes downward from left to right. Building locations are referenced from the street looking at the front of the residence. Maximum relief across the lot is approximately 10 feet. Surface water runoff appears to drain to the right.

The site has been stripped of surface cover and topsoil. It appears that 6 inches of topsoil has been removed from the building pad area.

Structural fill has been placed at the site to level the building pad. Based on our observations, we understand the pad has been filled according to the following:

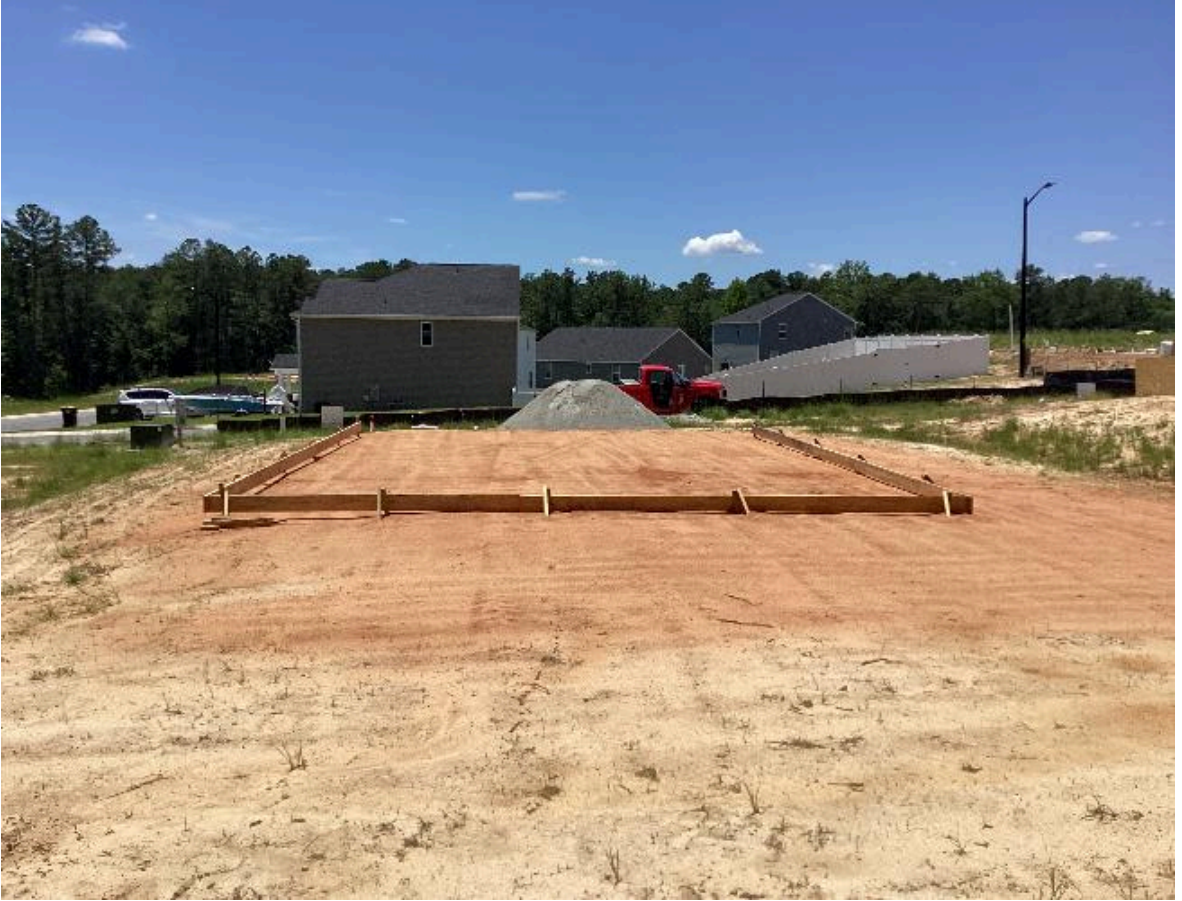
Picture ID	Rear
109401

Hand Rod Probing: Our representative performed hand rod probing of the surface of the building pad. Hand rod probing of the bearing material generally showed an average penetration of approximately 1 inches. Areas of soft material were noted on the back left with the hand rod probing to a depth of about 4 inches.
