**RE:** Daily Field Report for 06/05/2025  
Lot 553 Creekside Oaks North (CMT) Lillington, NC  
Building & Earth Project No : RD250526

## Field Observations Report

### 1 : Foundation Inspection

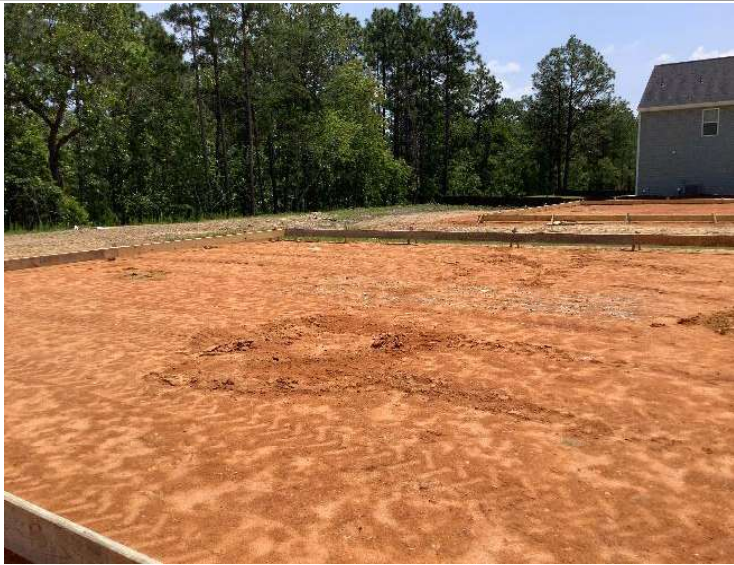
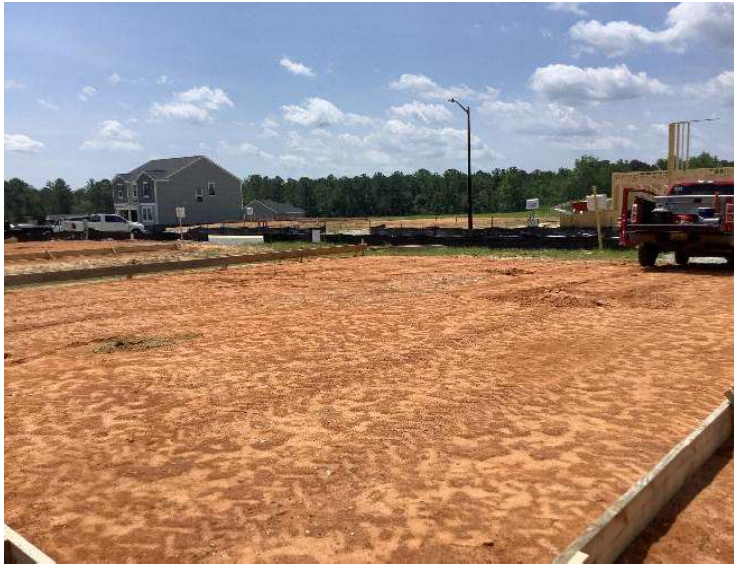
### Photographs

Based on our observations and test results, the newly placed fill/existing soils appear to be disturbed we recommend to reroll the surface soil before the placement of the slab.

Comment 1 : Based on our observations and test results, the newly placed fill/existing soils appear to be disturbed we recommend to reroll the surface soil before the placement of the slab.
