**RE:** Daily Field Report for 06/09/2025  
Lot 568 Creekside Oaks North (CMT) Lillington, NC  
Building & Earth Project No : RD250528

## Field Observations Report

### 1 : Shallow Foundation Inspection

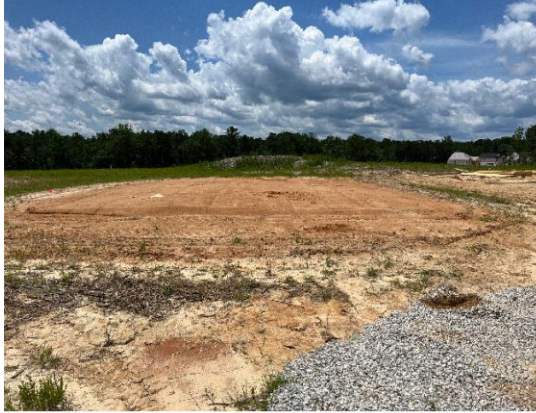
| Picture ID | Observation Area |
|---|---|
| 108389 | |

We arrived onsite to evaluate the building pad area for this residential lot. We understand the residence has been designed to be supported on a monolithic slab foundation. Upon arrival, the contractor had not finished excavating the footings. Our evaluation as documented in this report includes:

The site has been stripped of surface cover and topsoil. It appears that 4 inches of topsoil has been removed from the building pad area.

Structural fill has been placed at the site to level the building pad. Based on our observations, we understand the pad has been filled according to the following:

Based on our observations and test results, the newly placed fill/existing soils appear to be suitable to provide support for the floor slab and footings, provided the floor slab has a loading of less than 150 pounds per square foot, and the footings have a design bearing capacity of 2,000, or less.
