**RE:** Daily Field Report for 06/09/2025  
Lot 571 Creekside Oaks North (CMT) Lillington, NC  
Building & Earth Project No : RD250530

## Field Observations Report

### 1 : Shallow Foundation Inspection

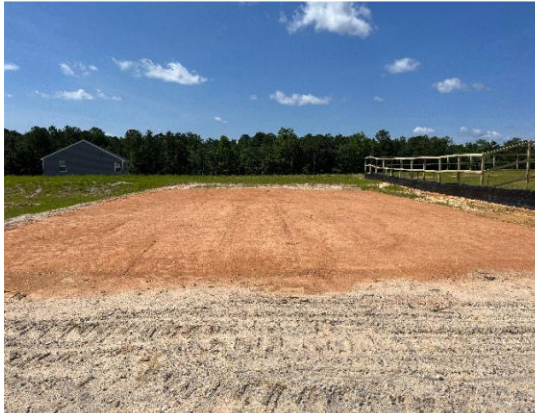
Picture ID	Observation Area
108393

We arrived onsite to evaluate the building pad area for this residential lot. We understand the residence has been designed to be supported on a monolithic slab foundation. Upon arrival, the contractor had not finished excavating the footings. Our evaluation as documented in this report includes:

The lot is relatively flat. The site slopes downward from Back to Front. Building locations are referenced from the street looking at the front of the residence. Maximum relief across the lot is approximately 1 foot. Surface water runoff appears to drain towards the road.

The site has been stripped of surface cover and topsoil. It appears that 4 inches of topsoil has been removed from the building pad area.

Based on our observations and test results, the newly placed fill/existing soils appear to be suitable to provide support for the floor slab and footings, provided the floor slab has a loading of less than 150 pounds per square foot, and the footings have a design bearing capacity of 2,000, or less.
