**RE:** Daily Field Report for 08/27/2025  
Lot 577 Creekside Oaks North (CMT) Lillington, NC  
Building & Earth Project No : RD250806

## Field Observations Report

### 1 : Foundation Inspection

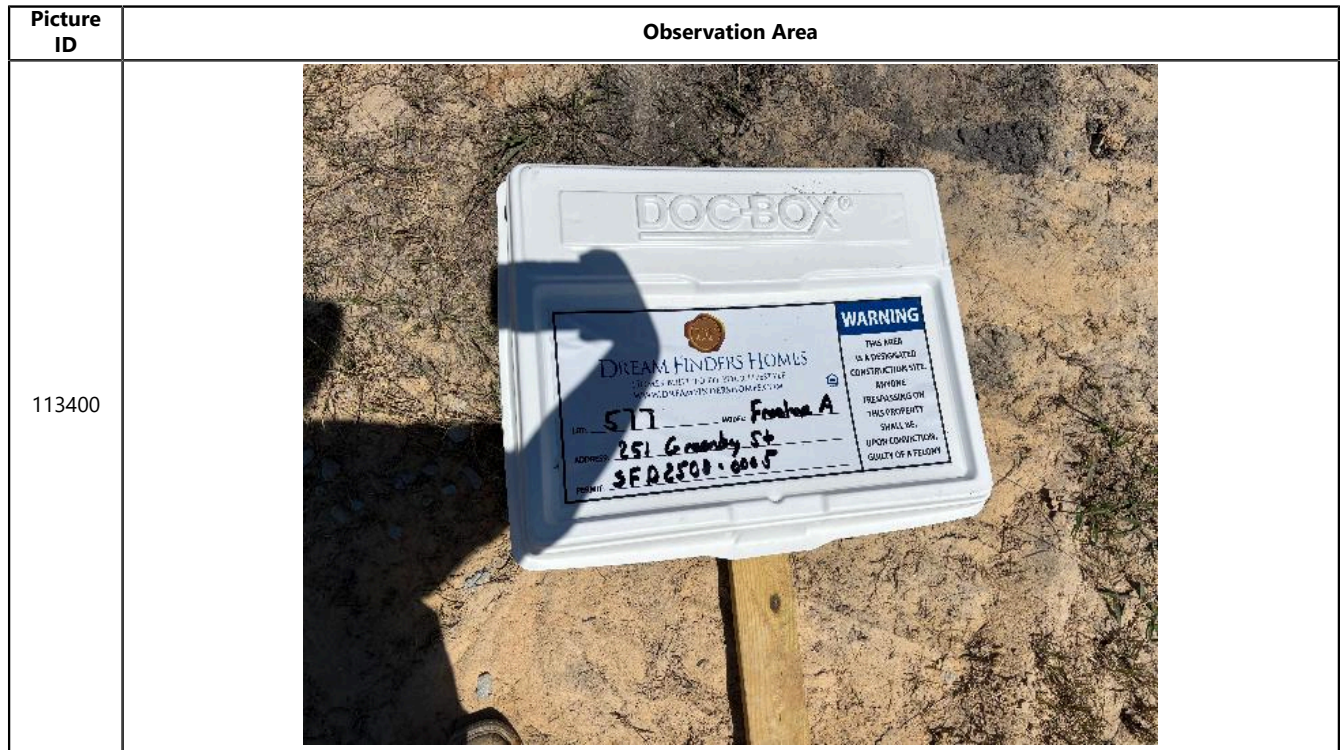
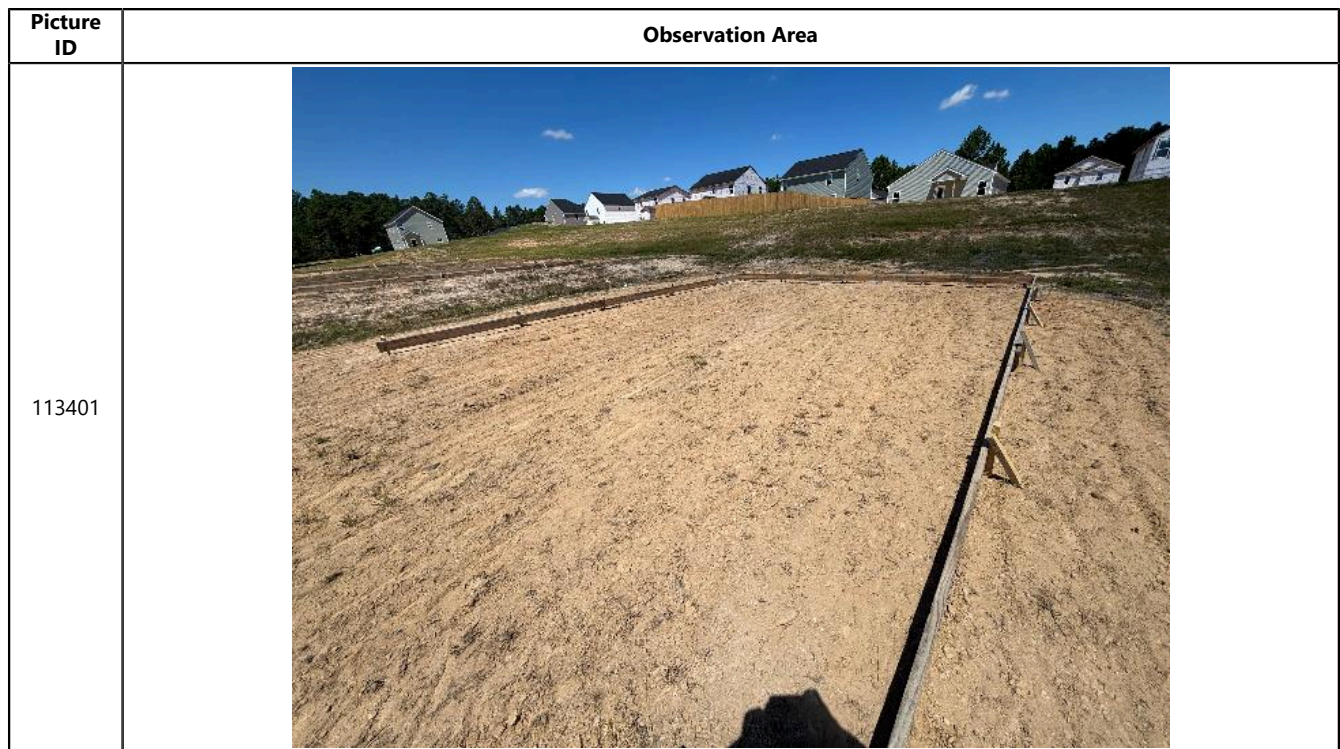
**Photographs**

We arrived onsite to evaluate the building pad area for this residential lot. We understand the residence has been designed to be supported on a monolithic slab foundation. Upon arrival, the contractor had not finished excavating the footings. Our evaluation as documented in this report includes:

The site has been stripped of surface cover and topsoil. It appears that 4 inches of topsoil has been removed from the building pad area.

Structural fill has been placed at the site to level the building pad. Based on our observations, we understand the pad has been filled according to the following:

To minimize the potential for future softening of the bearing materials due to water infiltration, the surface soils should be protected from construction traffic and inclement weather. The construction of the footings and structure should commence without delay. In the event that the subgrade soils become wet, or otherwise compromised from their current condition, should be observed and retested as necessary by Building and Earth Sciences.
