Job	Truss	Truss Type	Qty	Ply	AMERICAS HOME PLACE/JOHNSON RES
72521976REP2	B2	Truss	8	1	Job Reference (optional)

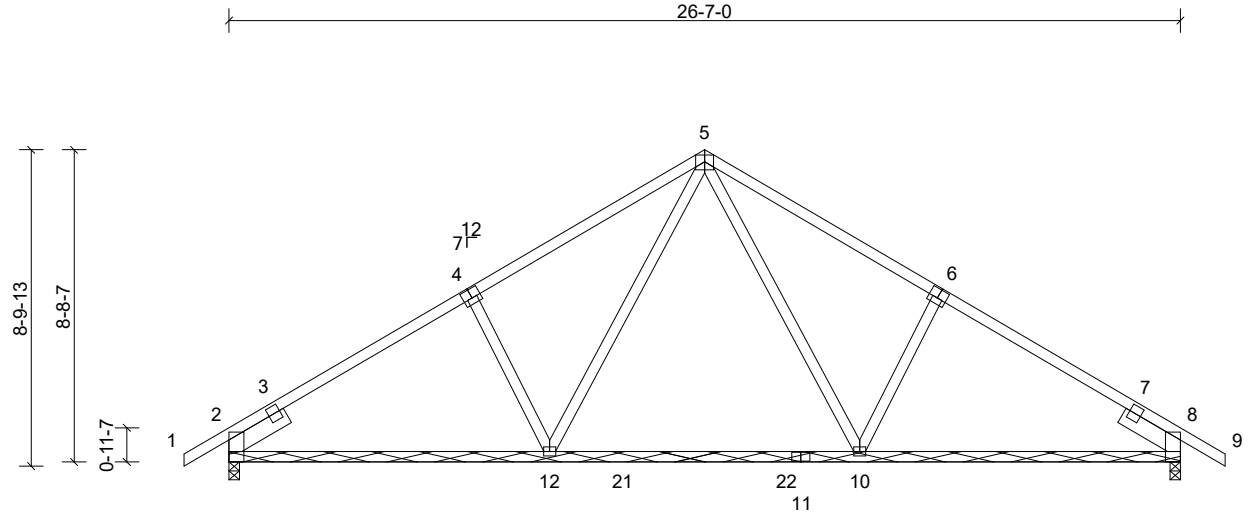
7) This repair has been prepared based on information and use conditions supplied by client. Designer has made a good faith effort to outline damage and repair conditions as reported by client. When actual field conditions do not approximate those indicated on this drawing, client shall immediately inform the engineer and refrain from applying the repair.

2x4 scab(s) may be attached with two rows of 10d nails spaced 9" oc to build down bottom chord 1" (max.) to match ceiling plane.
