AVERY POND

LOT 121

SOIL/SITE EVALUATION for ON-SITE WASTEWATER SYSTEM

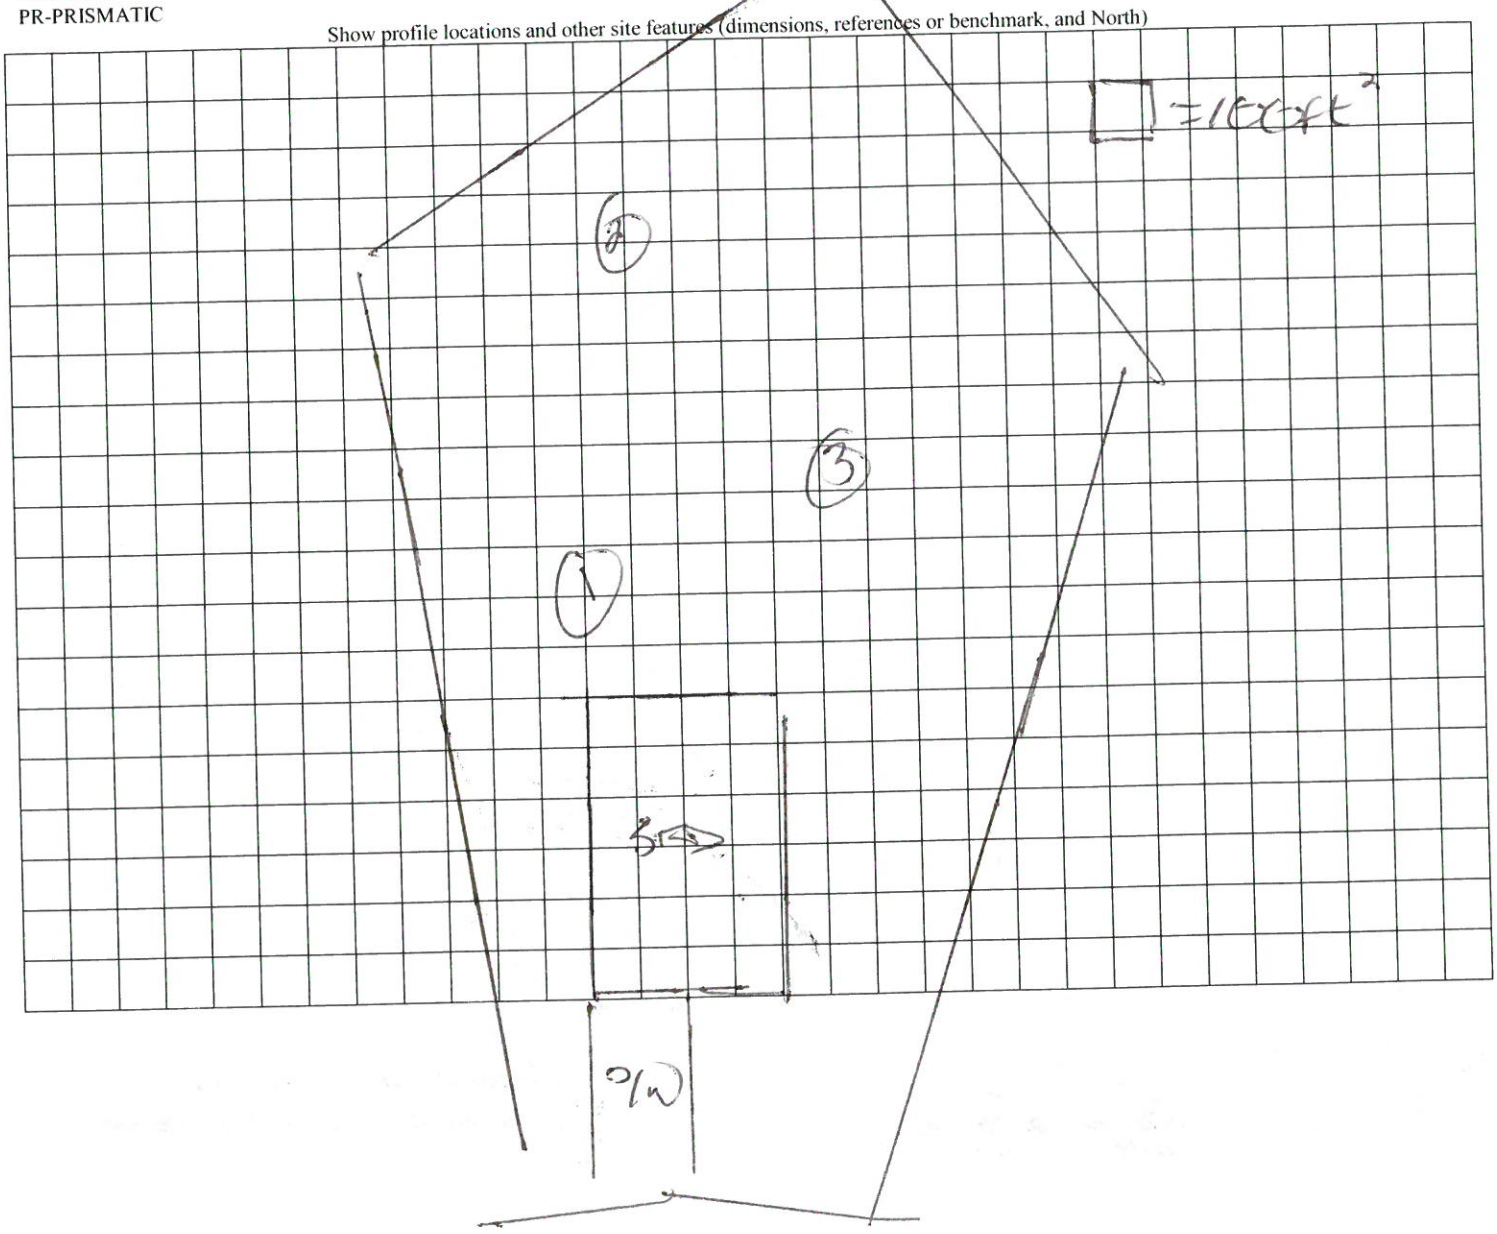
Show profile locations and other site features (dimensions, references or benchmark, and North)
