Job	Truss	Truss Type	Qty	Ply	Prof -BRUNSWICK CRAFTSMAN GR RF
72401330REP1	A2	Truss	9	1	Job Reference (optional)

Repair for a break in the top chord where indicated.

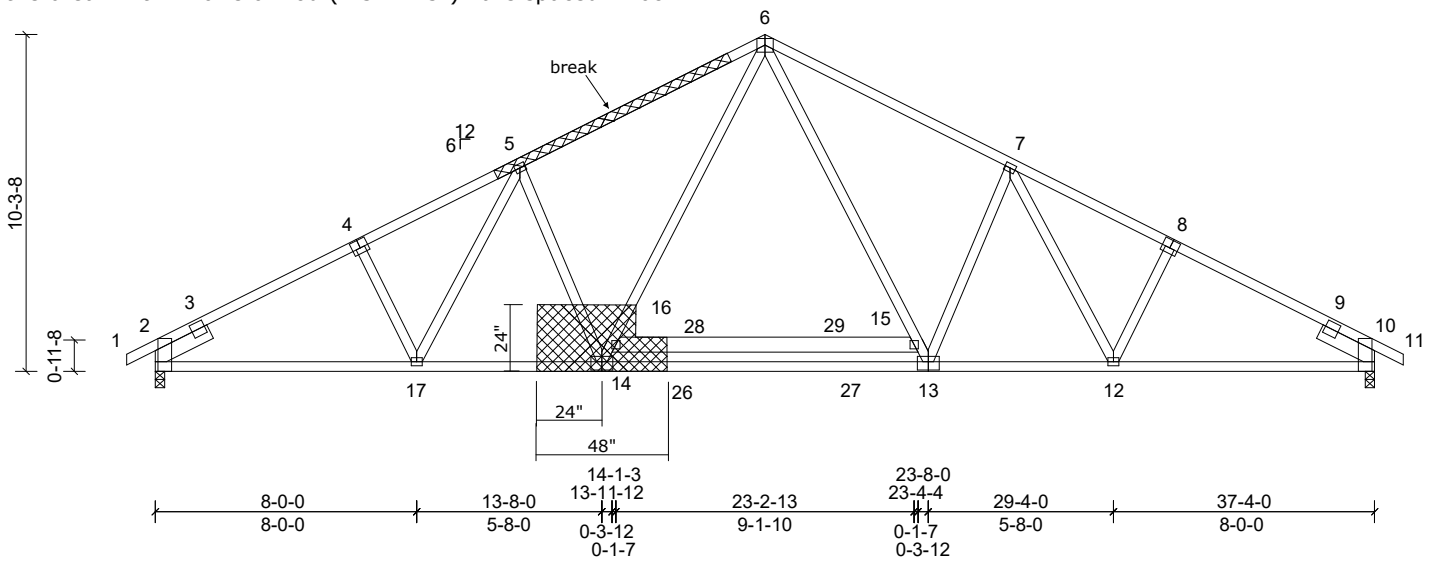
Repair for plates pulled loose at joint 14.

Attach 2x4 x 8' SP or SPF No.2 scab to each face of truss centered at the break with 2 rows of 10d (.131" x 3") nails spaced 4" oc

Attach 1/2" Plywood or 7/16" OSB (APA Rated Sheathing Exposure 1) gusset to both sides of truss as shown with two rows of 10d (.131" x 3") nails spaced 4" oc in all members from each face, driven through both sheets of plywood.
