JULY 20, 2022	FLOOR GABLE REPAIR DETAIL	MII-FLR-GBL

MiTek USA, Inc.

ENGINEERED BY TRENCO
A MiTek Affiliate

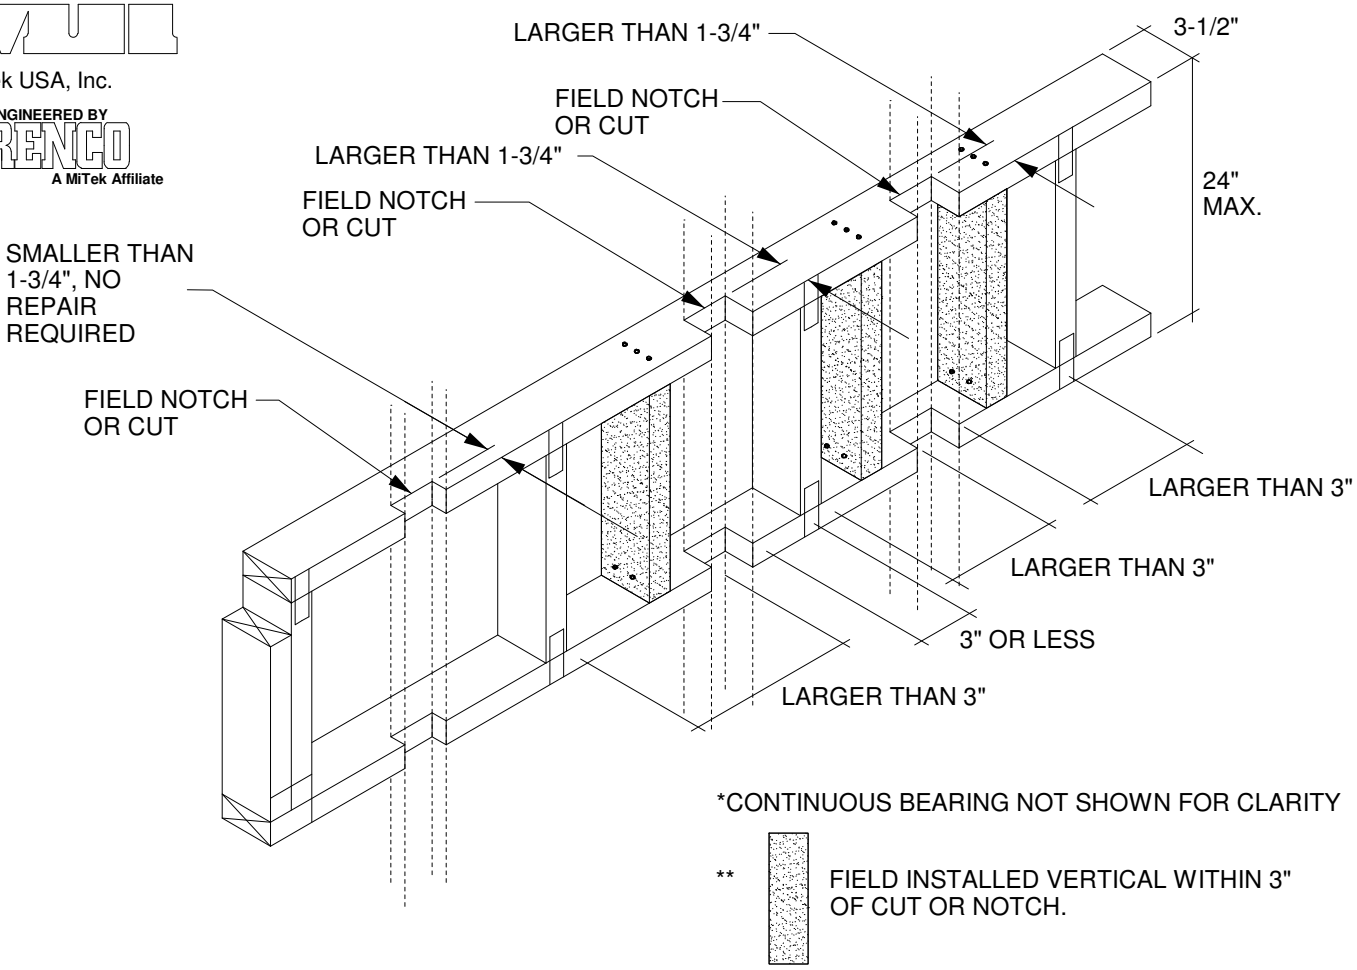
*CONTINUOUS BEARING NOT SHOWN FOR CLARITY

** FIELD INSTALLED VERTICAL WITHIN 3" OF CUT OR NOTCH.

1. THIS DETAIL VALID ONLY FOR VERTICAL DOWNWARD ACTING LOADS. DRAG, SHEAR, OR LATERAL LOADS HAVE NOT BEEN CONSIDERED.
2. FLOOR GABLES MAY BE STUBBED DUE TO CHANGE IN FIELD CONDITIONS; ADD FIELD INSTALLED MEMBER(S) AT STUBBED END.

3. NOTCHING/CUTTING OF CHORDS SHALL BE PERMITTED AS SHOWN. FIELD INSTALLED VERTICALS SHALL BE ADDED WHEN THE NOTCH/CUT IS LARGER THAN 1-3/4" AND NOTCH/CUT END IS GREATER THAN 3" FROM ANOTHER VERTICAL MEMBER.

4. FIELD INSTALLED MEMBERS SHALL BE 2x4 No. 3 OR BETTER, CUT TO FIT TIGHT, AND ATTACHED WITH (3) 3" x 0.131" END NAILS OR (4) 3"x 0.131" TOE NAILS AT EACH END.
