Pre-Demolition Asbestos Survey Report

**Erwin Elementary School
301 South 10th Street
Erwin, North Carolina**

October 2, 2019
Terracon Project No. 70197439

Re: Pre-Demolition Asbestos Survey
Erwin Elementary School
301 South 10th Street
Erwin, North Carolina 28339
Terracon Project No.: 70197439

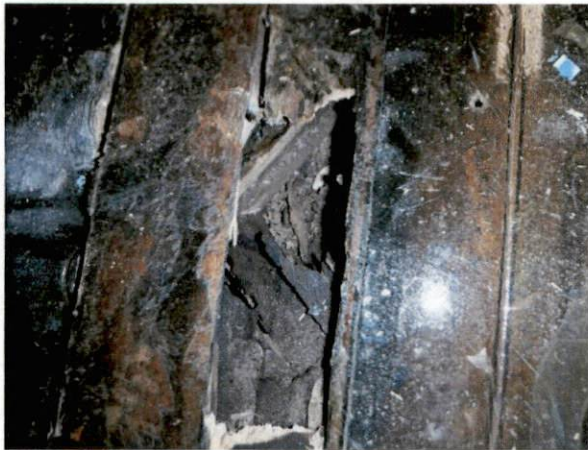
Photo #7 View of HA 1, non-asbestos containing black felt paper under hardwood flooring.

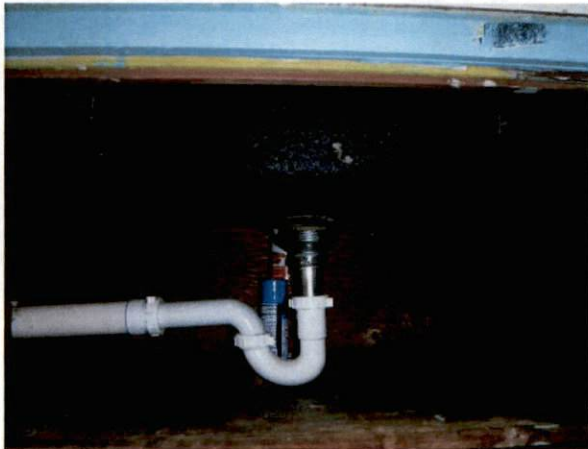
Photo #9 View of HA 4, asbestos-containing black sink mastic.

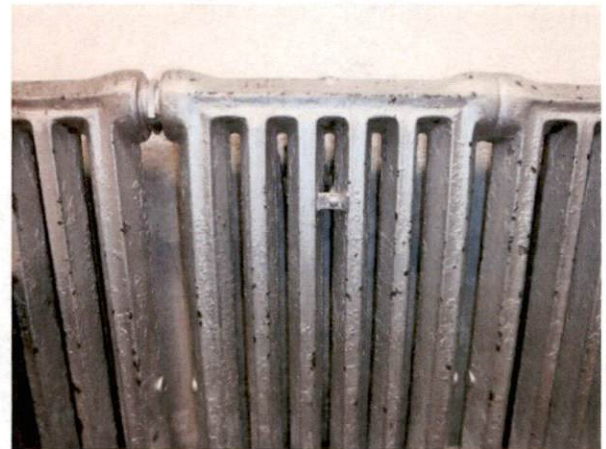
Photo #10 View of HA 5, non-asbestos containing silver paint on radiators.

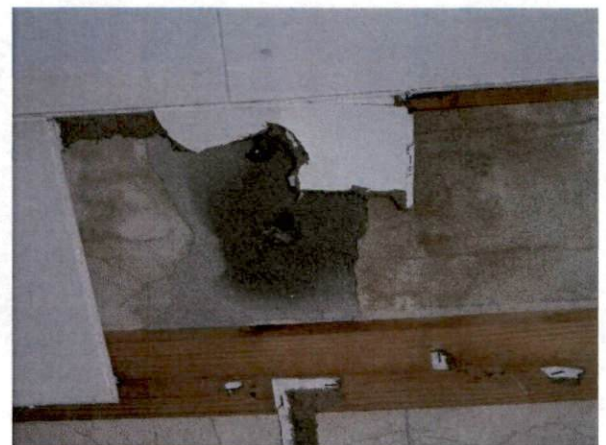
Photo #12 View of HA 8, non-asbestos containing textured plaster.

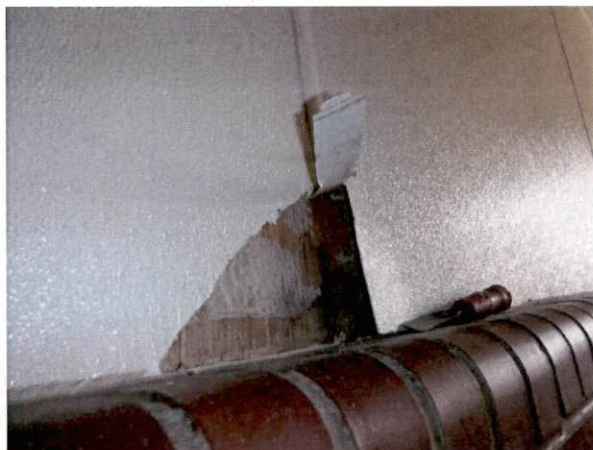
Photo #13 View of HA 9, non-asbestos containing beige FRP adhesive.

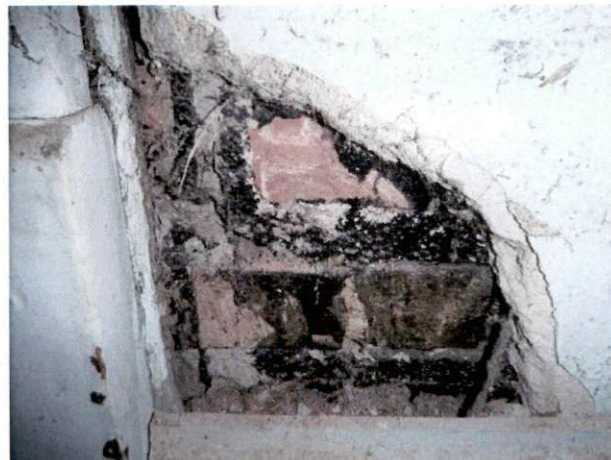
Photo #14 View of HA 10, non-asbestos containing black waterproofing.

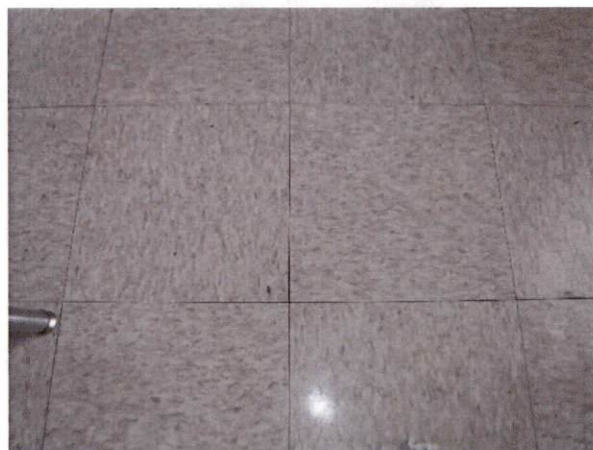
Photo #15 View of HA 11, non-asbestos containing 12" x 12" tri-tan floor tile and mastic.

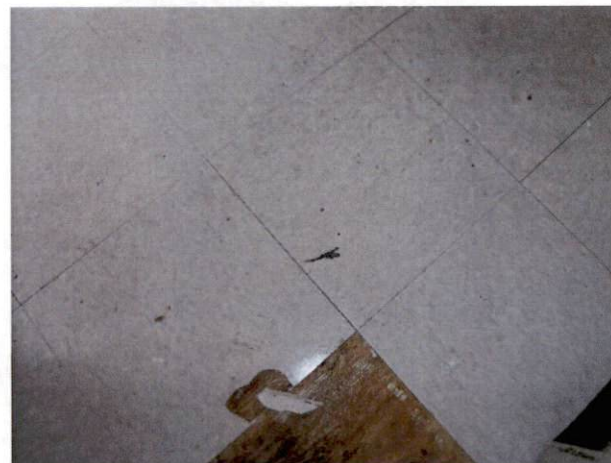
Photo #16 View of HA 12, non-asbestos containing 12" x 12" tri-light gray floor tile and mastic.

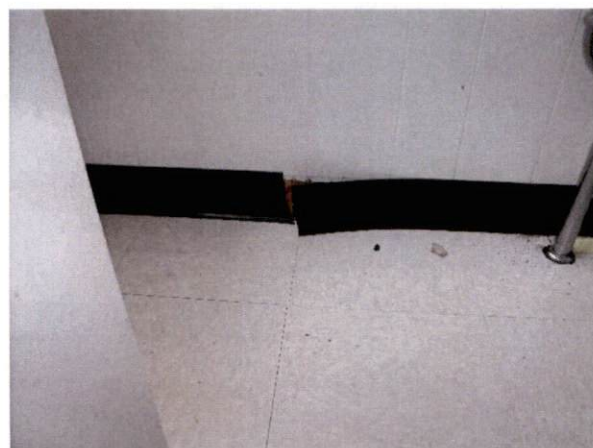
Photo #17 View of HA 13, non-asbestos containing 4" black cove base and mastic.

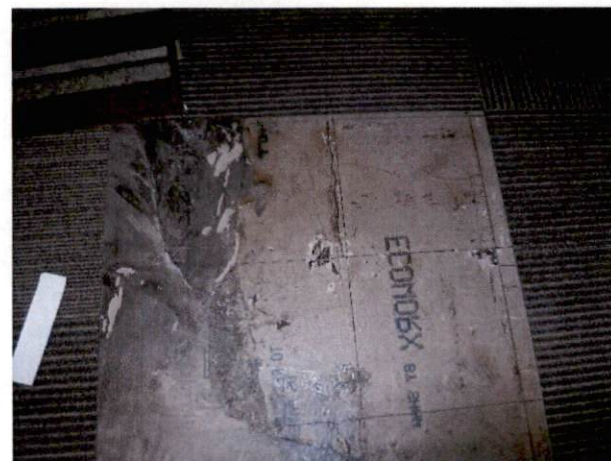
Photo #18 View of HA 14, asbestos-containing 9" x 9" tan floor tile and mastic.

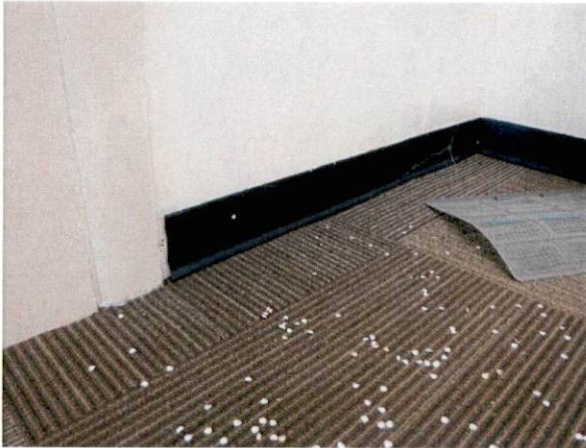
Photo #19 View of HA 15, non-asbestos containing 4" blue cove base and mastic.

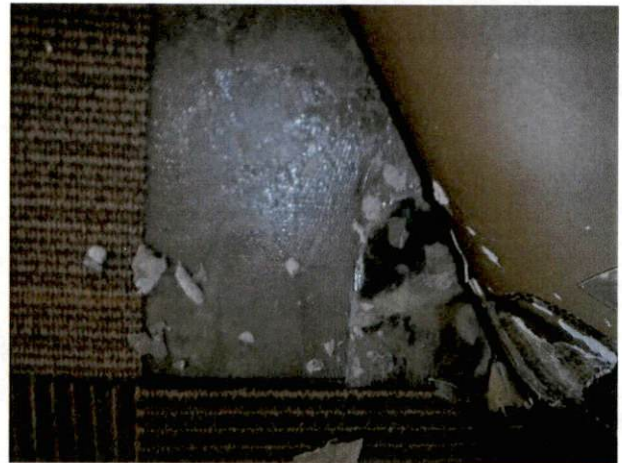
Photo #20 View of HA 16, non-asbestos containing gray leveling compound.

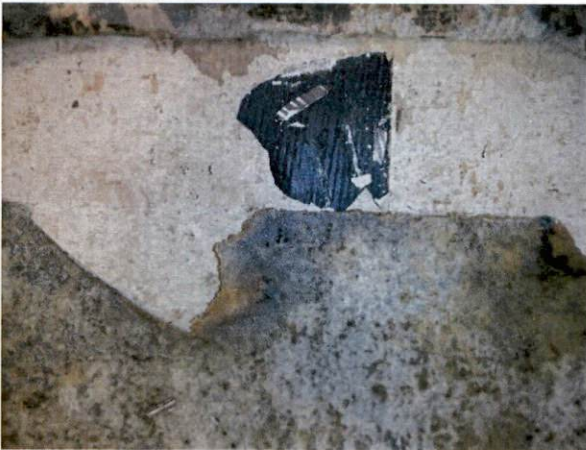
Photo #21 View of HA 17, asbestos-containing 12" x 12" tan with brown dots floor tile with non-asbestos containing mastic.

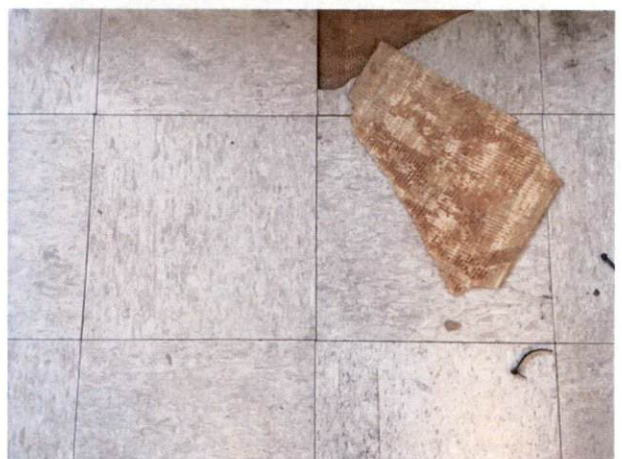
Photo #24 View of HA 20, non-asbestos containing 12" x 12" beige with tan and white splotches floor tile and mastic.

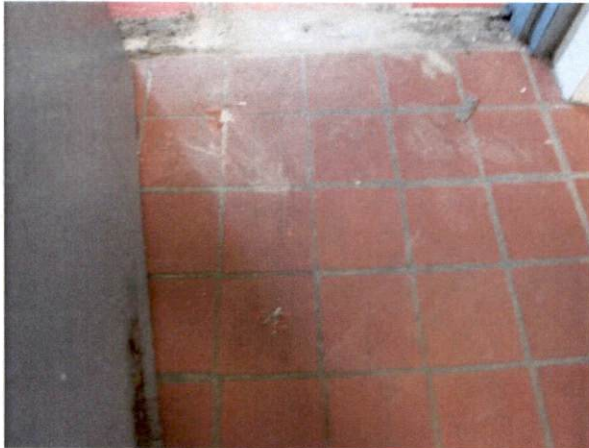
Photo #25 View of HA 21, non-asbestos containing ceramic tile grout and mortar.

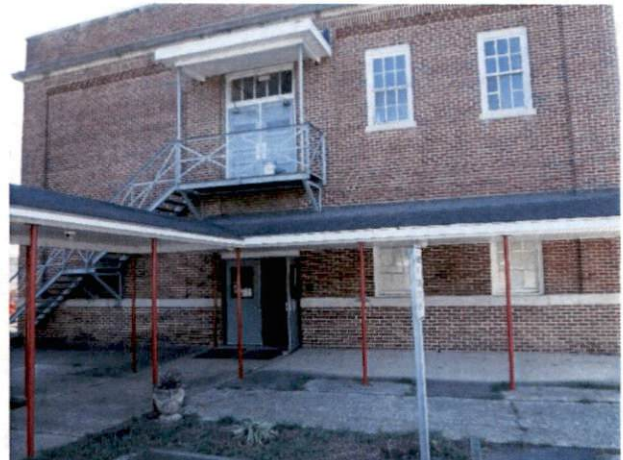
Photo #26 Canopy with HA 22, non-asbestos containing gray/black asphalt shingles and felt paper.

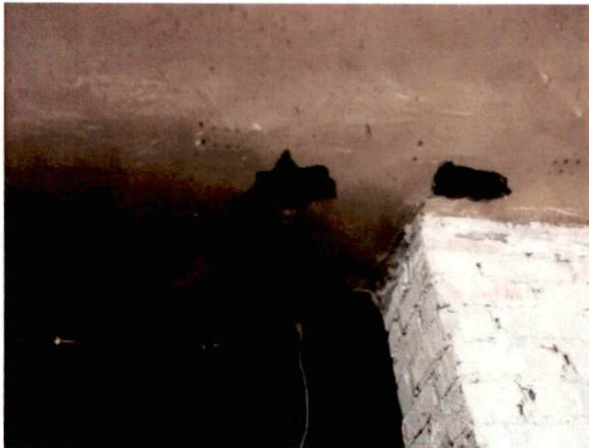
Photo #27 View of HA 23, non-asbestos containing plaster in boiler room.

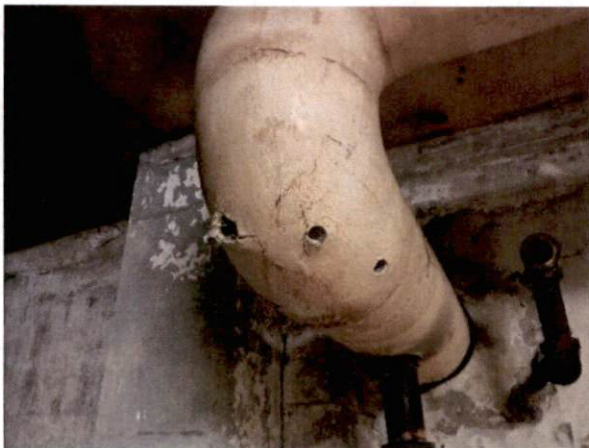
Photo #29 View of HA 25, non-asbestos containing hard TSI elbow.

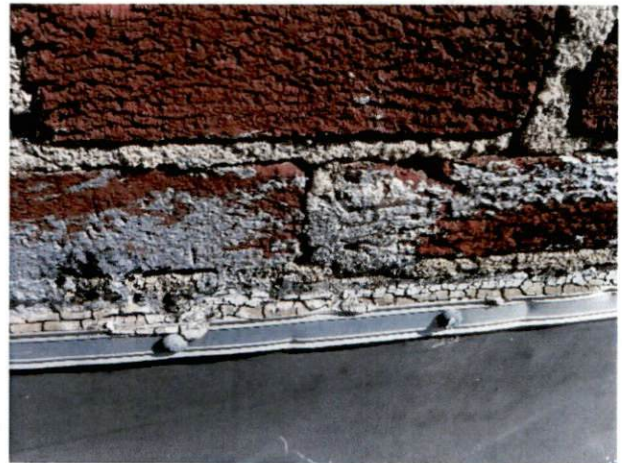
HA	Sample Number	Description	Sample Location	Lab Results
28	1-92	Silver Paint	2nd Floor Canopy Roof	3% Chrysotile
28	1-93	Silver Paint	2nd Floor Canopy Roof	Positive Stop (Not Analyzed)
28	1-94	Silver Paint	2nd Floor Canopy Roof	Positive Stop (Not Analyzed)
29	1-95	White Roof Caulk	Main Roof South	None Detected
29	1-96	White Roof Caulk	Main Roof South	None Detected
29	1-97	White Roof Caulk	Main Roof South	None Detected
30	1-98	Black Roof Caulk	Main Roof South	None Detected
30	1-99	Black Roof Caulk	Main Roof South	None Detected
30	1-100	Black Roof Caulk	Main Roof South	None Detected
31	1-101	Black Roof Mastic on Brick	Main Roof North/South Parapet Wall	10% Chrysotile
31	1-102	Black Roof Mastic on Brick	Main Roof North/South Parapet Wall	Positive Stop (Not Analyzed)
31	1-103	Black Roof Mastic on Brick	Main Roof North/South Parapet Wall	Positive Stop (Not Analyzed)
32	1-104	Built-up Roofing on Canopy	2nd Floor Canopy Roof	None Detected

Photo #32 View of HA 28, asbestos-containing silver paint.

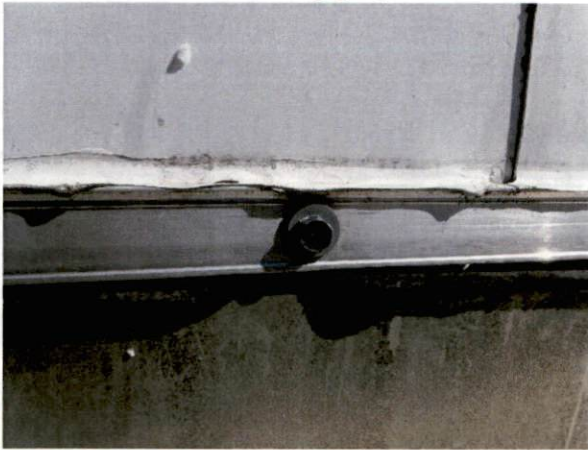
Photo #33 View of HA 29, non-asbestos containing white roof caulk on main roof.

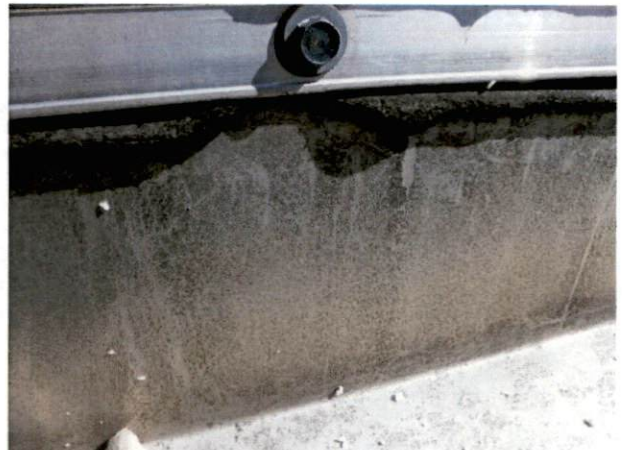
Photo #34 View of HA 30, non-asbestos containing black roof caulk on main roof.

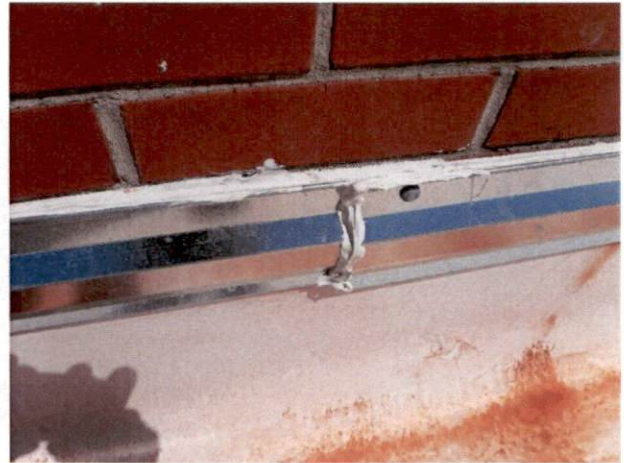
Photo #8 View of HA 1, non-asbestos containing white roof caulk at brick on west roof.

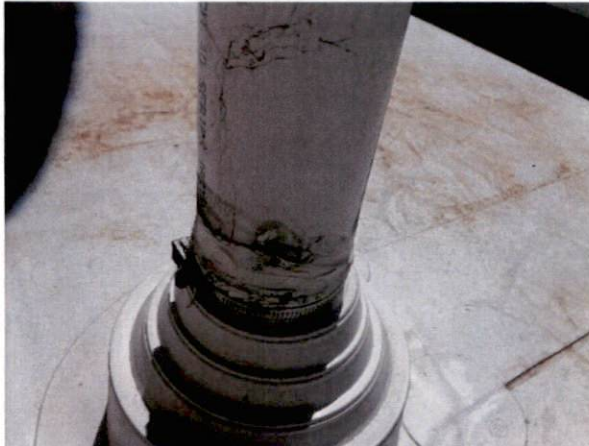
Photo #9 View of HA 2, asbestos-containing white roof caulk at penetrations on west roof.

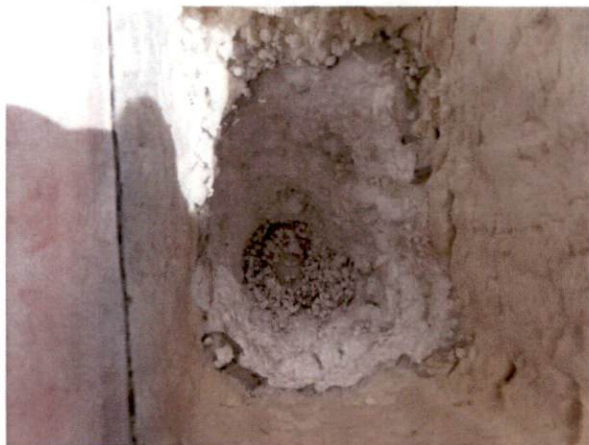
Photo #11 View of HA 4, non-asbestos containing lightweight concrete.

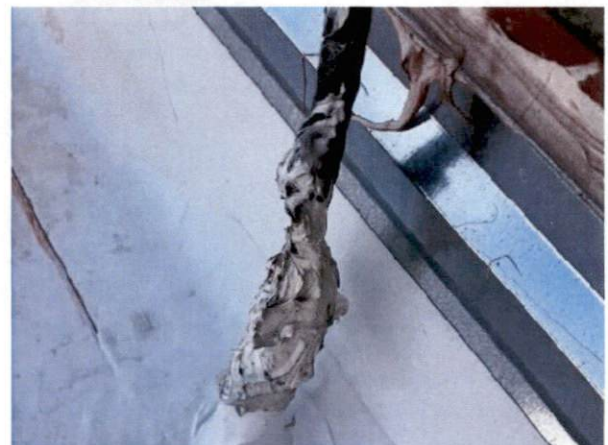
Photo #12 View of HA 5, non-asbestos containing white caulk at lightning rod mount.

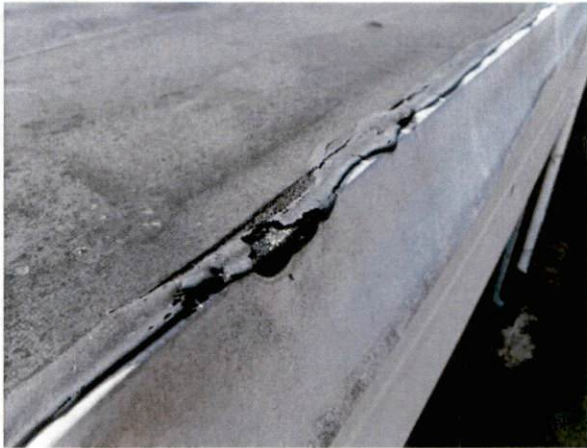
Photo #13 View of HA 6, non-asbestos containing black roof caulk on southwest roof.

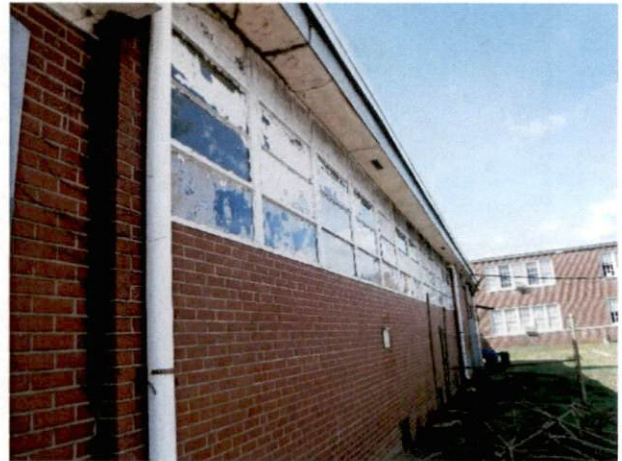
Photo #14 View of exterior with HA 7, non-asbestos containing textured exterior soffit.

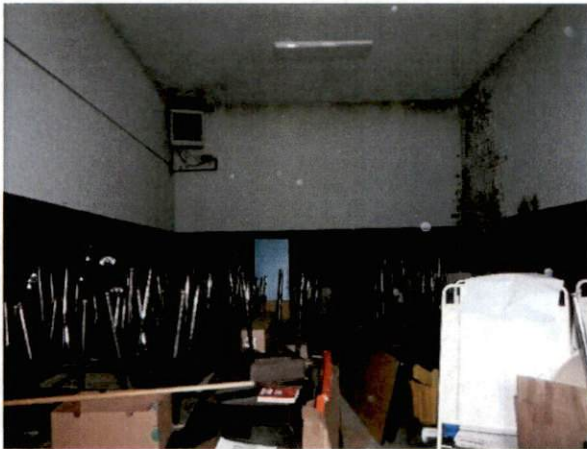
Photo #15 View of storage room with HA 8, non-asbestos containing textured ceiling plaster.

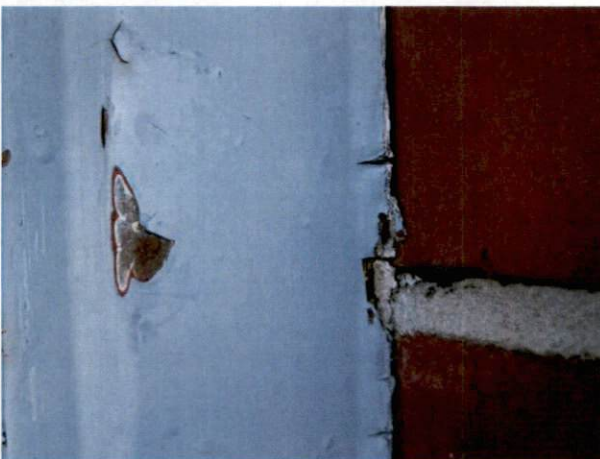
Photo #17 View of HA 10, asbestos-containing beige exterior door caulk.

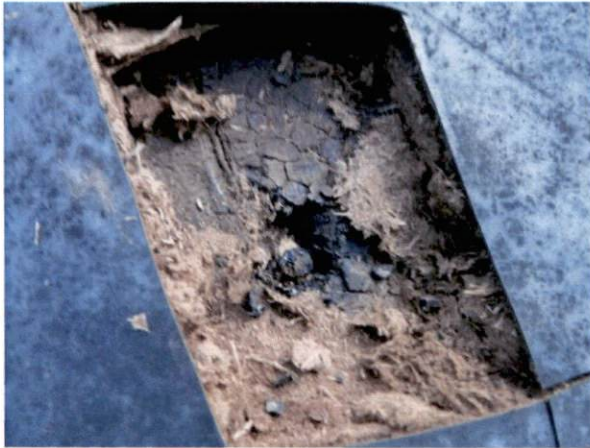
Photo #19 View of HA 12, non-asbestos containing built-up roofing under black membrane on southwest roof.

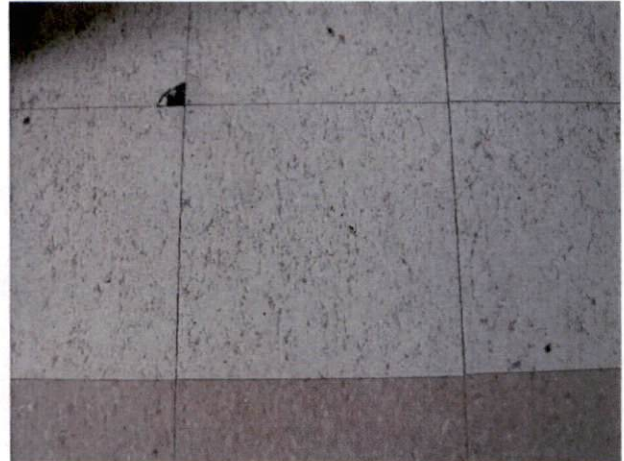
Photo #20 View of HA 14, asbestos-containing mastic with OSHA-regulated asbestos-containing 12" x 12" off-white with brown and white specks floor tile.

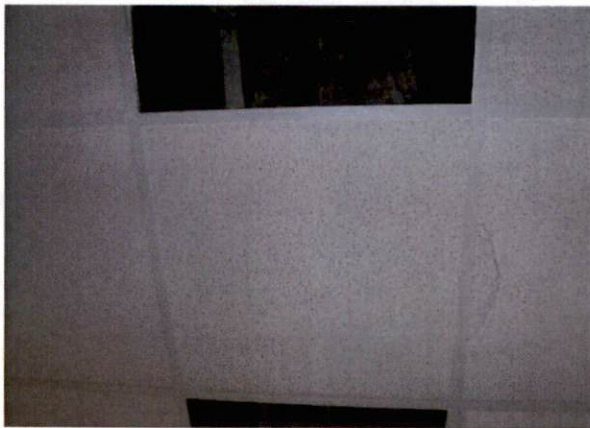
Photo #21 View of HA 17, non-asbestos containing 2' x 2' white ceiling tile with dots.

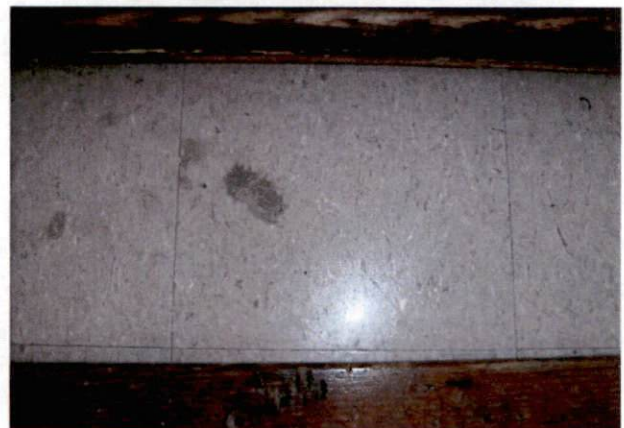
Photo #22 View of HA 18, asbestos-containing mastic with OSHA-regulated asbestos-containing 12" x 12" pink with white specks floor tile.

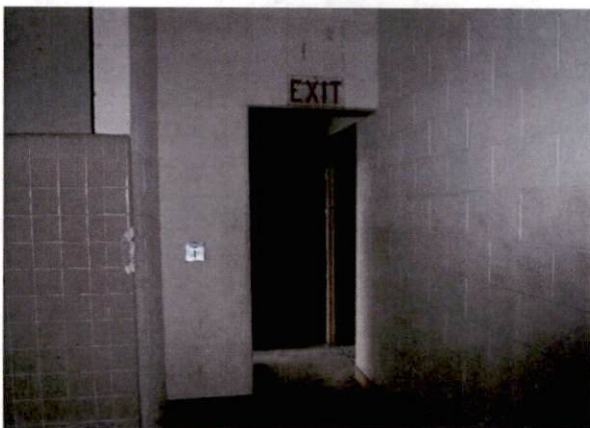
Photo #23 View of HA 19, non-asbestos containing CMU block filler.

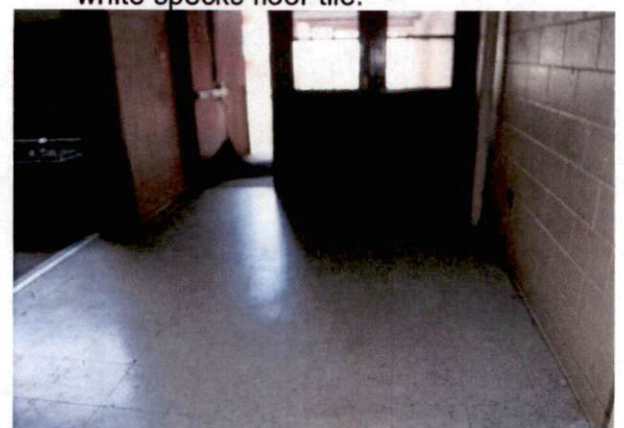
Photo #24 View of HA 20, asbestos-containing mastic with OSHA-regulated asbestos-containing 12" x 12" light gray with white specks floor tile.

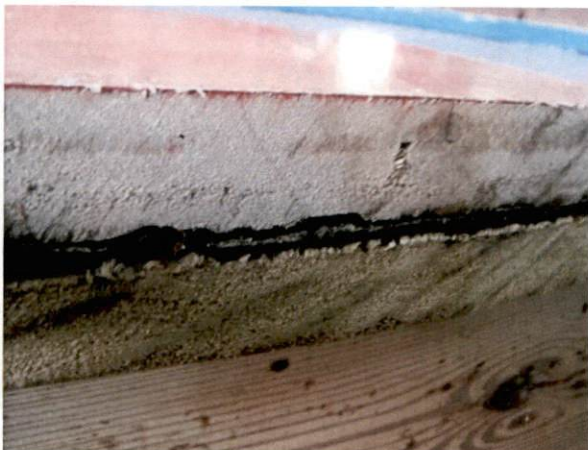
Photo #25 View of HA 21, non-asbestos containing black felt paper under hardwood flooring.

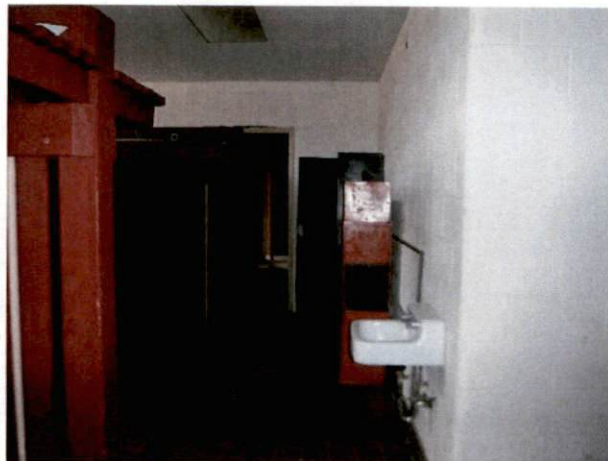
Photo #26 View of boy's locker room with HA 22, non-asbestos containing 2' x 2' white drywall ceiling tile.

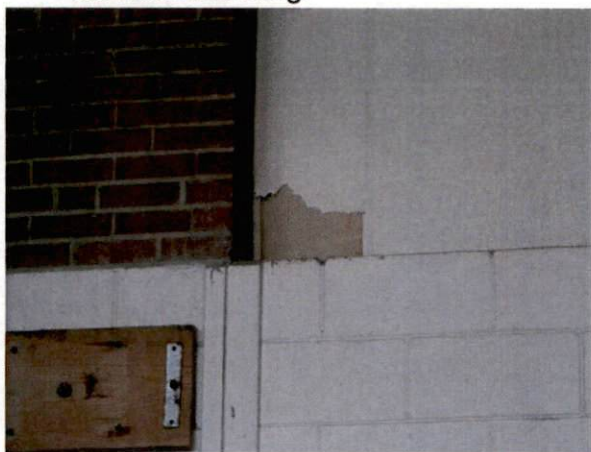
Photo #27 View of HA 23, non-asbestos containing beige FRP adhesive.

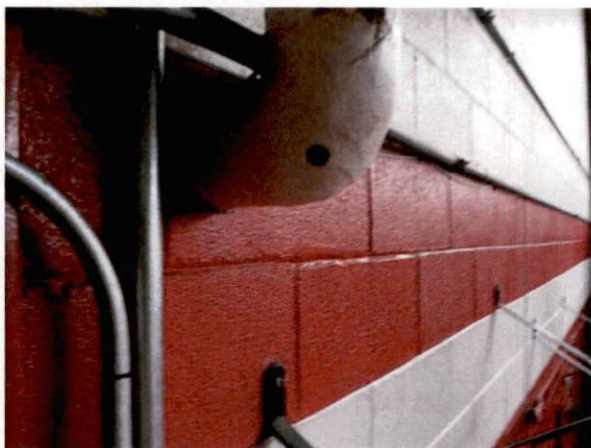
Photo #29 View of HA 25, non-asbestos containing hard TSI elbow with canvas wrap.

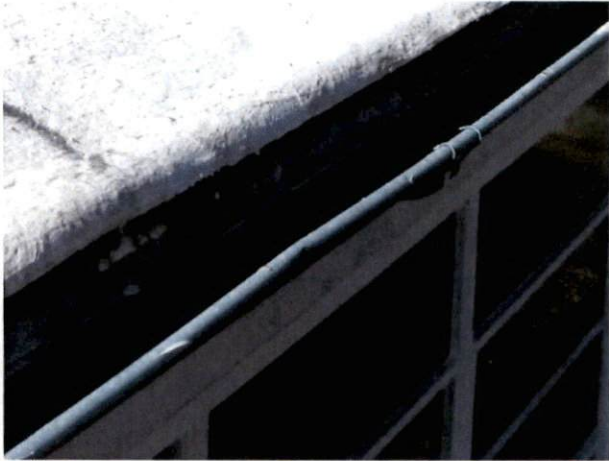
Photo #31 View of HA 27, non-asbestos containing black roof mastic on main roof.

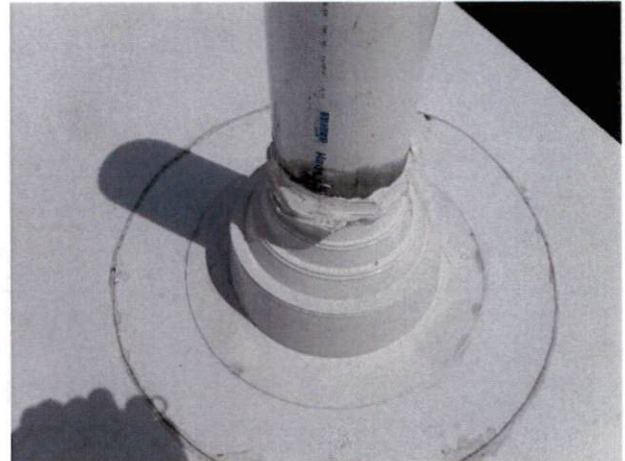
Photo #8 View of HA 2, non-asbestos containing white roof caulk at penetrations on east roof.

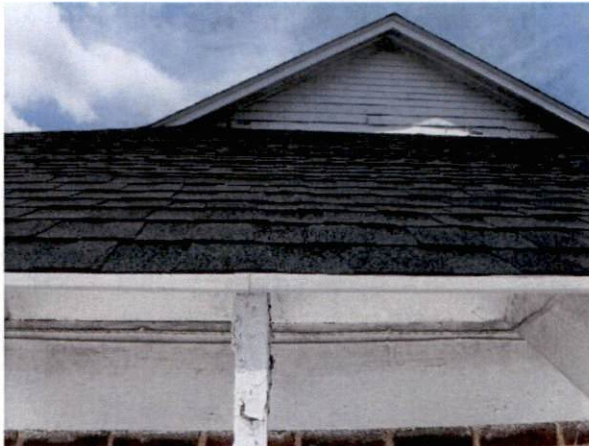
Photo #9 View of HA 3, non-asbestos-containing black shingles and felt paper.

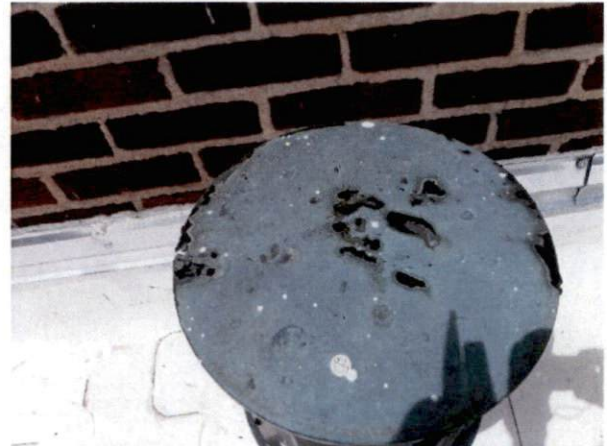
Photo #10 View of HA 4, non-asbestos containing black roof mastic on east roof.

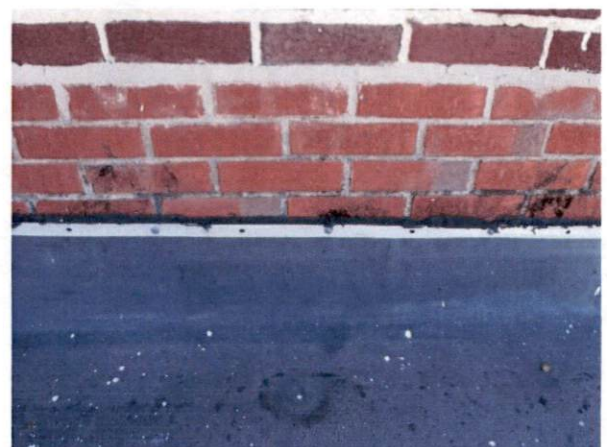
Photo #12 View of HA 5, non-asbestos containing black roof caulk on west roof.

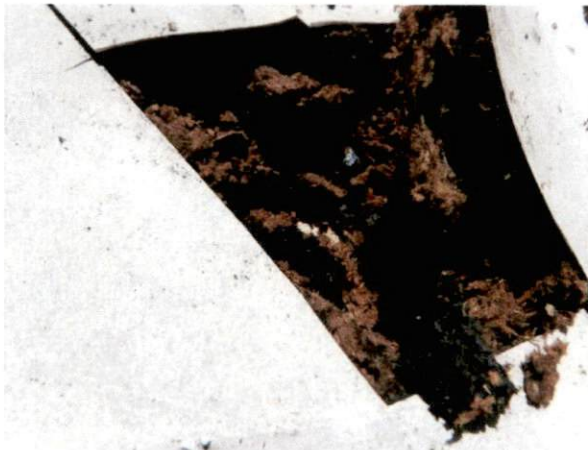
Photo #13 View of HA 6, non-asbestos containing white mastic on EPDM over built-up roofing on west roof.

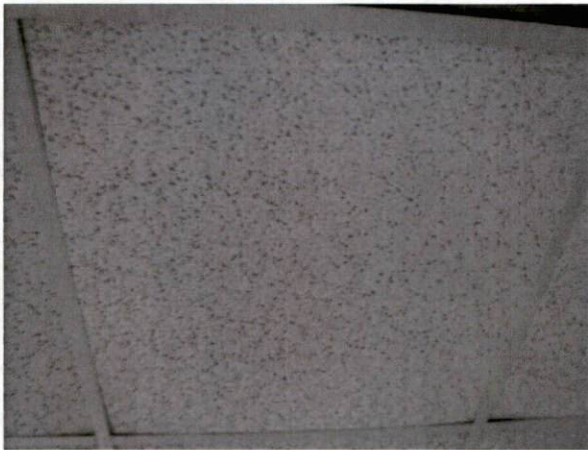
Photo #15 View of HA 8, non-asbestos containing 2' x 2' white ceiling tile with dots and pits.

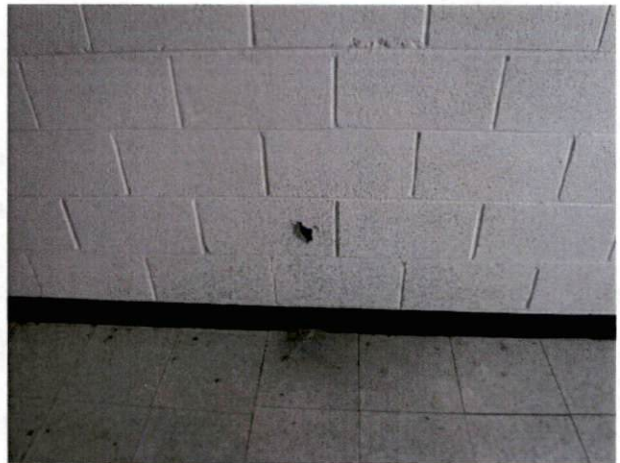
Photo #16 View of HA 9, non-asbestos containing 4" black cove base and mastic.

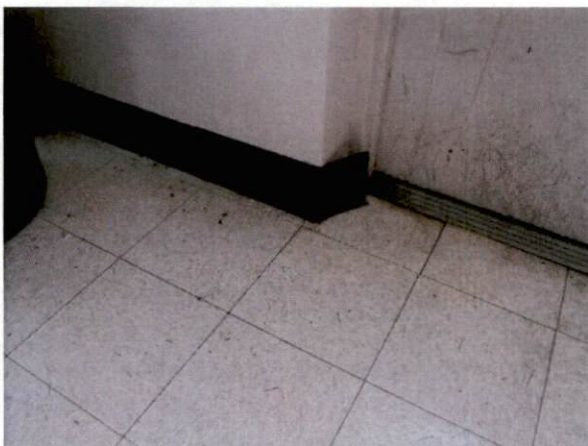
Photo #17 View of HA 10, non-asbestos containing 6" black cove base and mastic.

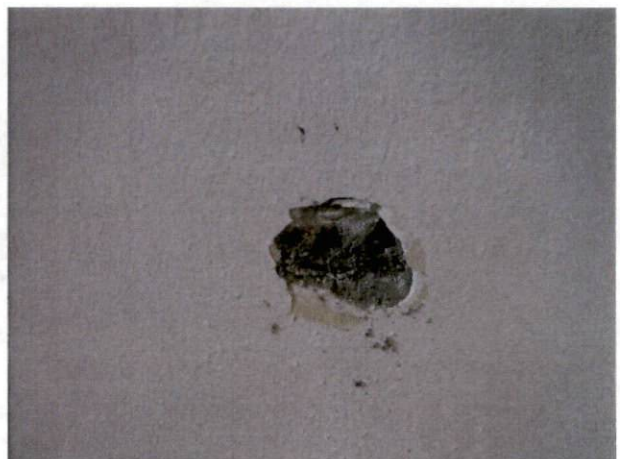
Photo #18 View of HA 11, non-asbestos containing plaster.

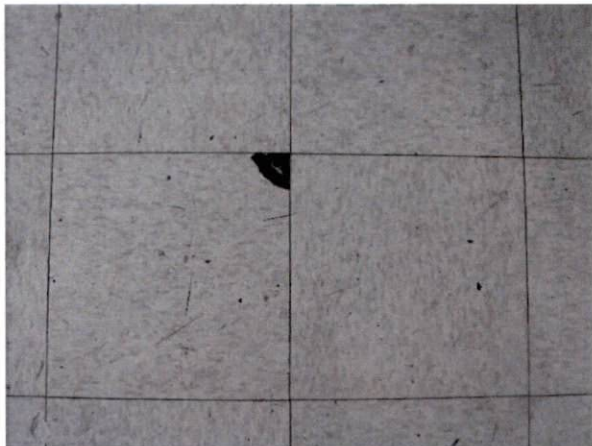
Photo #19 View of HA 13, asbestos-containing mastic associated with non-asbestos containing 12" x 12" tri-beige floor tile and mastic.

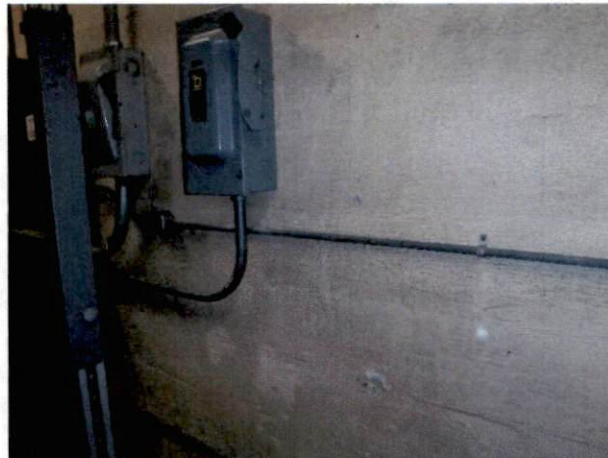
Photo #20 View of HA 14, asbestos-containing textured coating on CMU and brick walls.

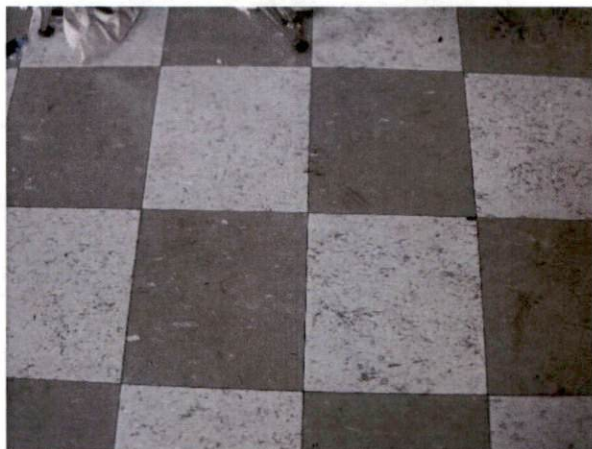
Photo #21 View of HA 15, asbestos-containing checkered 12" x 12" beige with brown specks/green floor tile and mastic.

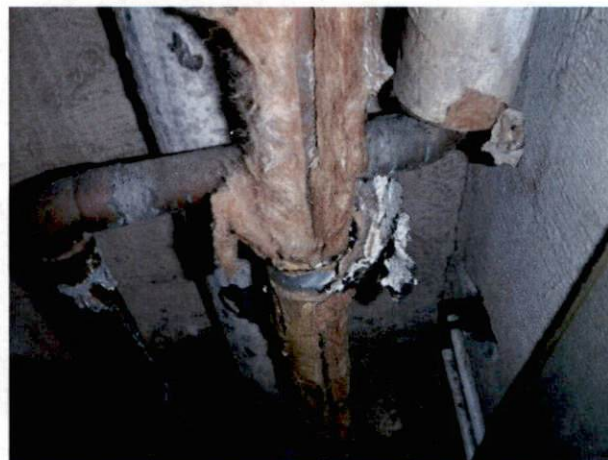
Photo #22 View of HA 16, non-asbestos containing black mastic on foil-backed paper over fiberglass pipe insulation.

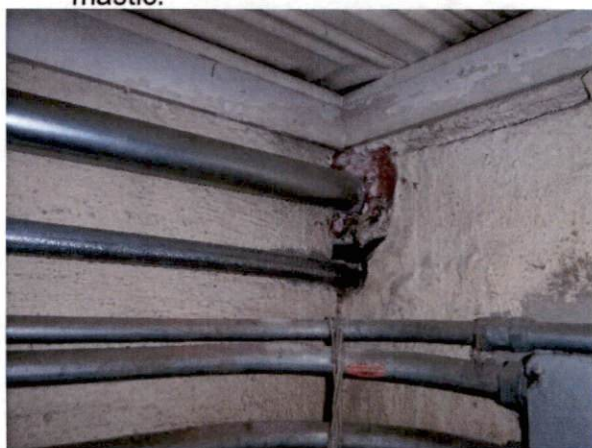
Photo #23 View of HA 17, non-asbestos containing brittle red fire caulk.

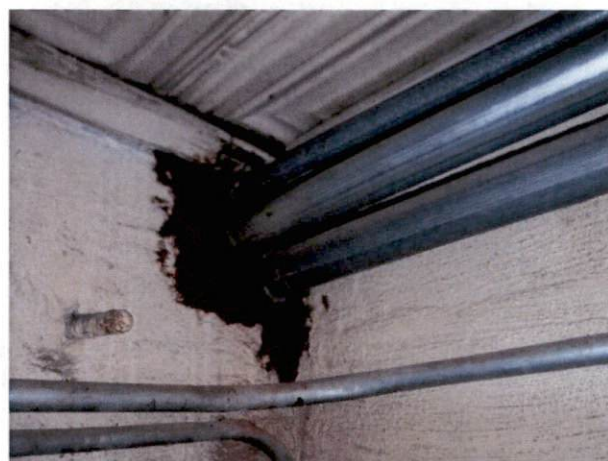
Photo #24 View of HA 18, non-asbestos containing dark red fire caulk.

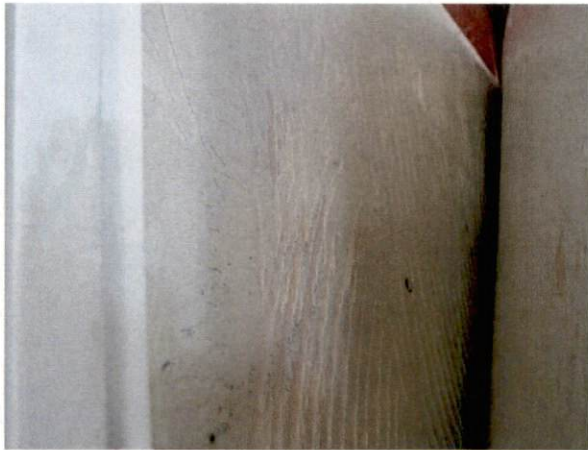
Photo #25 View of HA 19, non-asbestos containing beige FRP mastic.

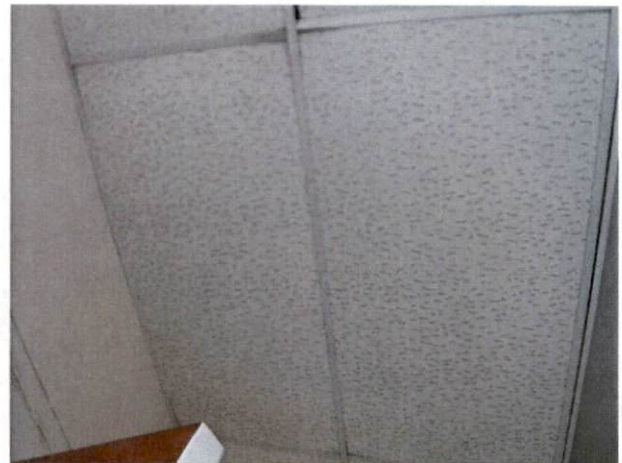
Photo #26 View of HA 20, non-asbestos containing 2' x 4' white ceiling tile with dots and fissures.

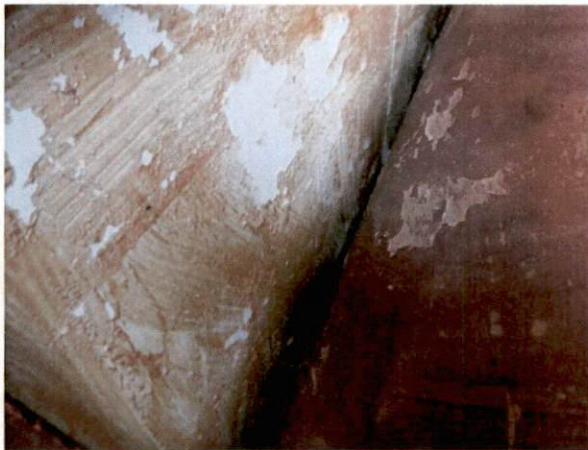
Photo #27 View of HA 21, non-asbestos containing tan glue behind plastic panel.

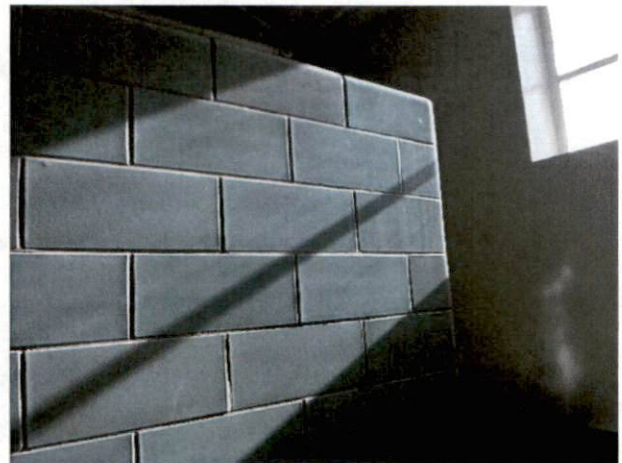
Photo #28 View of HA 22, non-asbestos containing ceramic wall tile grout and mortar.

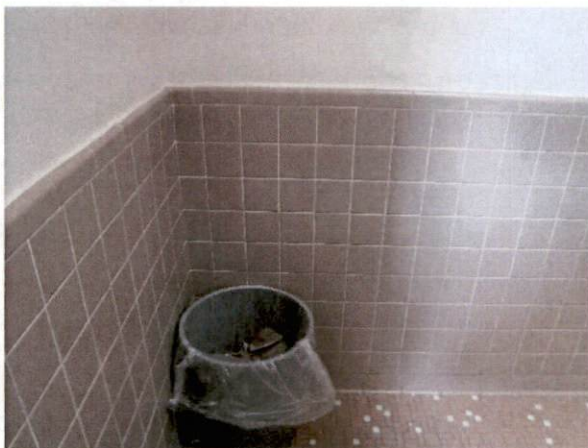
Photo #29 View of HA 23, non-asbestos containing ceramic wall tile grout and mortar.

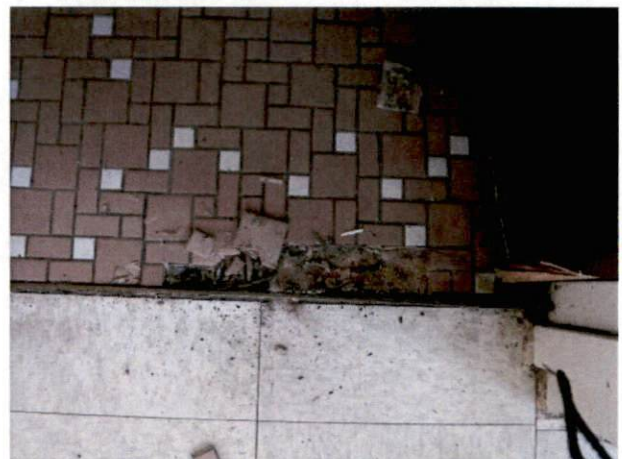
Photo #30 View of HA 24, non-asbestos containing ceramic floor tile grout and mortar.

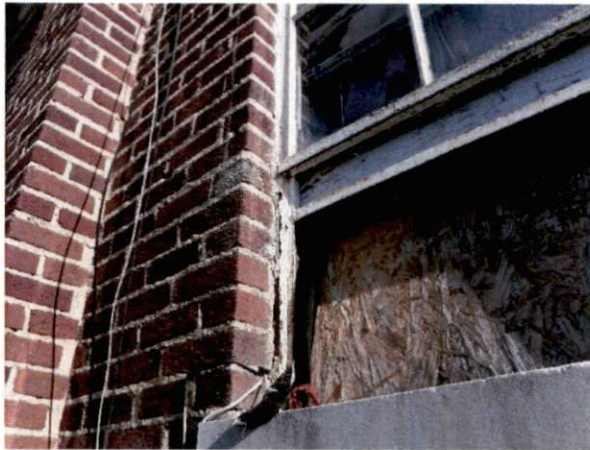
Photo #33 View of HA 27, non-asbestos containing exterior window caulk at brick.

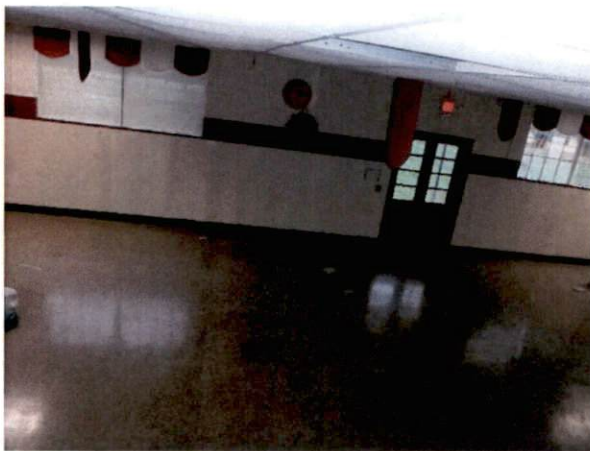
Photo #35 View of cafeteria with HA 29, asbestos-containing interior window glazing.

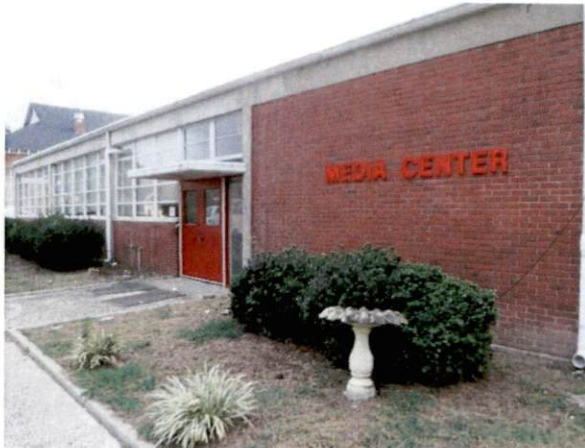
Photo #1 View of building exterior.

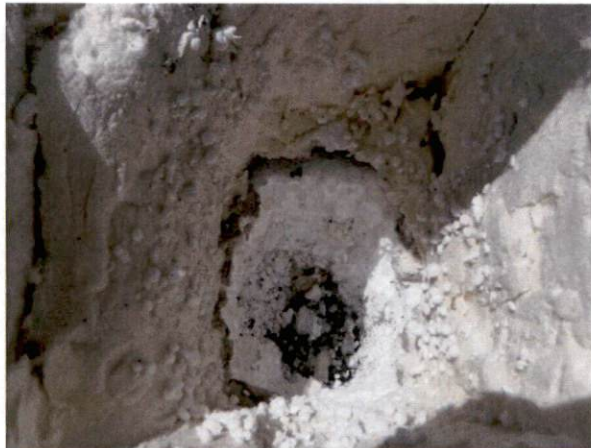
Photo #9 View of HA 2, non-asbestos-containing black tar under roof membrane and foam insulation.

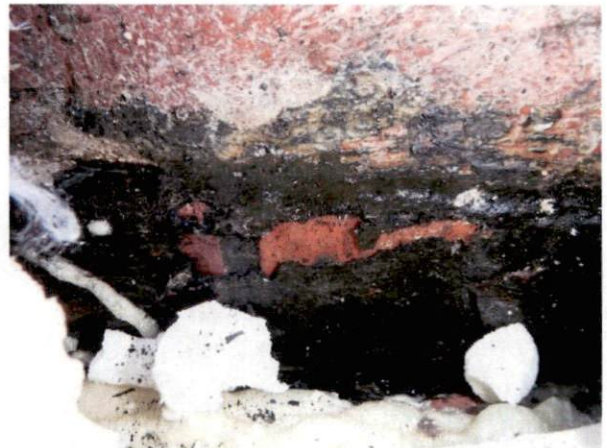
Photo #10 View of HA 3, non-asbestos containing black roof mastic on east roof.

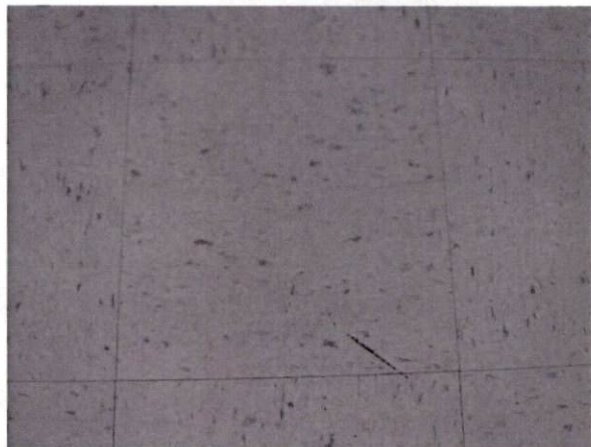
Photo #11 View of HA 4, non-asbestos containing 12" x 12" white with blue and green specks floor tile and mastic.

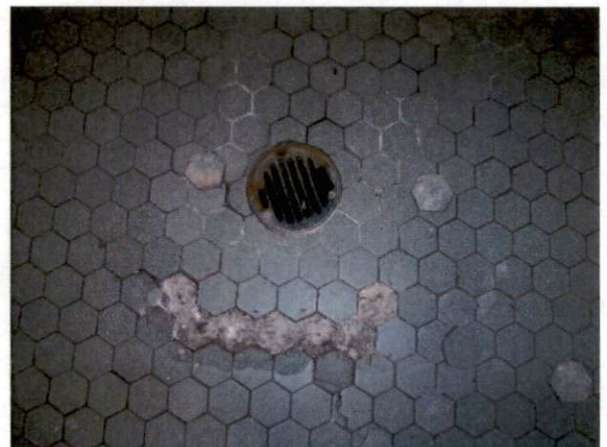
Photo #12 View of HA 5, non-asbestos containing ceramic floor tile grout and mortar.

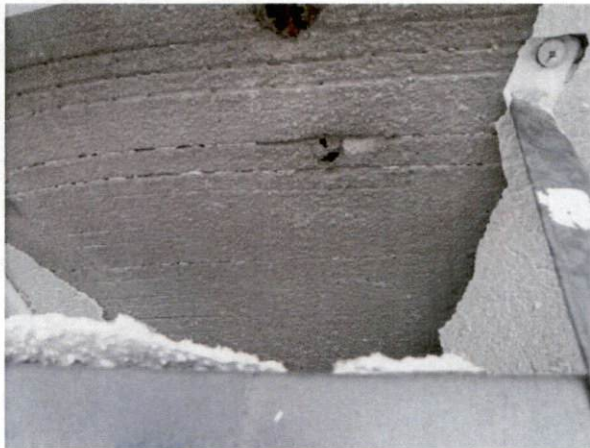
Photo #13 View of HA 6, non-asbestos containing textured ceiling plaster.

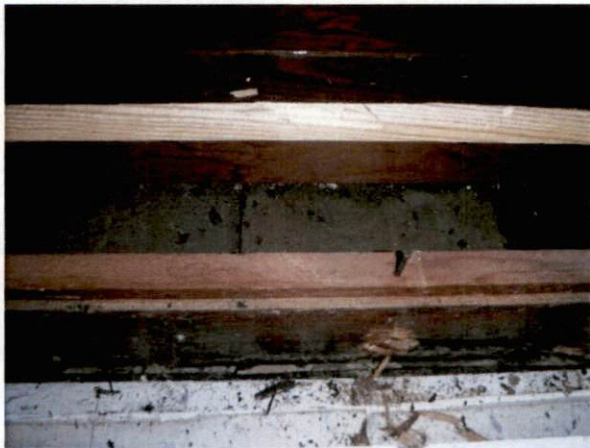
Photo #15 View of HA 9, asbestos-containing 9" x 9" brown floor tile and mastic remaining under built-in shelving.

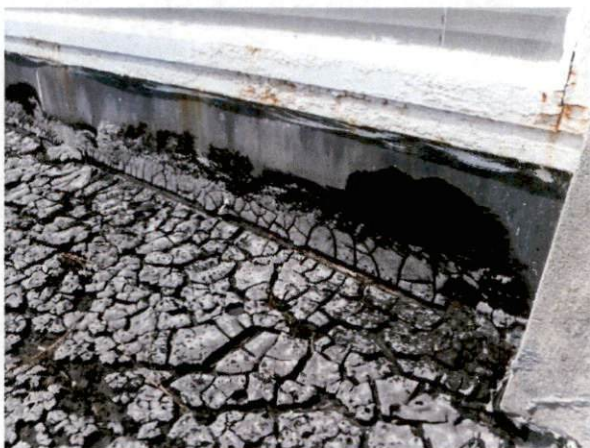
Photo #17 View of HA 11, non-asbestos containing black roof mastic on canopy.

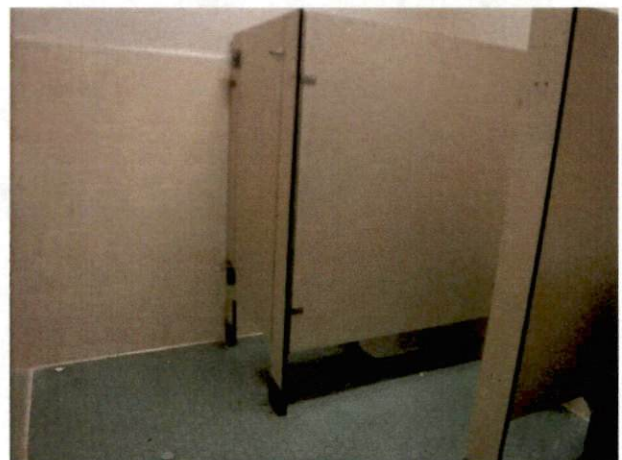
Photo #18 View of HA 12, non-asbestos containing ceramic wall tile grout and mortar.

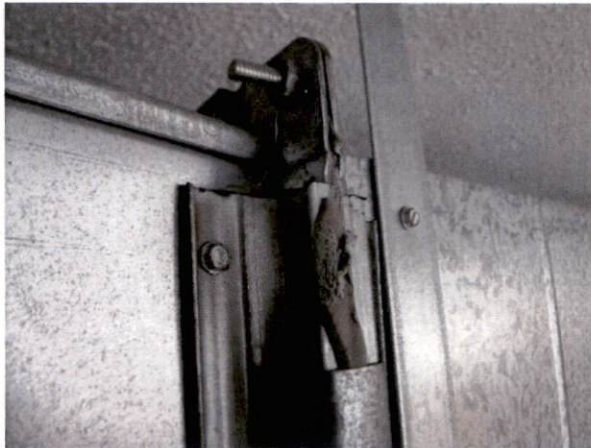
Photo #19 View of HA 13, non-asbestos containing gray HVAC duct putty.

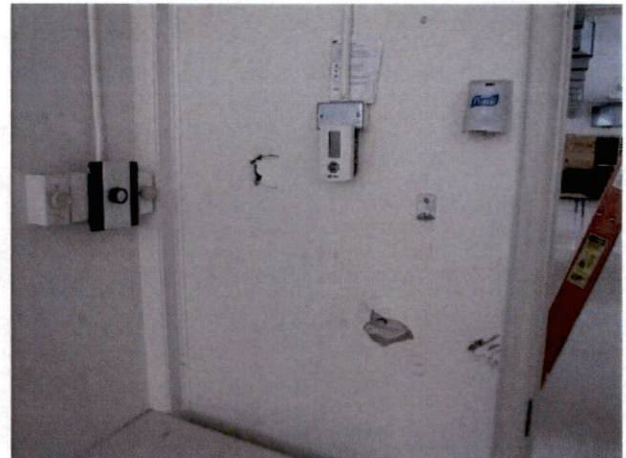
Photo #20 View of HA 14, non-asbestos containing drywall.

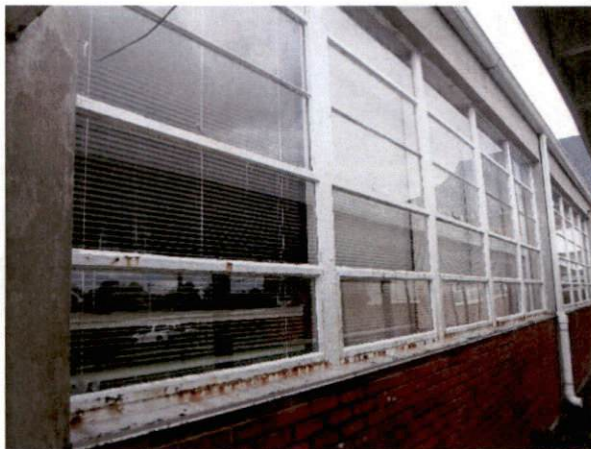
Photo #21 View of windows with HA 15, non-asbestos containing off-white exterior window glazing.

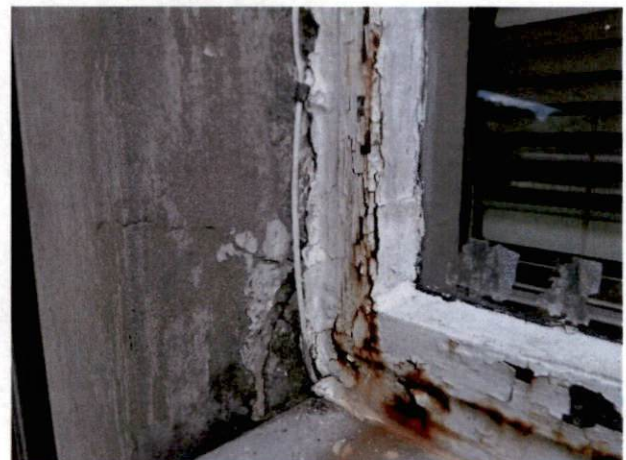
Photo #22 View of HA 16, non-asbestos containing white exterior caulk.

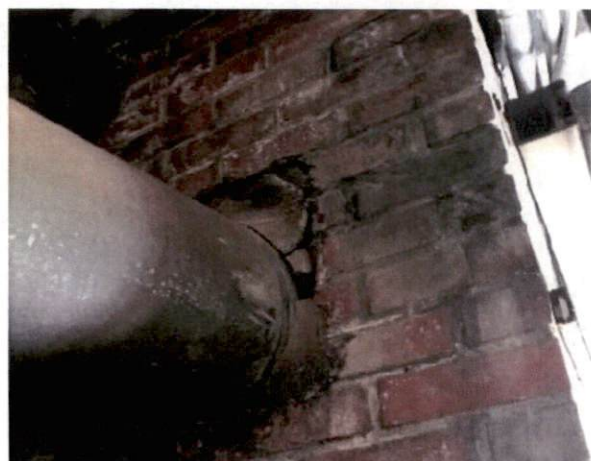
Photo #23 View of HA 17, non-asbestos containing concrete at flue.
