Pre-Demolition Asbestos Survey Report

**Erwin Elementary School
301 South 10th Street
Erwin, North Carolina**

October 2, 2019
Terracon Project No. 70197439

Re: Pre-Demolition Asbestos Survey
Erwin Elementary School
301 South 10th Street
Erwin, North Carolina 28339
Terracon Project No.: 70197439

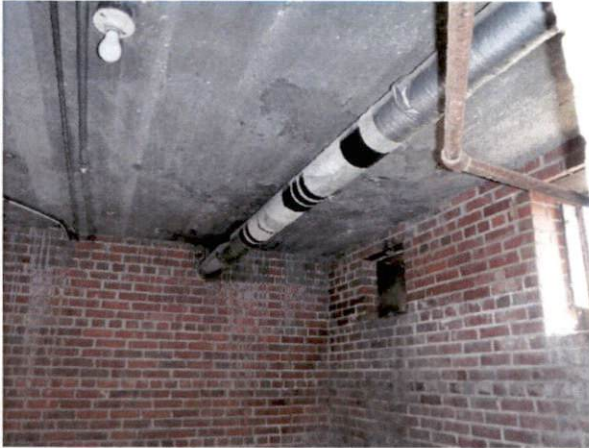
Photo #7 View of HA 1, asbestos-containing air-o-cell pipe insulation.

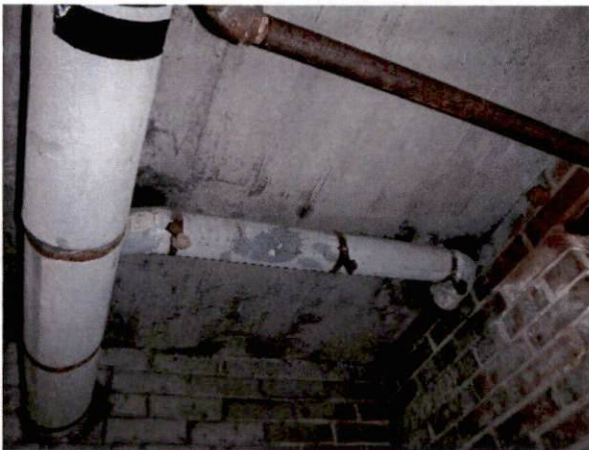
Photo #9 View of HA 3, asbestos-containing hard TSI joint associated with HA 1.

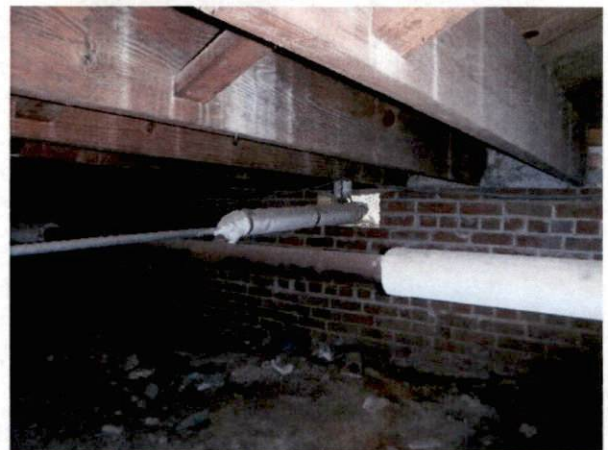
Photo #10 View of crawlspace with HA 1, asbestos-containing air-o-cell pipe insulation and HA 3, asbestos-containing hard TSI joint.

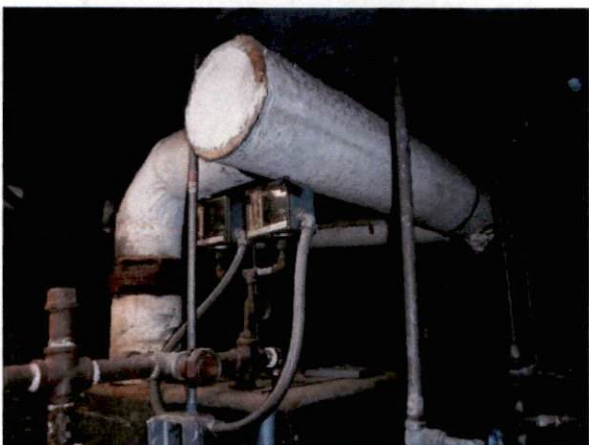
Photo #11 View of HA 4, non-asbestos containing white mud TSI joint.

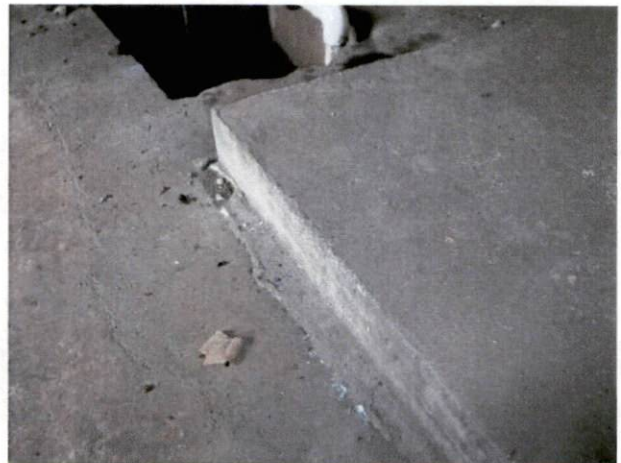
Photo #14 View of HA 6, non-asbestos containing lightweight concrete.

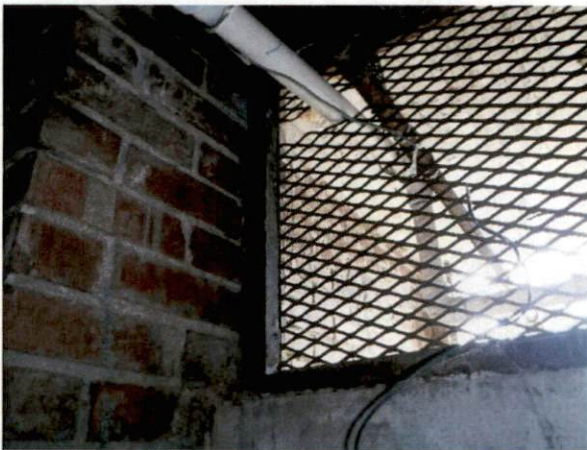
Photo #15 View of boiler window with HA 7, asbestos-containing interior window glazing.

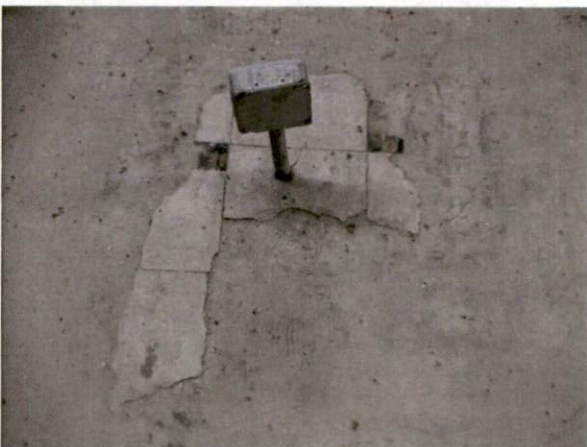
Photo #17 View of HA 9, asbestos-containing 9" x 9" gray floor tile and mastic in basement.

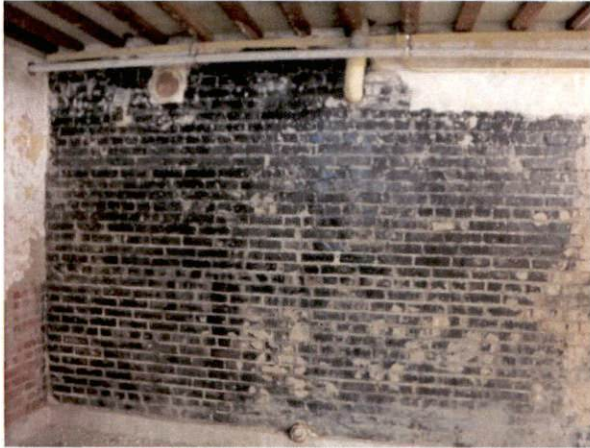
Photo #19 View of HA 11, non-asbestos containing black waterproofing.

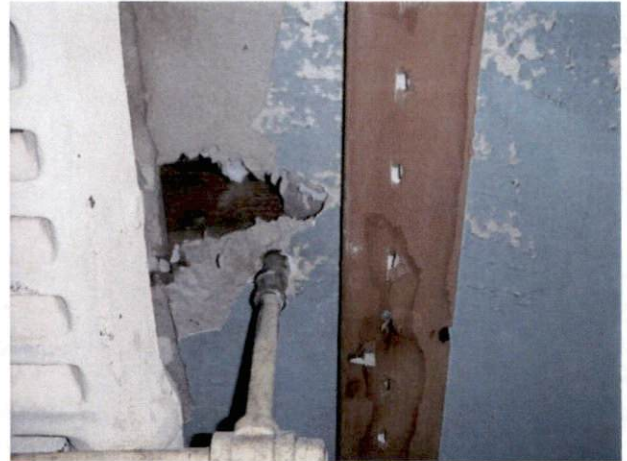
Photo #20 View of HA 12, non-asbestos containing plaster over non-asbestos containing drywall lathe.

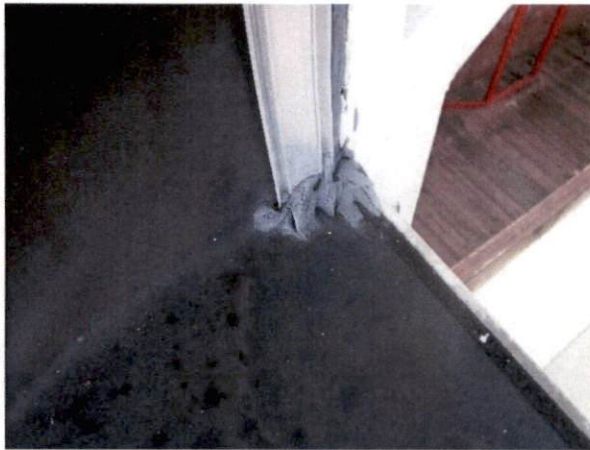
Photo #21 View of HA 13, non-asbestos containing black roof caulk.

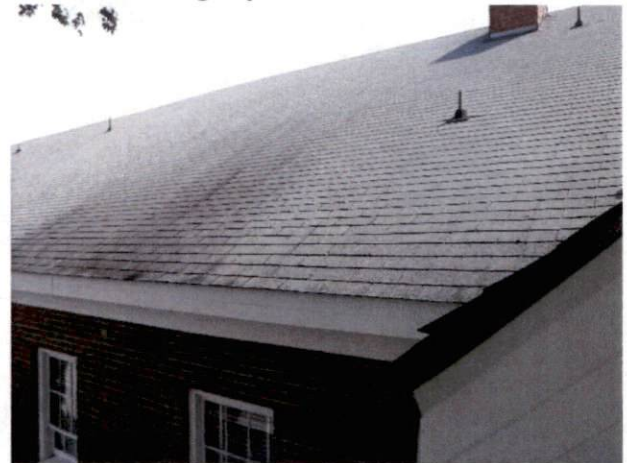
Photo #22 View of HA 14, non-asbestos containing gray shingles and felt paper.

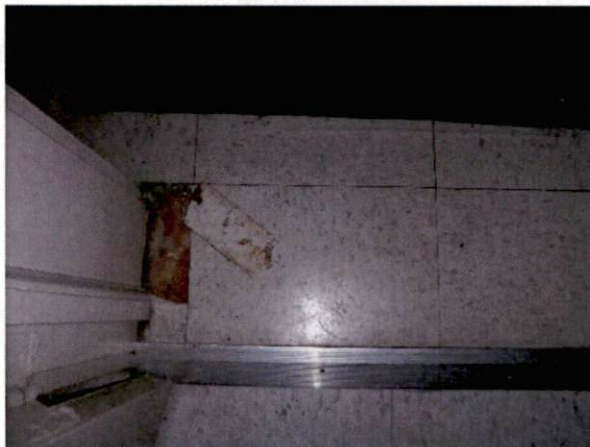
Photo #23 View of HA 15, non-asbestos containing 12" x 12" off-white speckled floor tile and mastic.

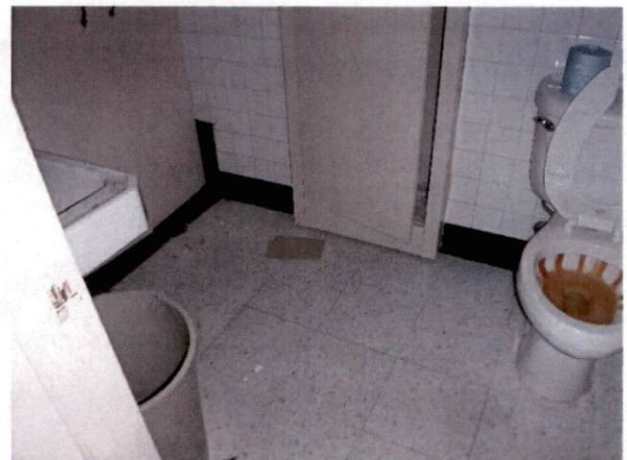
Photo #24 View of HA 16, restroom with non-asbestos containing 12" x 12" light gray with gray specks floor tile and mastic.

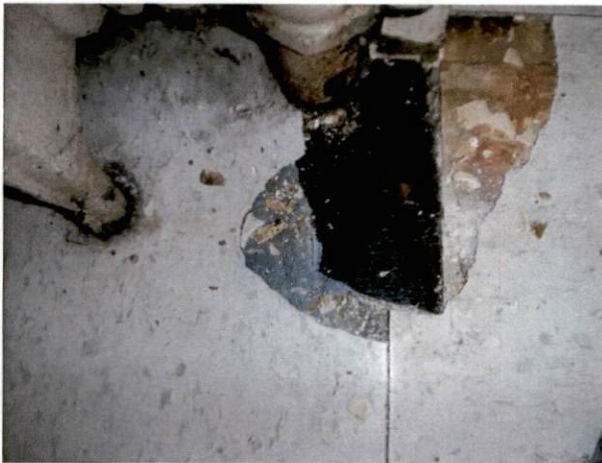
Photo #25 View of HA 17, asbestos-containing tan floor tile and mastic and HA 18, non-asbestos containing blue floor tile with asbestos-containing mastic.

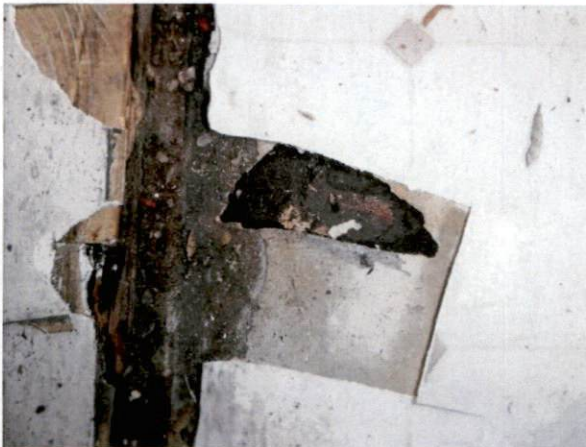
Photo #27 View of HA 20, non-asbestos containing gray vinyl sheet flooring with black felt backing.

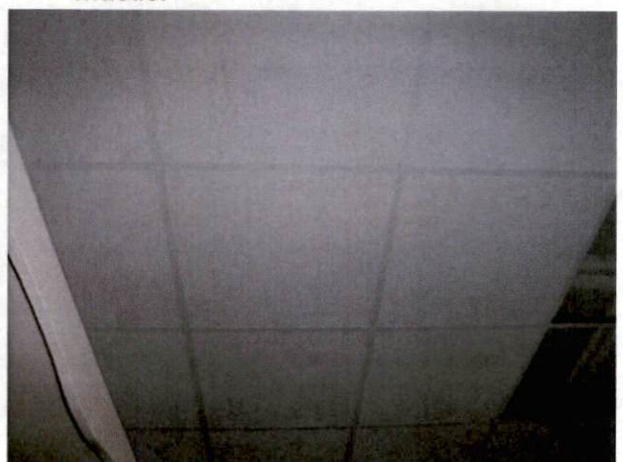
Photo #30 View of HA 23 non-asbestos drywall and joint compound above HA 24, non-asbestos containing ceiling tile.

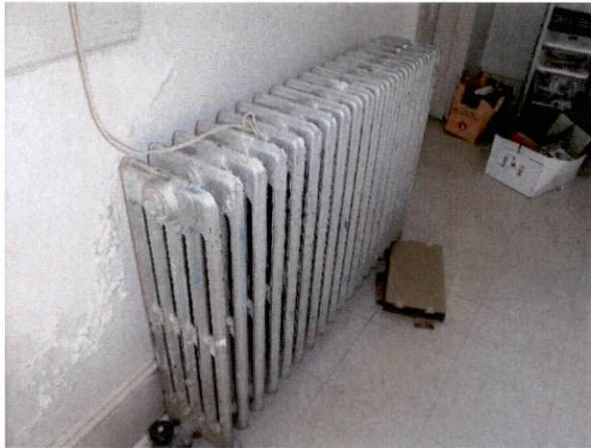
Photo #31 View of radiator with HA 25, non-asbestos containing silver paint.

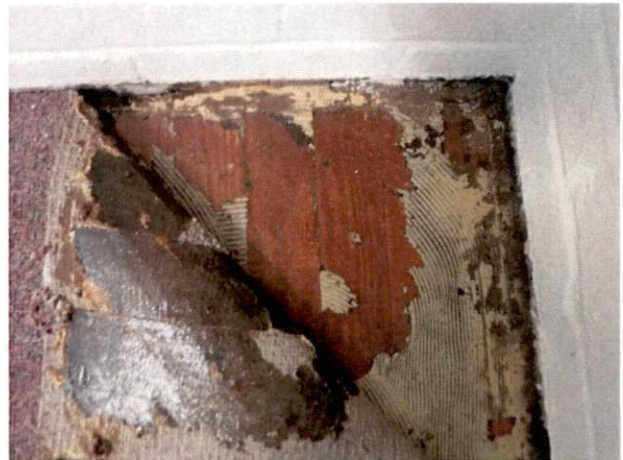
Photo #32 View of HA 26, non-asbestos containing yellow carpet glue and brown paint.

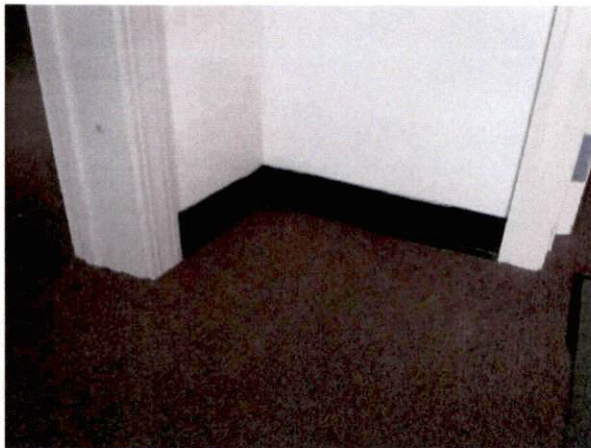
Photo #33 View of HA 27, non-asbestos containing 4" black cove base and mastic.

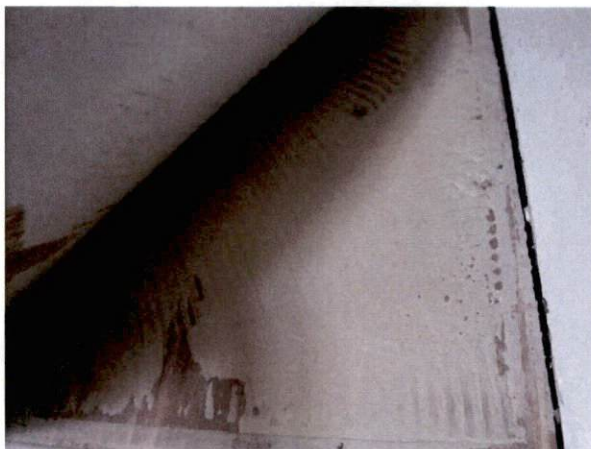
Photo #35 View of HA 30, non-asbestos containing beige FRP mastic.

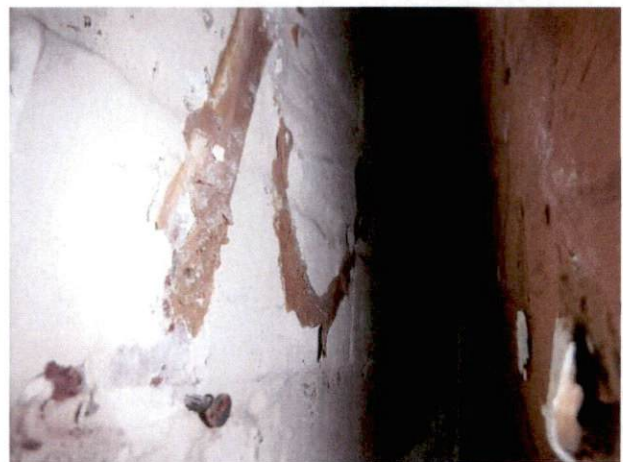
Photo #36 View of HA 31, non-asbestos containing brown FRP mastic.

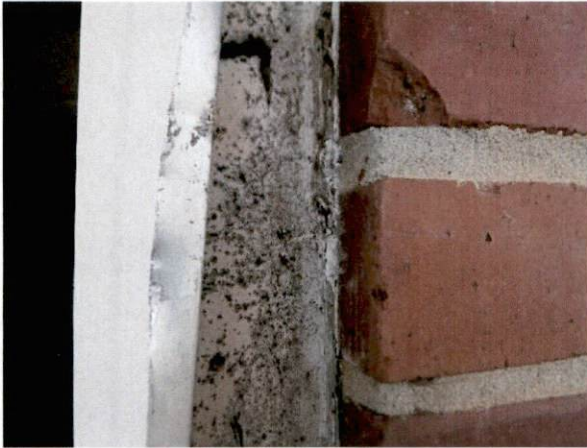
Photo #37 View of HA 32, asbestos-containing exterior caulk.

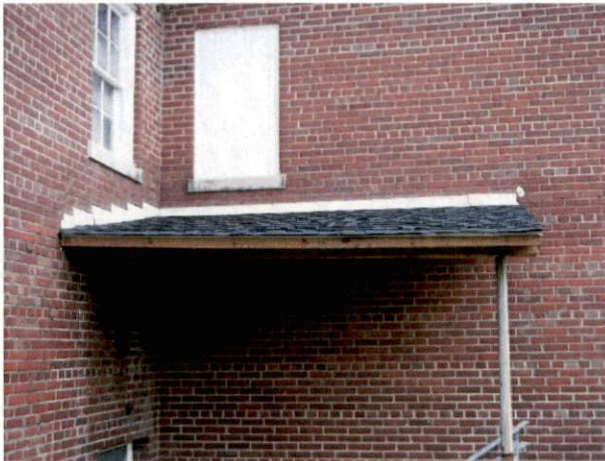
Photo #39 View of HA 34, non-asbestos containing black shingles and felt paper.

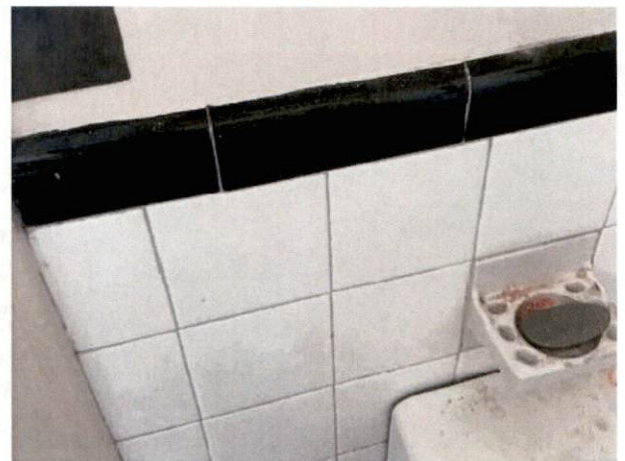
Photo #40 View of HA 36, non-asbestos containing ceramic wall tile grout and mortar.
