November 12, 2018

Re: Damage from Falling Tree
State Farm Claim: #33-5770-G43
Insured: Randall & Kathy Griffen
D.O.L.: 9/14/2018
FAEC File No.: 500-248-NC-18

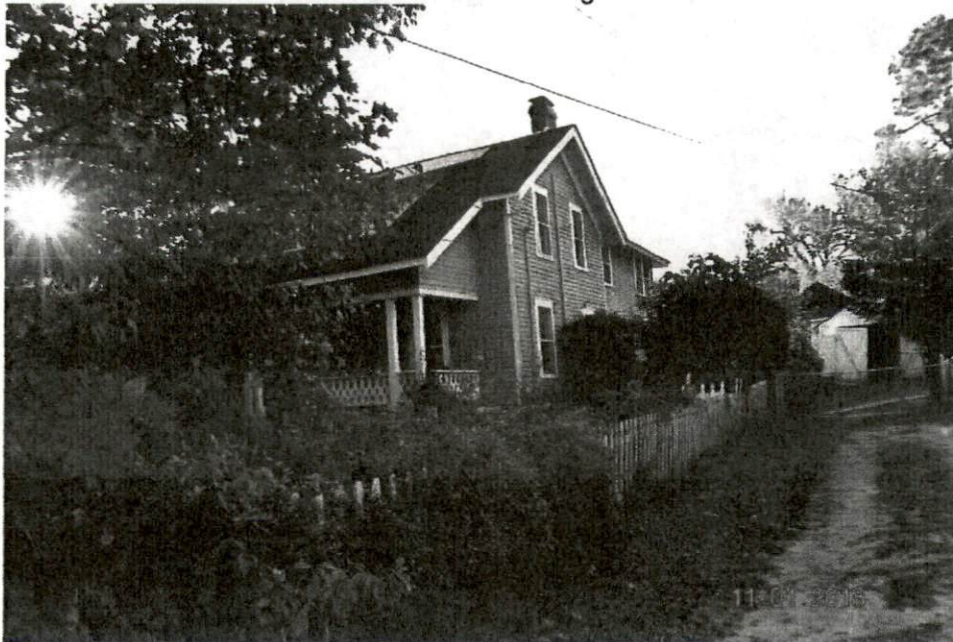
Photograph No. 2 – A view of the home from the right front.

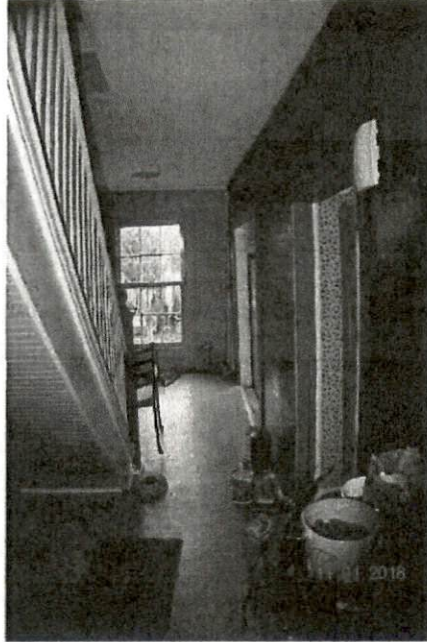
Photograph No. 13 – That hallway as seen from the front of the house.

4. The floor and wall surfaces in the affected area of the hallway and leading into the kitchen will be required to be striped to the studs and floor/ceiling framing for repair access and to determine if there is hidden internal damage. Once the structure is stable and reasonably level with replaced piers in place, the framing damage is easily repaired by an NC-licensed general contractor familiar with and highly experienced in repair of aged homes.
