Project No. 19-1514

Re: Structural Observation — 45 Orchard Falls Drive, Spring Lake, NC 28390

PICTURE ADDENDUM

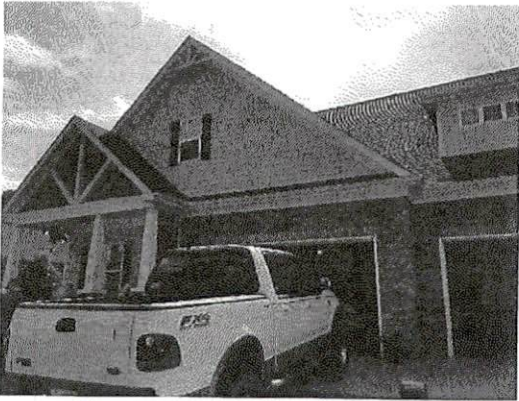
Picture 1 – 45 Orchard Falls Drive,
Spring Lake, NC

At your request, on June 10th, 2019 we performed a visual structural observation of signs of structural movement in the perimeter foundation at the Spring Lake residence noted above. The structure is a conventionally framed, detached, single family residence with raised first floor framing over a pier/girder foundation system with perimeter masonry foundation walls (*see picture 1*).
