RE: Daily Field Report for 02/17/2021
18446 NC 27 West (CMT) Cameron, NC
Building & Earth Project No : RD210063

Field Observations Report

Project Name: 18446 NC 27 West (CMT) Cameron, NC	Project Number: RD210063
Client Name: Clayton Homes	Placement#: FO-1
Contractor: Clayton Homes	Technician: Frank Hamlin
Monitoring: DCP

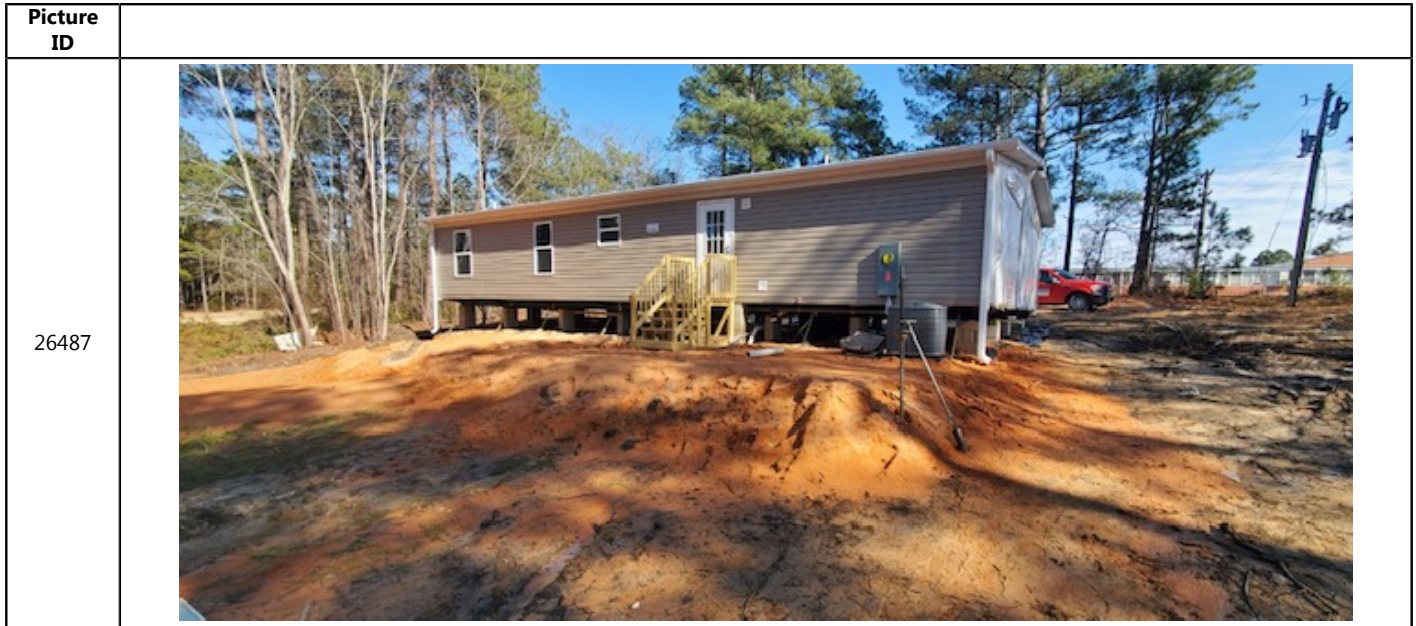
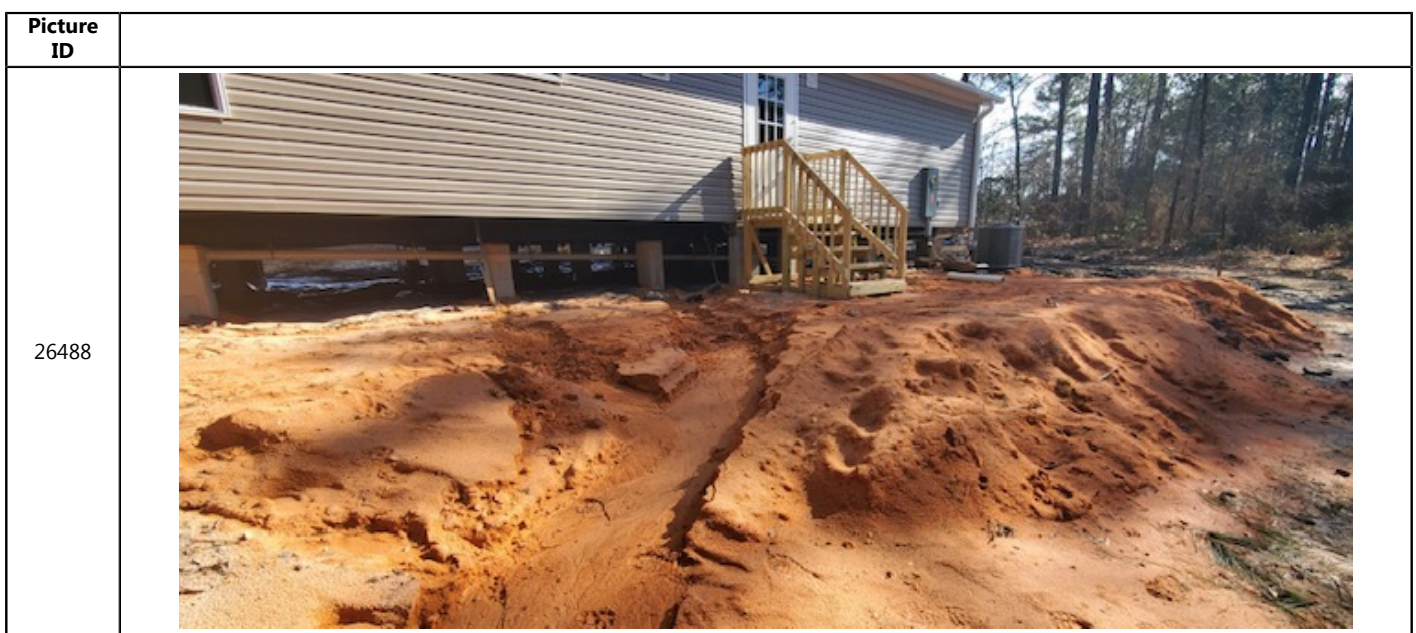
Photographs

Based on our observations and test results, the required bearing capacity of 2,000 psf is available at Test Location #1 and #2 on this date. However, bearing capacity of 2,000 psf is not available at Test Location #3 to a depth of -2' (Back Right Corner) as we encountered loose/wet soils. See attached photos.
