Cody Johnston, PE
Stonewall Structural Engineering, PLLC
4800 Falls of Neuse Rd. #120
Raleigh, NC 27609
(919)407-8663

Re: Structural Observation — 50 North Ida Street, Coats, NC 27521

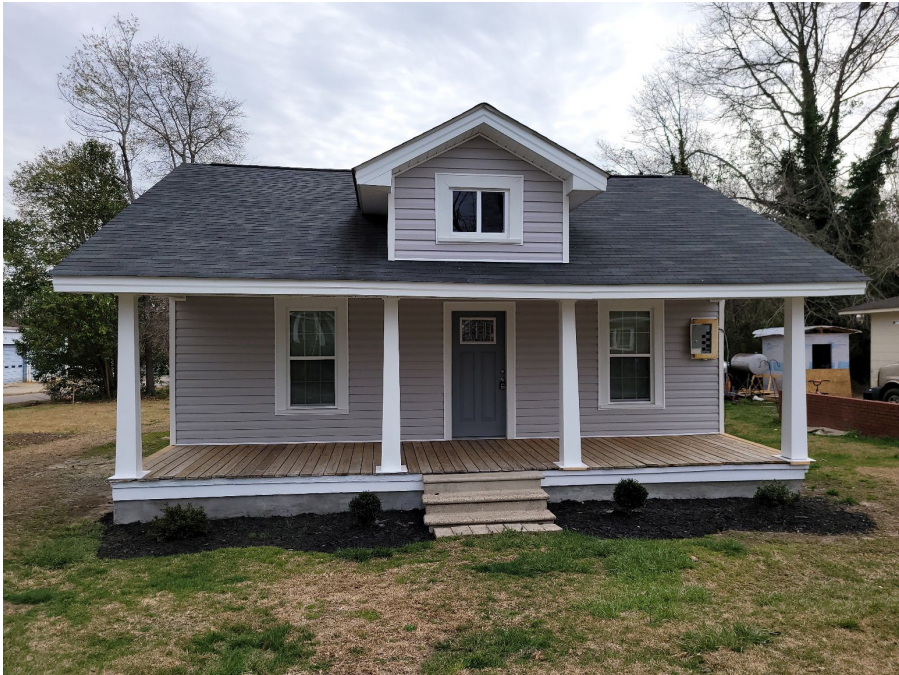
*Picture 1 – 50 N. Ida Street
Coats, NC 27521*

At your request, on March 16, 2022 we performed a visual structural observation of prior repairs to the first floor framing at the Coats residence noted above. The structure is a conventionally framed, detached, single family residence with raised first floor framing over a pier/curtain wall foundation system (*see picture 1*).
