Reference: Engineering Services
369 Byrd's Mill Rd
Erwin, NC 28339
TE&D Project No. 2301-020111

A representative of Tyndall Engineering & Design (TE&D) has observed the following items:

- 1) Observed and analyzed existing foundation supporting the residential dwelling at the above referenced address with regard to compliance with the 2019 State of North Carolina Regulations for Manufactured Homes. We observed the home at the above referenced address consisted of (1) components:
 - a. The manufactured home (approximately 60'-2" x 23'-1")

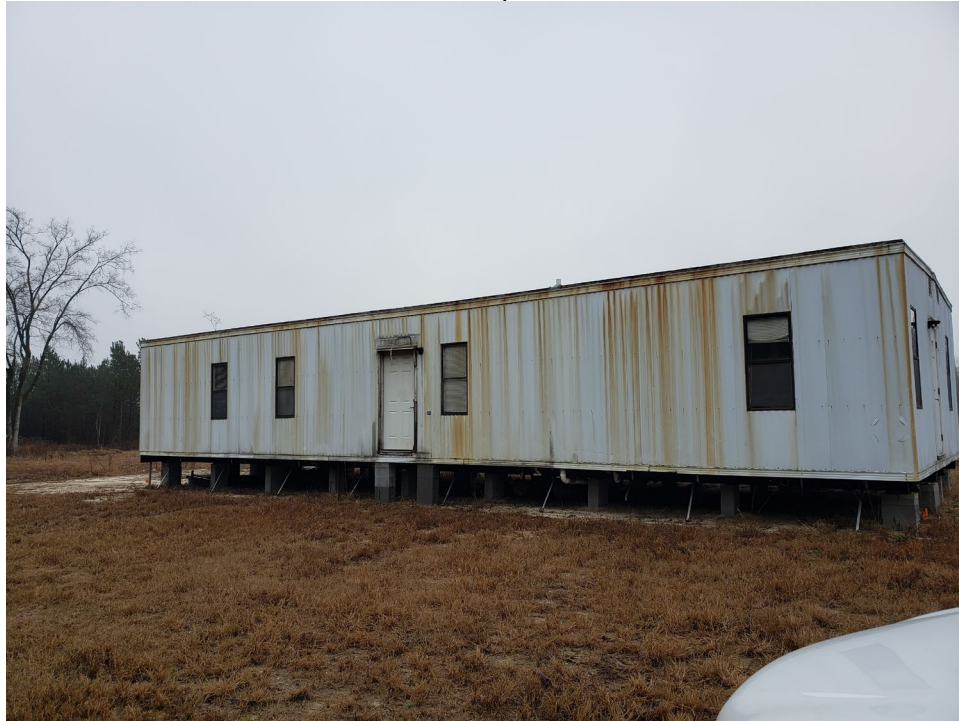
- 1) Based on our visual observations, the existing home foundation consists of CMU dry stacked piers on ABS pads. Tie down straps were observed around the perimeter as well as below the center of the house. All pier footings did not bear a minimum of 4" below grade. No curtain wall was observed. This is inadequate to meet the 2019 State of North Carolina Regulations for Manufactured Homes guidelines. TE&D recommends the following modifications be made:
 - A) There is currently no curtain wall. TE&D recommends installing a masonry curtain wall on a continuous concrete footing, minimum 8" wide x 4" thick.

No perimeter curtain wall on continuous footing observed
