Reference: Engineering Services
447 Deanne Lane
Coats, NC 27521
TE&D Project No.: 1901-020458_A

- 1) Structural assessment of the first-floor framing within the crawlspace.

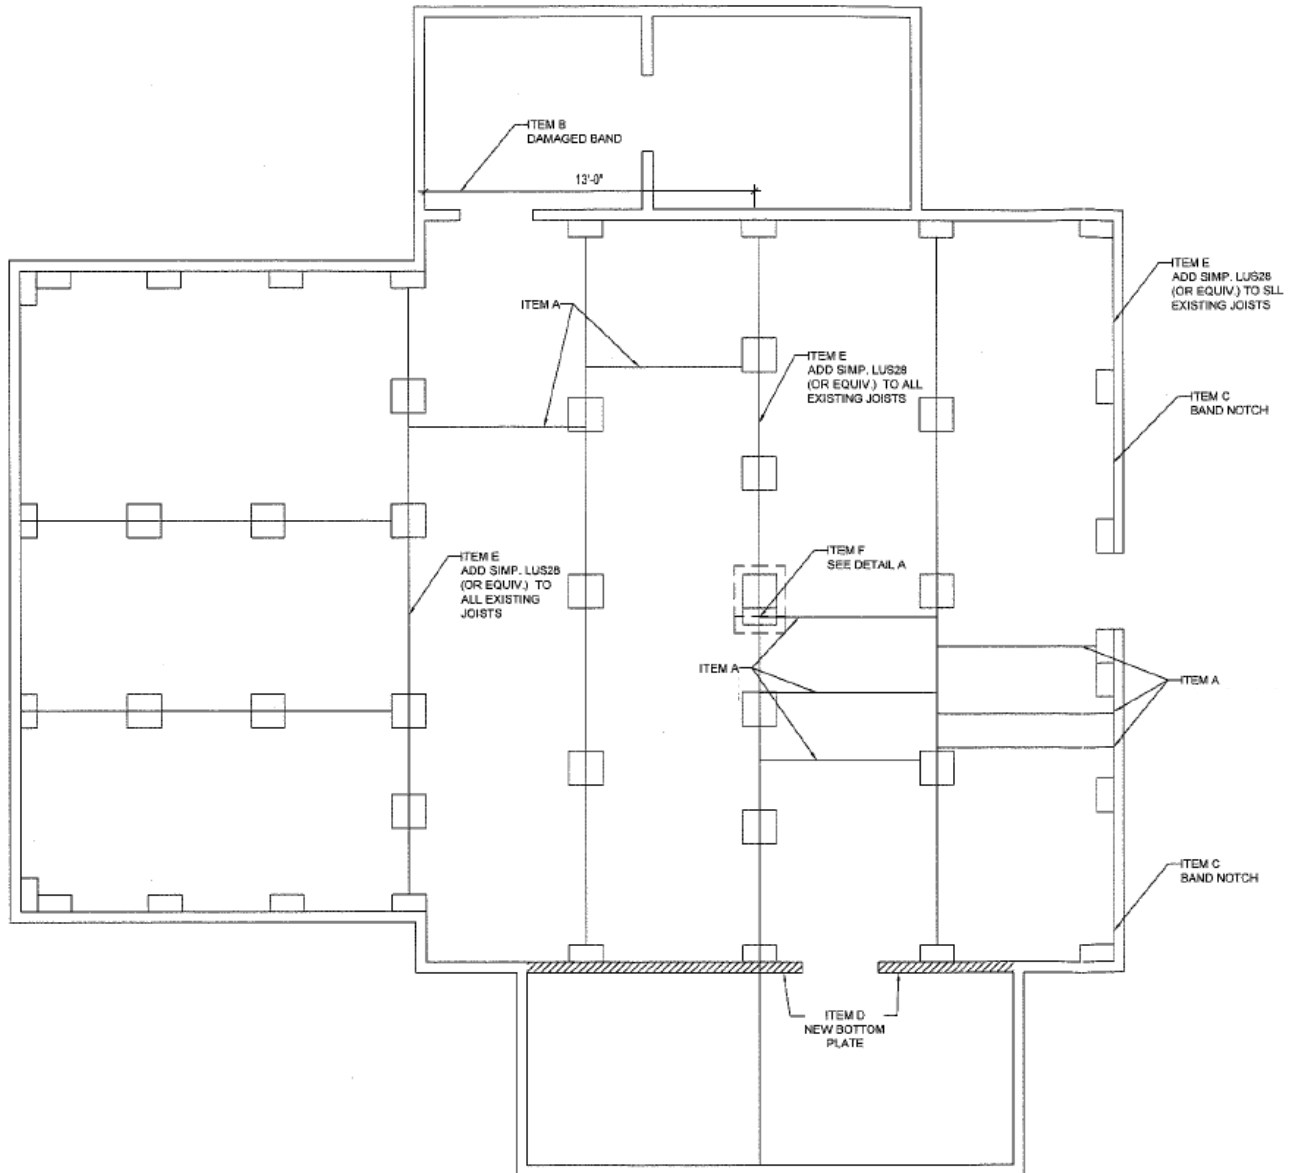
- A) Eight (8) 2 x 8 joists were observed to have been previously damaged by wood destroying insects. New, treated 2 x 8 joists are to be "sistered" to all damaged joists with (2) rows of 10D nails at 16" o.c. New joists are to have full bearing at each end. (see plan for joist locations)

- B) Approximately 13'-0" of the 2 x 8 band at the rear of the house was observed to be damaged. Based on our observations and analysis, the band is to be reinforced with 2 x 10 blocking installed vertically at 16" o.c. Blocking is to be secured to the exterior deck band with 5/8" diameter through bolts. A (2) 2 x 8 header is to be installed over the crawlspace opening.

Install (2) 2 x 8 header over crawl opening
