SFA Design Group, LLC

February 15, 2023

RE: Existing Condition Report
Hopfauf Residence
303 Quail Hollow
Sanford, NC 27332

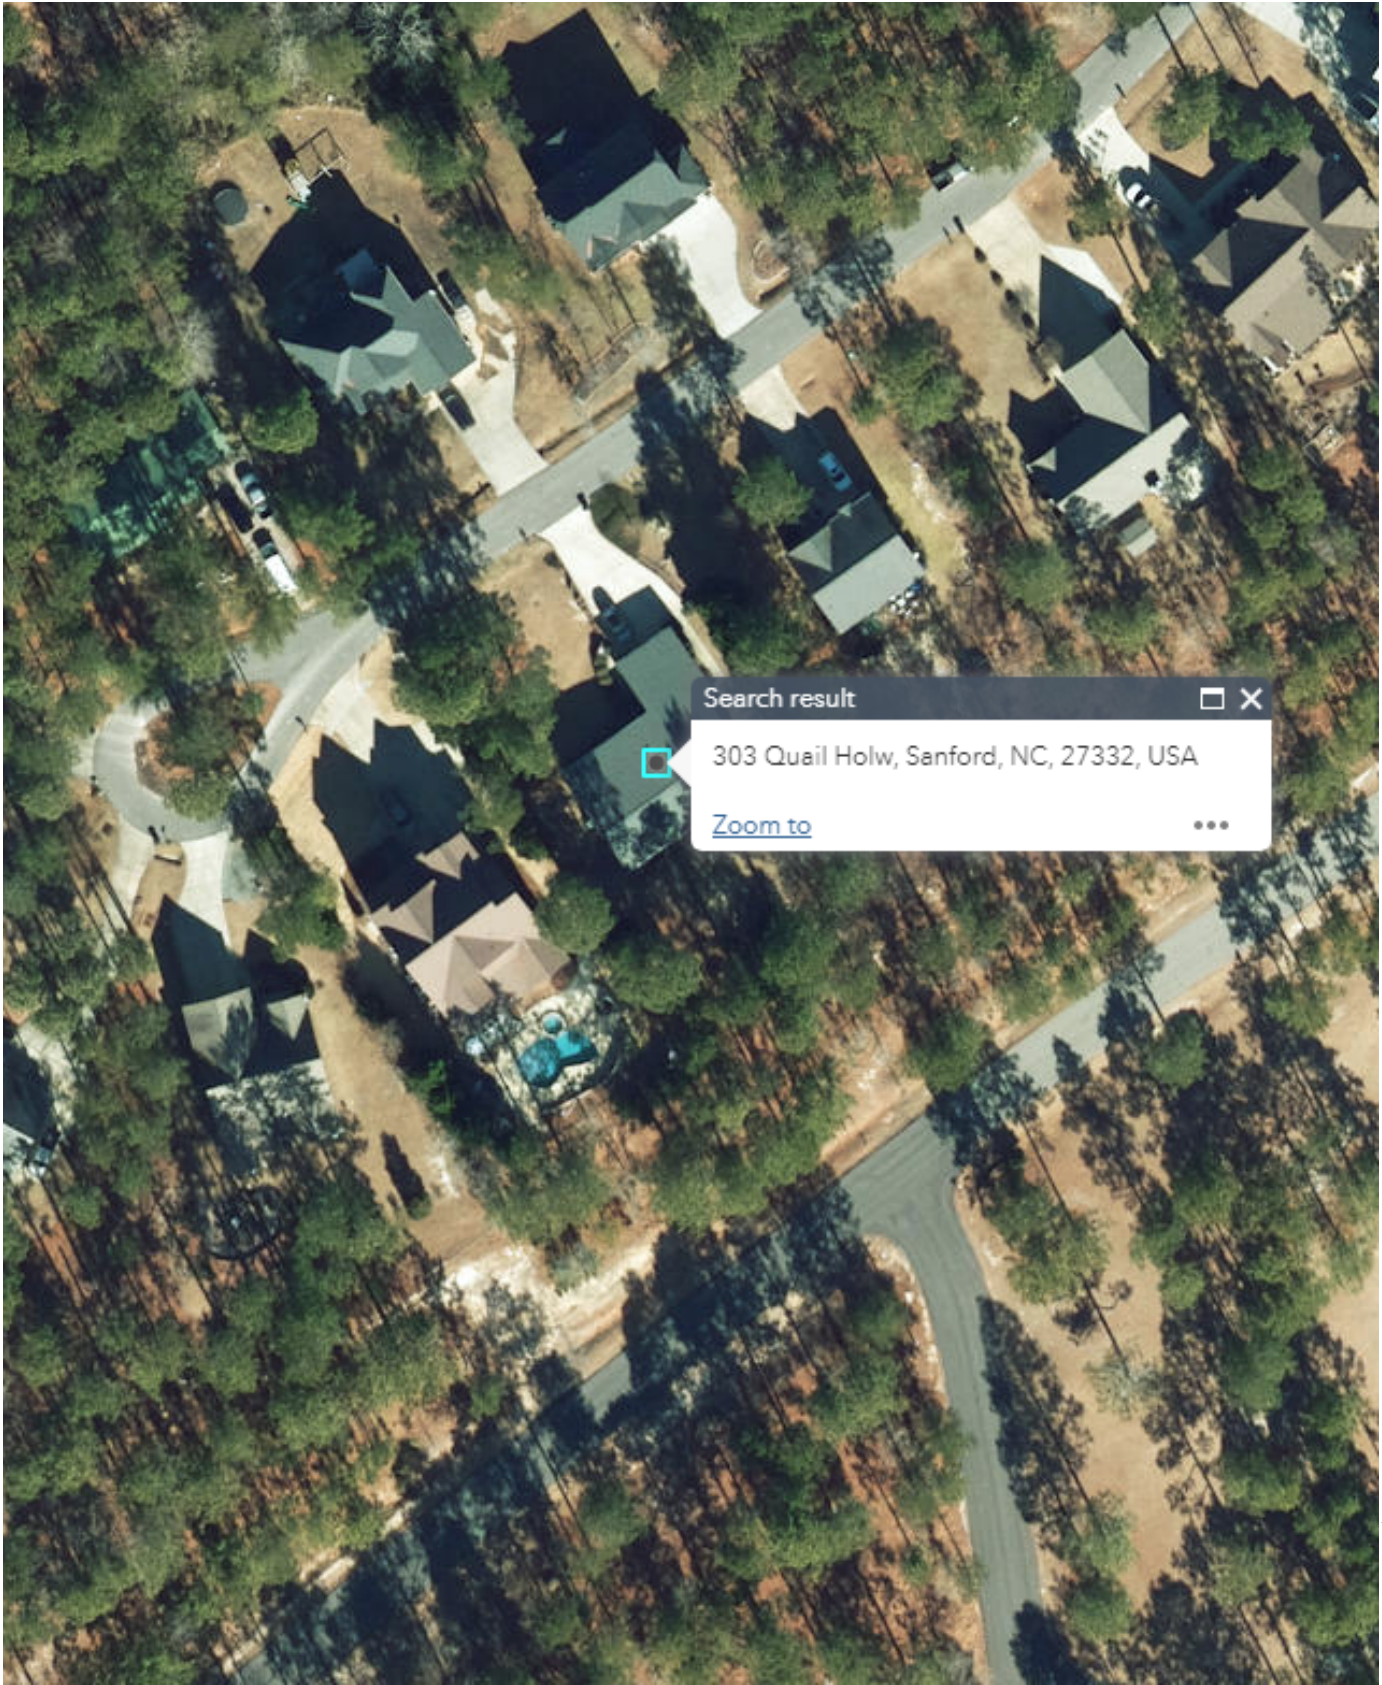
SITE MAP 303 Quail Hollow Sanford, NC 27332	Project Number: RBC23-023
		FIGURE-A

SFA Design Group conducted a visual observation of the Hopfauf Residence on January 31th, 2023. The subject property is located at 303 Quail Hollow, Sanford, NC 27332 (Figure-A). Originally built in 1989, the existing structure is a single-story, wood-framed, single family home of approximately 2,172 sq-ft. The foundation consists of traditional CMU stemwall with brick veneer, resting on a continuous concrete footing at the perimeter, with CMU pilaster and beam construction at the interior and a concrete slab on grade at the interior of the garage (Figure-C). The residence is located on a 0.39 acre lot. The results of the investigation and the corresponding repair recommendations are presented in the following pages.

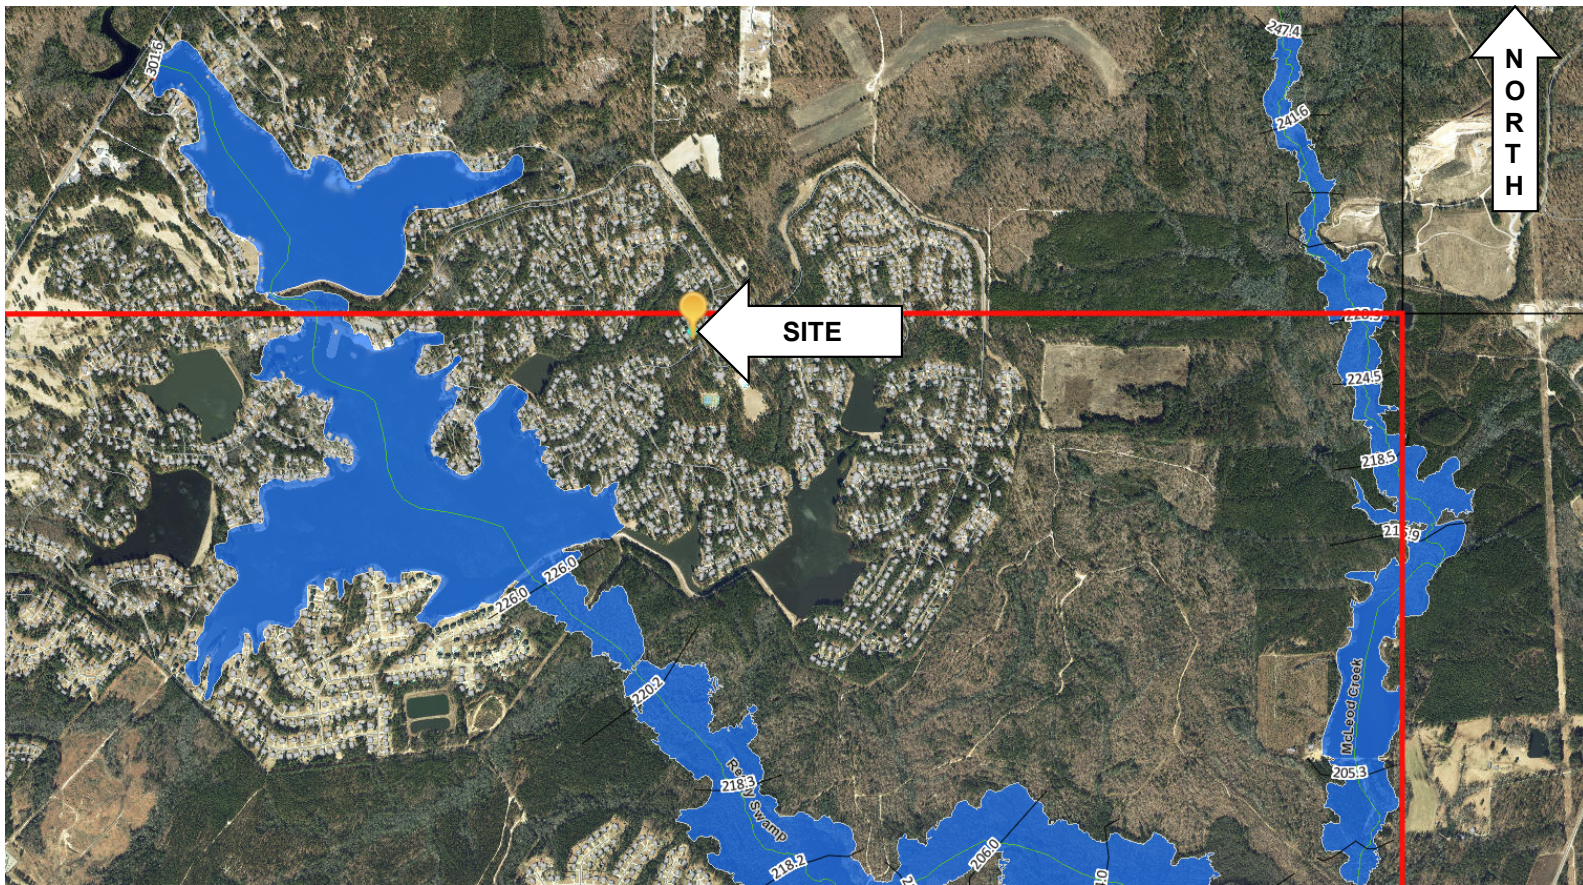
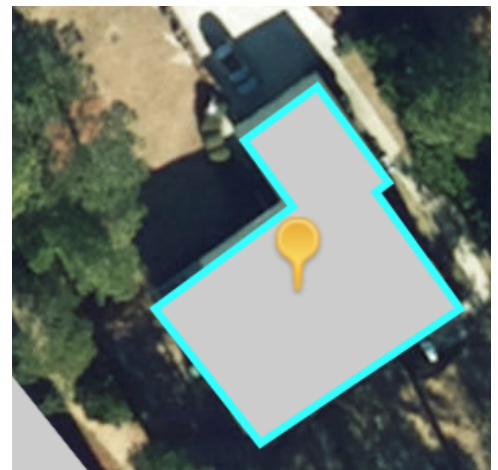
FLOOD HAZARD MAP 303 Quail Hollow Sanford, NC 27332	Project Number: RBC23-023
		FIGURE-B

Based on maps provided by the North Carolina Flood Risk Information System² the property is not in an area that is at risk of flooding; nor are there any geotechnical or ground water conditions which would indicate a potential for permanent ground displacement (Figure-B).
