INSPECTION REPORT:

PROPERTY ADDRESS: 757 Atkins Road
Fuquay Varina, NC 27526

DATE OF INSPECTION: November 17, 2022

NORTH CAROLINA SEPTIC INSPECTIONS

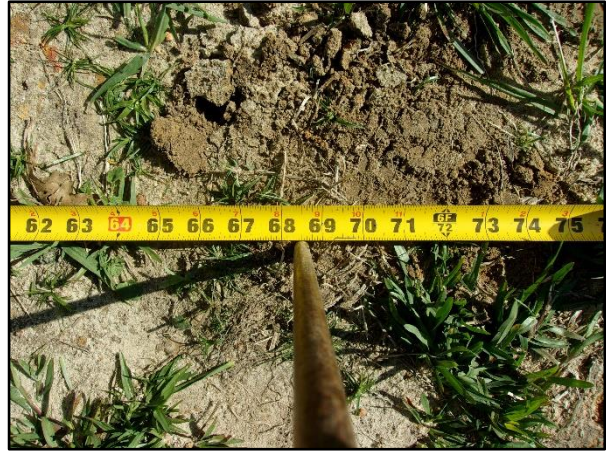
Distance from Foundation:

Feet from Foundation: <i>NC Code (No Less than 5 Feet)</i>	<input checked="" type="checkbox"/> 5 Feet 6 Inches		
Is Foundation of home an encroachment?	<input checked="" type="checkbox"/> No		
Feet from Deck? <i>NC Code (No Less than 3 Feet)</i>	<input checked="" type="checkbox"/> 22 Feet		
Is Driveway an encroachment?	<input type="checkbox"/> Yes	<input checked="" type="checkbox"/> No	<input type="checkbox"/> Non-applicable
Feet from well if applicable: <i>NC Code (No Less than 50 feet)</i>	<input checked="" type="checkbox"/> Non-applicable		
Community water or county water?	<input checked="" type="checkbox"/> Yes	<input type="checkbox"/> No	<input type="checkbox"/> Non-applicable
Feet from main water line if applicable: <i>NC Code (No Less than 10 Feet)</i>	<input checked="" type="checkbox"/> 10 Plus Feet <input type="checkbox"/> Less Than 10 Feet	<input type="checkbox"/> Non-applicable	
Is there and irrigation system?	<input type="checkbox"/> Yes	<input type="checkbox"/> No	<input checked="" type="checkbox"/> Could not Confirm

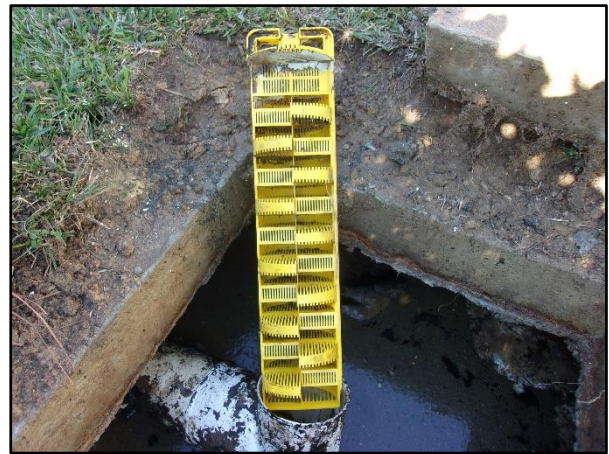
Cleaned Effluent Strainer:

- 1). The combined depth of surface scum, mixed solids, and sludge does not equal the 25 to 30 percent of the liquid holding capacity necessary for pumping, however, because of the non-biodegradable materials, in addition to the thickness of primary chamber surface scum, consideration should be given to **pumping** the tank at this time. FYI: To prevent a backup of sewage resulting in an interruption in service, periodic removal, and cleaning of effluent strainer is also recommended (see page 9 for additional information and pictures).

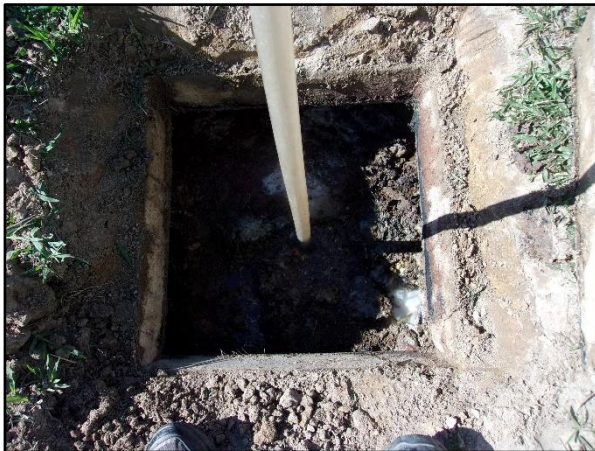
Primary Chamber Sludge Measurement:

<i>Is leakage suspected?</i>	<input checked="" type="checkbox"/> No
<i>Is concrete etching present at static water line?</i>	<input checked="" type="checkbox"/> Yes (Normal Age-related)
<i>Is interior corrosion present?</i>	<input checked="" type="checkbox"/> Normal Age-related Corrosion Present
<i>Evidence of multiple inlet wastewater pipe connections?</i>	<input checked="" type="checkbox"/> None Were Visible
<i>Inlet wastewater supply pipe visible?</i>	<input checked="" type="checkbox"/> Yes
<i>Outlet wastewater supply pipe visible?</i>	<input checked="" type="checkbox"/> Yes
<i>Inlet primary chamber floating scum measurement?</i>	<input checked="" type="checkbox"/> 6 to 7 Inches
<i>Inlet primary chamber bottom sludge measurement?</i>	<input checked="" type="checkbox"/> 6 to 8 Inches
<i>Outlet secondary chamber floating scum measurement?</i>	<input checked="" type="checkbox"/> 1/2 to 1 Inch
<i>Outlet secondary chamber bottom sludge measurement?</i>	<input checked="" type="checkbox"/> 3 to 5 Inches

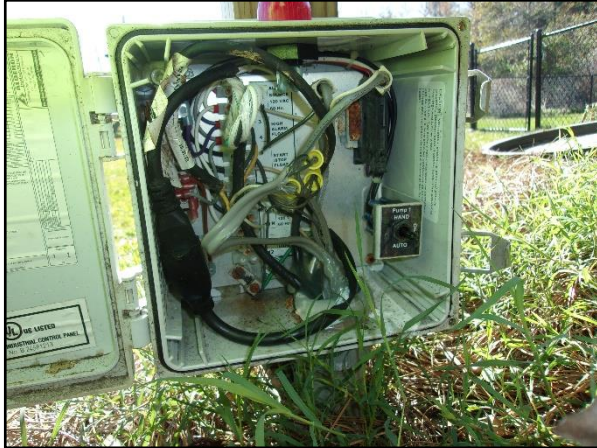
Pump Tank (Panel Box):

- 3). Electrical contacts in pump tank control panel box have rust and corrosion. To prevent possible electrical short, cleaning the terminals is recommended (see page 11 for additional information and pictures).

- 4). Pump tank Electrical control panel box should be a minimum of 12 inches above grade. In extreme rain events water possibly could reach levels of infiltration around base of box. FYI: The lesser height is not unusual when landscaping and backfill have been added around the tanks (see page 12 for additional information and pictures).
