Re: Wall Removal Letter
93 Marian Lane
Spring Lake, NC

Re: Limited Structural Inspection
93 Marian Lane
Spring Lake, NC

At your request, a limited structural inspection of the above property was performed on December 12, 2022. The report that follows has been prepared based on that inspection. The inspection was performed by Tyler Royster, EI of Giles Flythe Engineers.

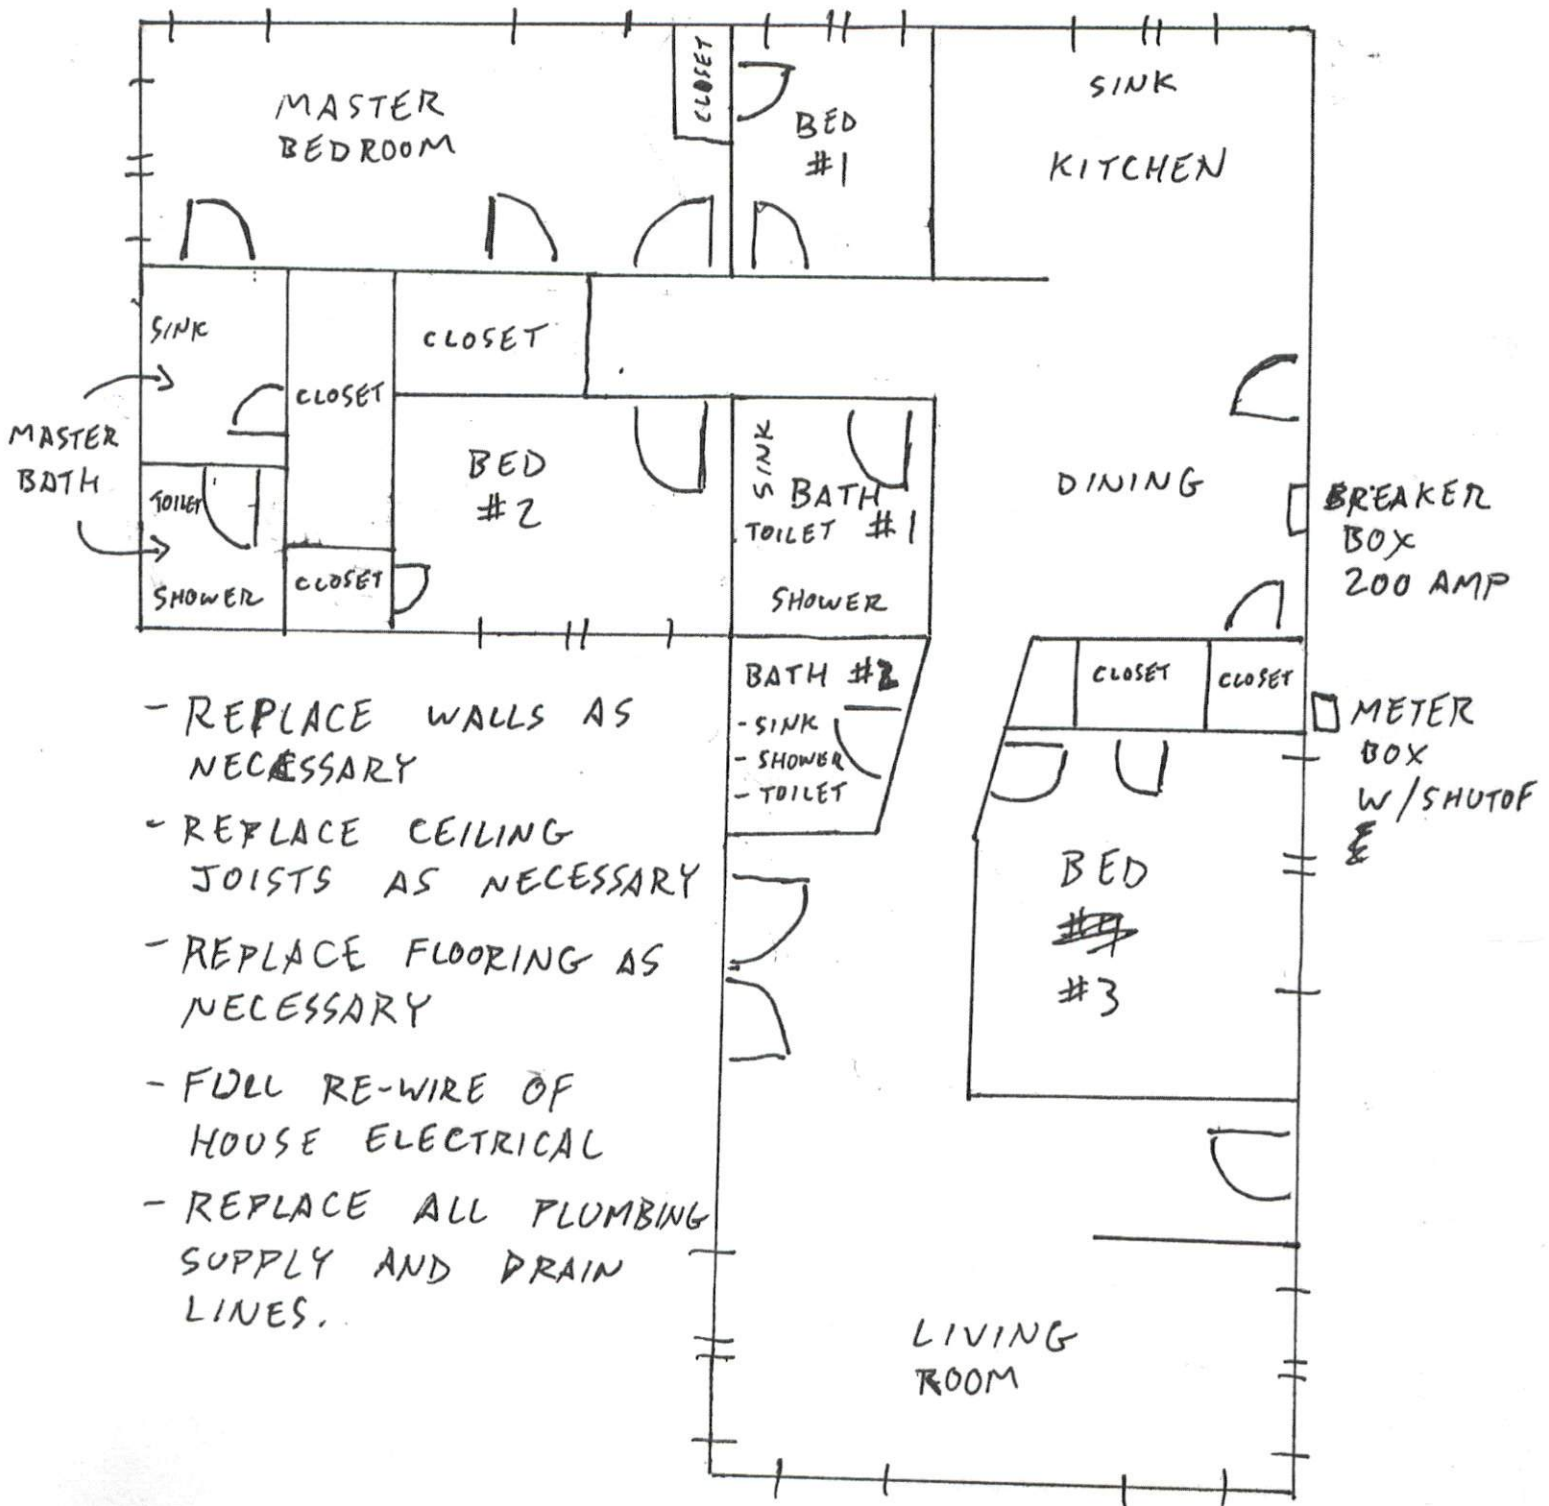
FLOOR JOISTS

THE HOME HAD EXTENSIVE TERMITE DAMAGE AND ROT. I HAVE REMOVED ALL THE EXISTING ELECTRICAL AND PLUMBING. I HAVE ALSO REPLACE ALL FLOOR JOIST, SUBFLOOR, WALLS, AND CEILING JOISTS. THE NUMBER AND LOCATION OF BATHROOMS AND BEDROOMS HAS NOT CHANGED FROM THE EXISTING FLOOR PLAN AND STRUCTURAL DESIGN. I HAVE ADDED TWO UNSUPPORTED SPANS: ONE IN THE KITCHEN, AND ONE IN THE LIVING ROOM. THE BUILDING STRUCTURAL DESIGN FOR THESE TWO SPANS WAS PROVIDED BY A LOCAL STRUCTURAL ENGINEERING FIRM ALONG WITH THE DIMENSIONS AND REQUIRED FASTNERS. THESE TWO SPANS ARE MADE OF 2 LVL EACH, 14" X 1.75". I PLAN TO INSTALL ALL NEW ELECTRICAL WIRING, LIGHT FIXTURES, AND OUTLETS USING 12/2 OR 12/3 FOR LOADS UNDER 20 AMPS AND 10/2 FOR 30 AMP LOADS. I PLAN TO INSTALL SINKS, TOILETS, AND SHOWERS IN THE THREE BATHROOMS. I PLAN TO INSTALL A SINK IN THE KITCHEN. ALL CEILINGS AND WALLS WILL BE INSULATED, AND COVERED IN 1/2" SHEET ROCK. ~~THE~~ I ALSO PLAN TO REPLACE THE HVAC SYSTEM AND ALL HVAC DUCTING.

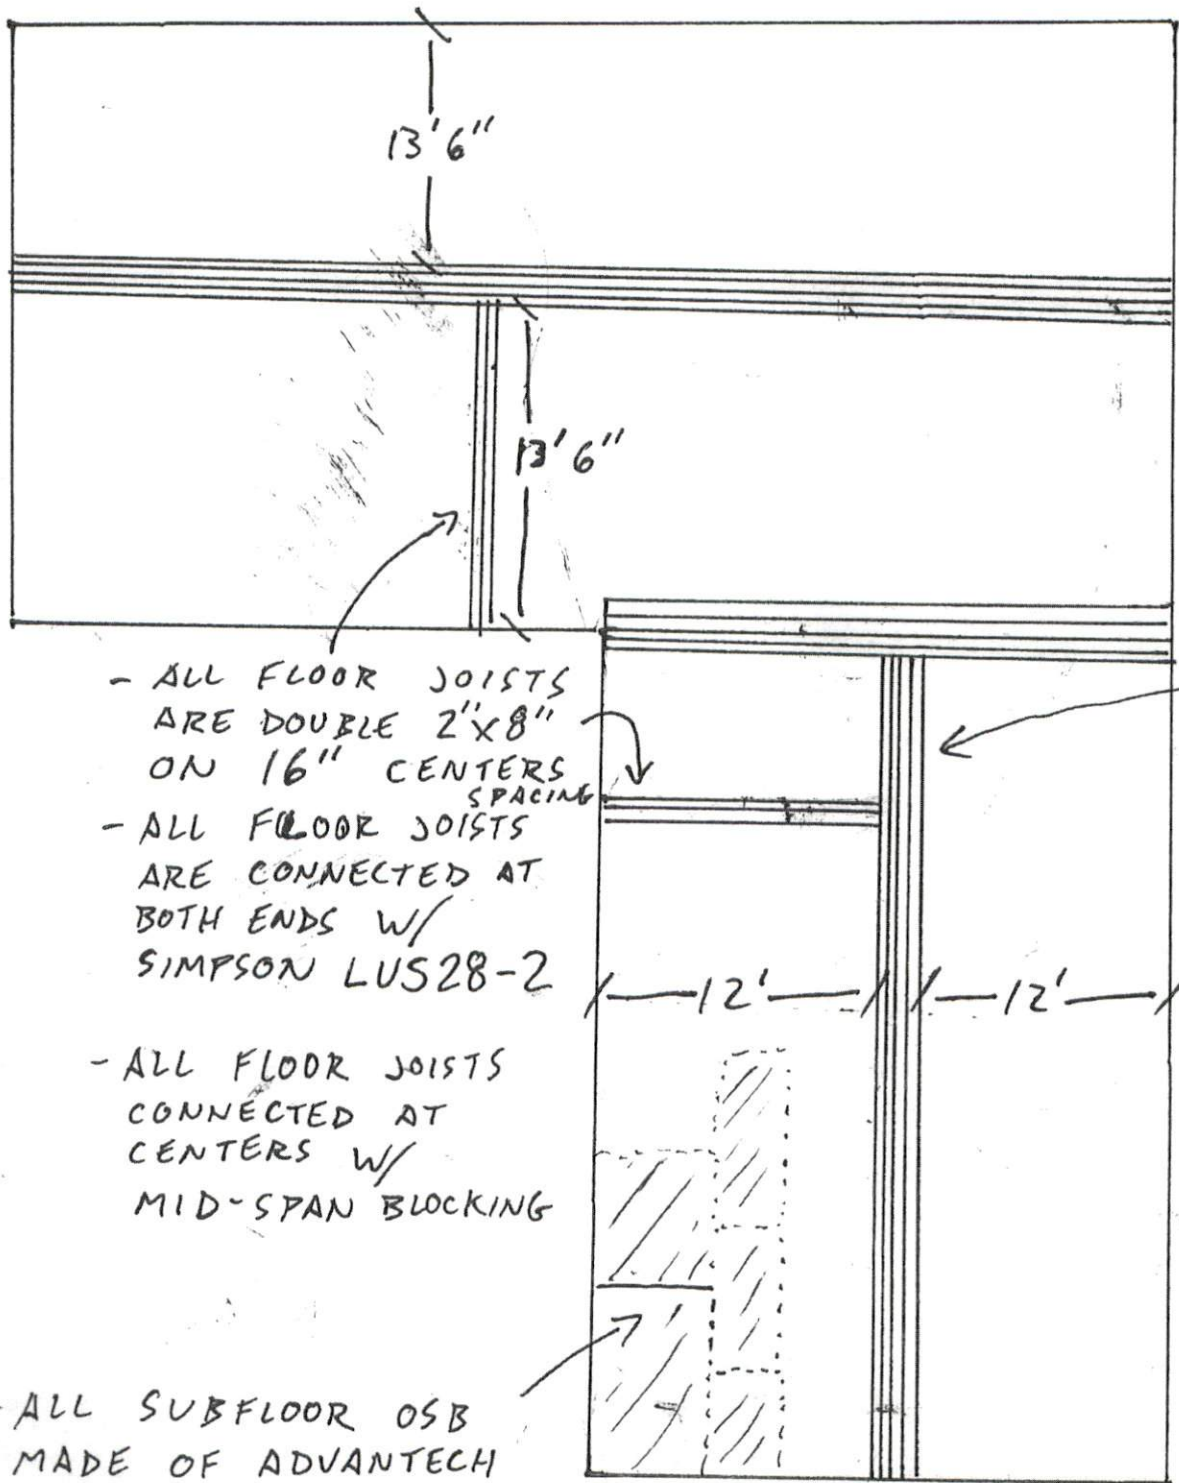
CENTER BEAMS MADE OF 2"x8" TREATED, 4 WIDE

- ALL FLOOR JOISTS ARE DOUBLE 2"x8" ON 16" CENTERS SPACING
- ALL FLOOR JOISTS ARE CONNECTED AT BOTH ENDS W/ SIMPSON LUS28-2
- ALL FLOOR JOISTS CONNECTED AT CENTERS W/ MID-SPAN BLOCKING

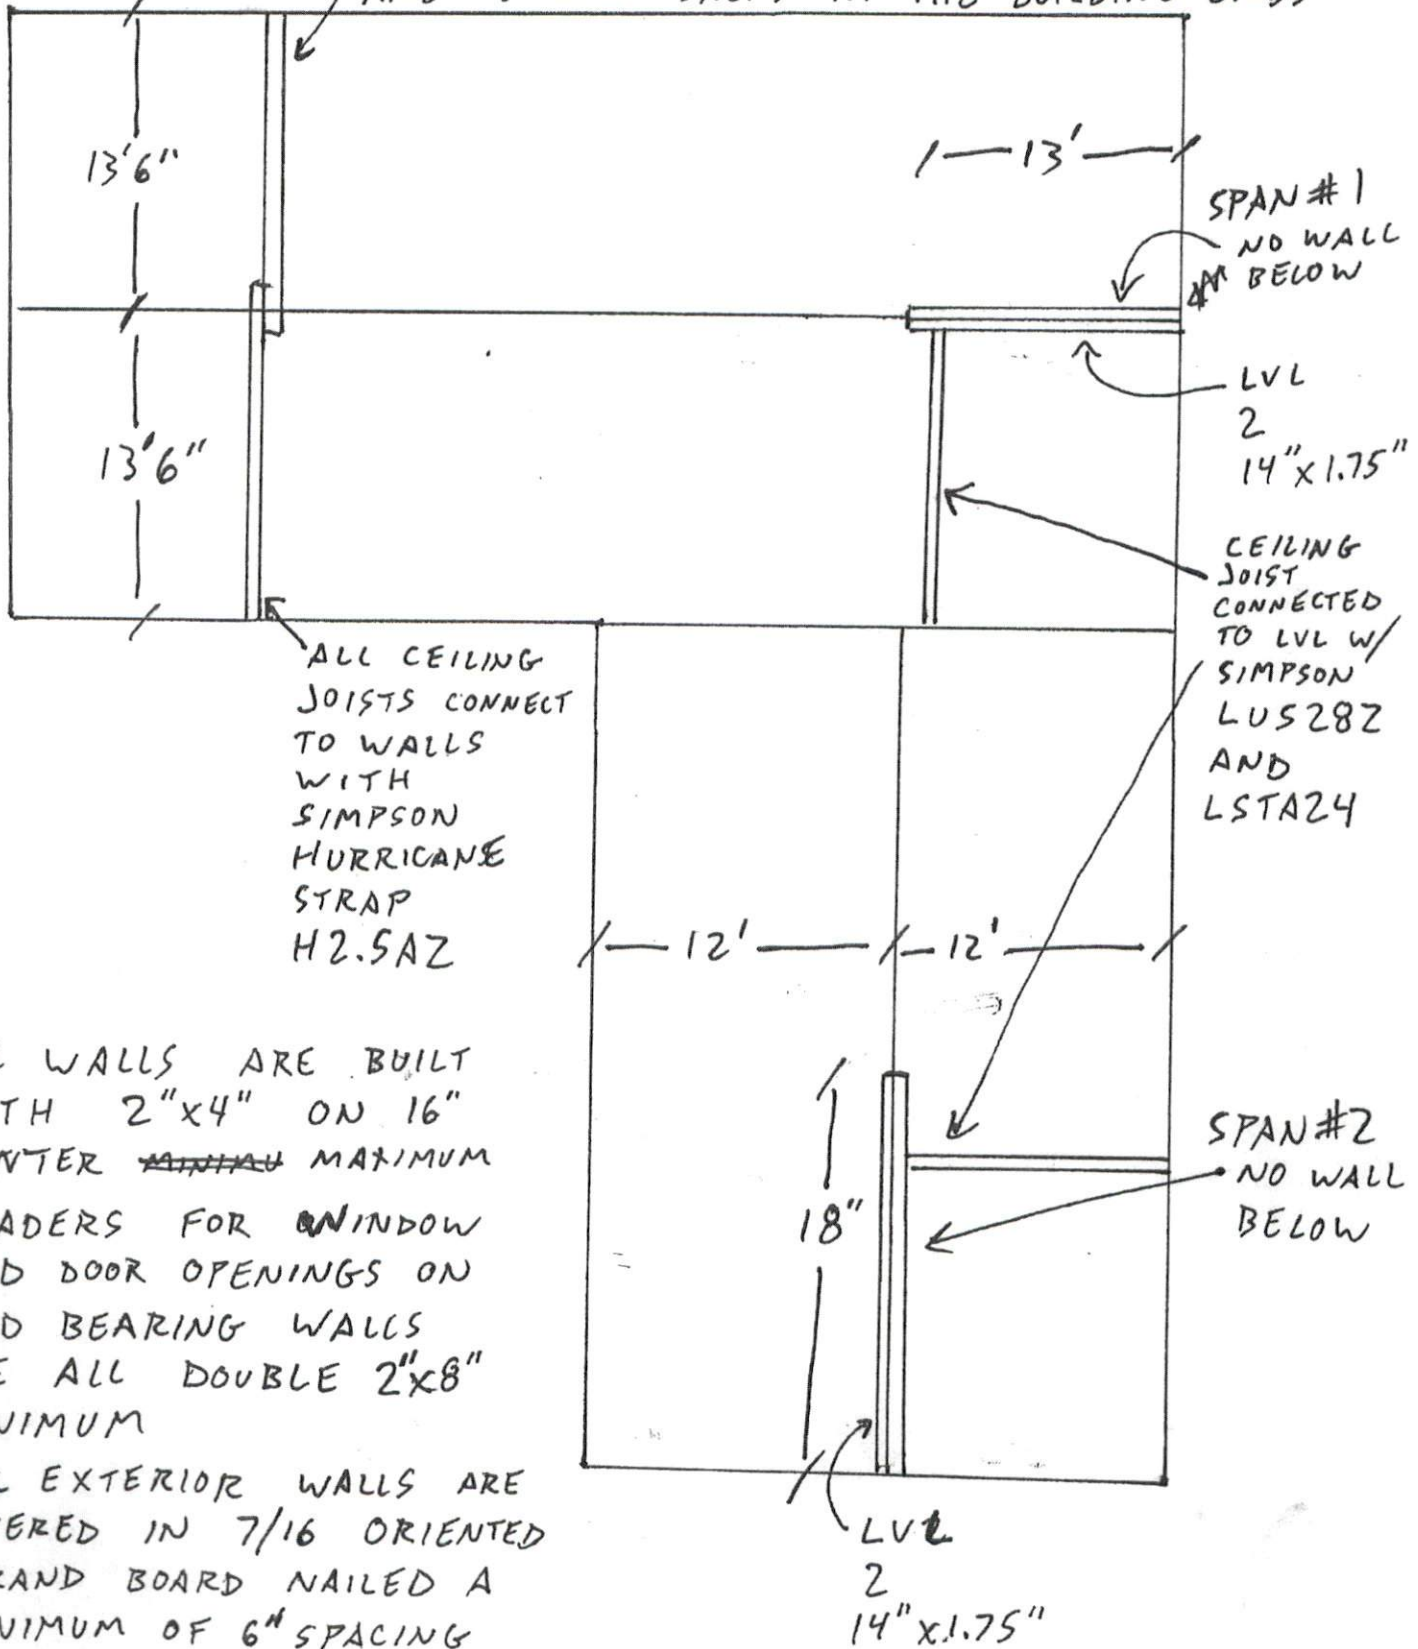
ALL CEILING JOIST ARE 2x8
ON 24" SPACING W/ MID-SPAN BLOCKING
AND STRONG BACKS AT THE BUILDING ENDS

ALL CEILING
JOISTS CONNECT
TO WALLS
WITH
SIMPSON
HURRICANE
STRAP
H2.5AZ

- ALL WALLS ARE BUILT WITH 2"x4" ON 16" CENTER ~~MINIMUM~~ MAXIMUM
- HEADERS FOR WINDOW AND DOOR OPENINGS ON LOAD BEARING WALLS ARE ALL DOUBLE 2"x8" MINIMUM
- ALL EXTERIOR WALLS ARE COVERED IN 7/16 ORIENTED STRAND BOARD NAILED A MINIMUM OF 6" SPACING ON ENDS, AND 12" SPACING IN FIELD.
