Re: Structural Observation — *174 Nature Trail Road, Dunn, NC 28334*

First Floor Framing Repair

Nathan Seeley
174 Nature Trail Rd
Dunn, NC 28334

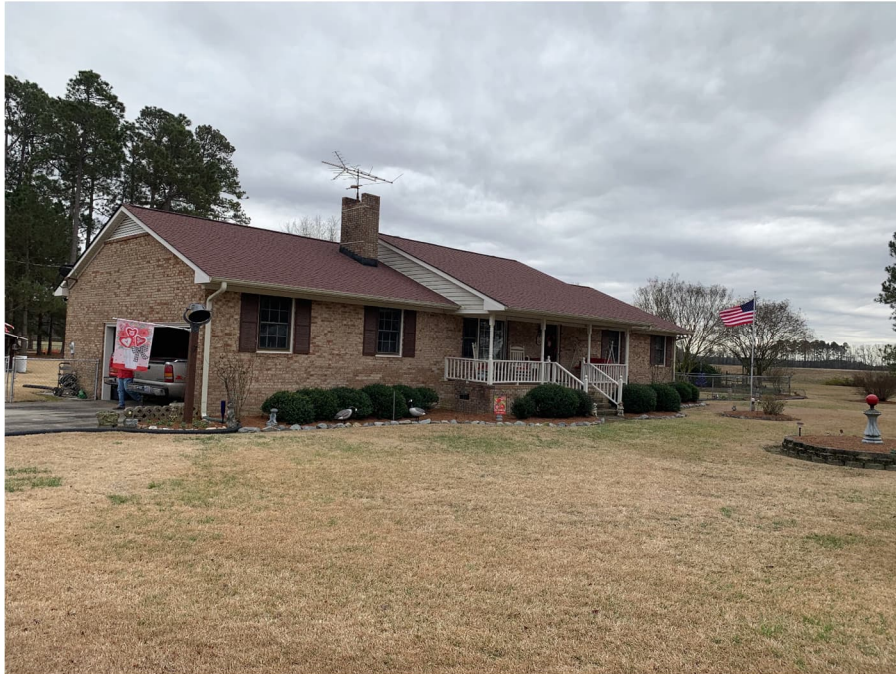
Picture 1 – 174 Nature Trail Road, Dunn, NC 28334

At your request, on February 21, 2025 we performed an on-site visual inspection and review of the structural plan proposed by *Tar Heel Basement Systems* for the first-floor framing repair work at the Dunn residence noted above. The structure is a conventionally framed, detached, single family residence with raised first-floor framing over a pier/girder foundation system with perimeter masonry foundation walls (*see picture 1*).
