ADDRESS . : 74 ROBERT BRANCH CIR

STRUCTURAL INSPECTION REPORT

LOT 23 MILL BRANCH SUBDIVISON 2300-sf± RESIDENCE

KIPLING, HARNETT COUNTY, NORTH CAROLINA

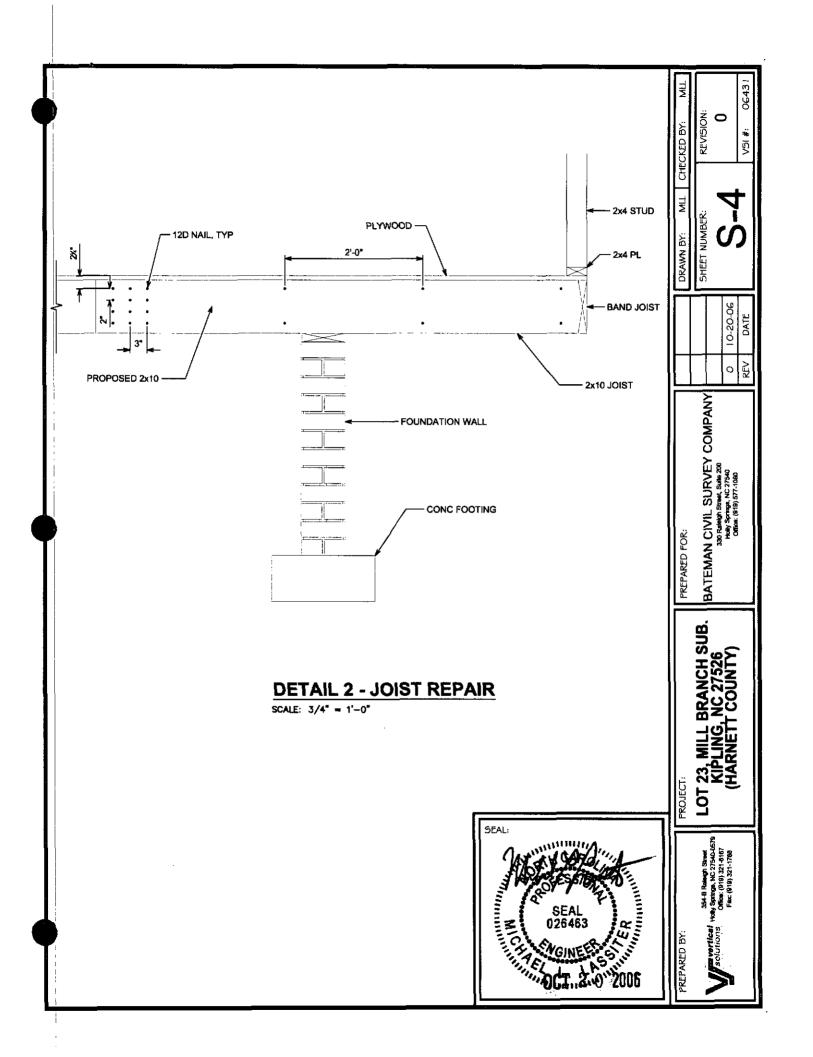
PLAN AT MASTER BATHROOM

Photograph **Observations and Notes** Item 3 Observation: A joist repair was observed beneath the cantilevered portion of the floor framing at the master bathroom, 2'-6" from the front wall. This repair conceals damage to original joist. Recommendation: Install a 2x10 joist beside repair. Refer to drawings in appendix for more details. Item 4 Observation: A damaged joist was observed beneath the cantilevered portion of the floor framing at the master bathroom, 1'-0" from the rear wall. Recommendation: Install a 2x10 joist beside damaged joist. Refer to drawings in appendix for more details.
