Application for Repair

SEPTIC SYSTEM EVALUATION

Date: April 3, 2020
Report for: Ronald & Leanne Gabriel
Inspection address: 5269 Cokesbury Road, Fuquay Varina, NC 27526
Realtor: Allison Griffith (eXp - Marti Hampton Team)
Home Built: 1994

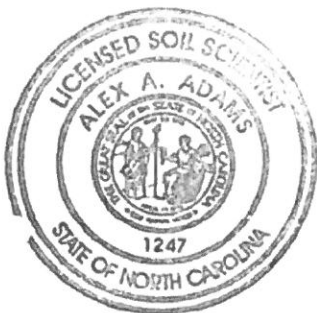
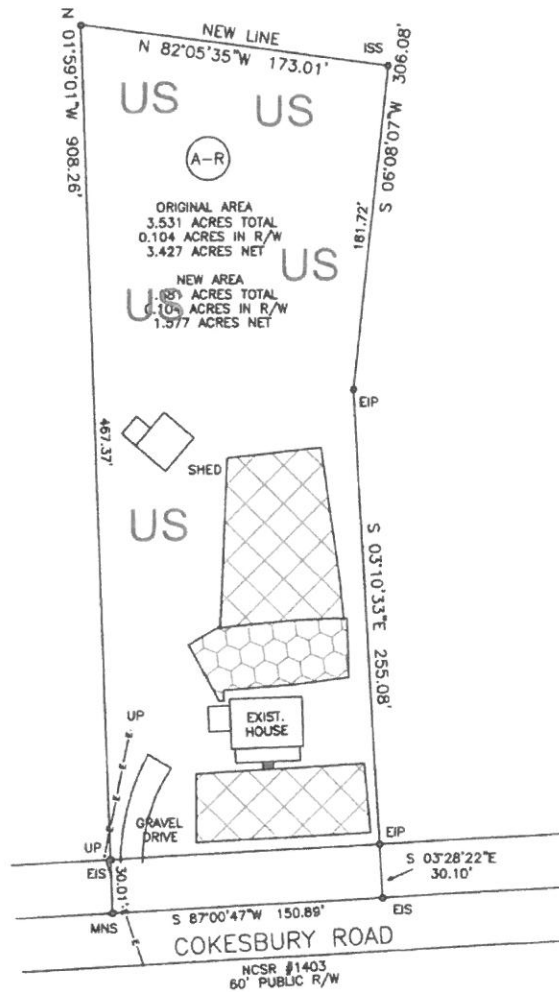
Preliminary Soils Evaluation Coy Jones 5269 Cokesbury Road Harnett County, NC

Unsuitable areas or areas not evaluated

*Not a Survey
(sketched from a Preliminary Plat)
