Application for Repair

NCSI

INSPECTION REPORT:

**PROPERTY ADDRESS: 134 Pear Tree Lane
Fuquay Varina, NC 27526**

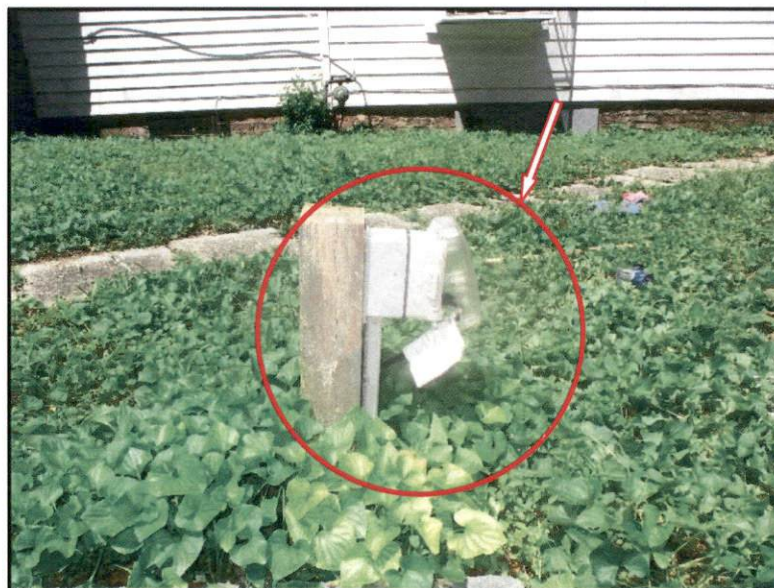
**Installing a Control Panel Box is Recommended:**

- 4). To prevent an interruption of service, it is recommended that Service Provider make the necessary upgrades to the wiring and electrical components servicing the pump tank (see page 11 for additional information and pictures).

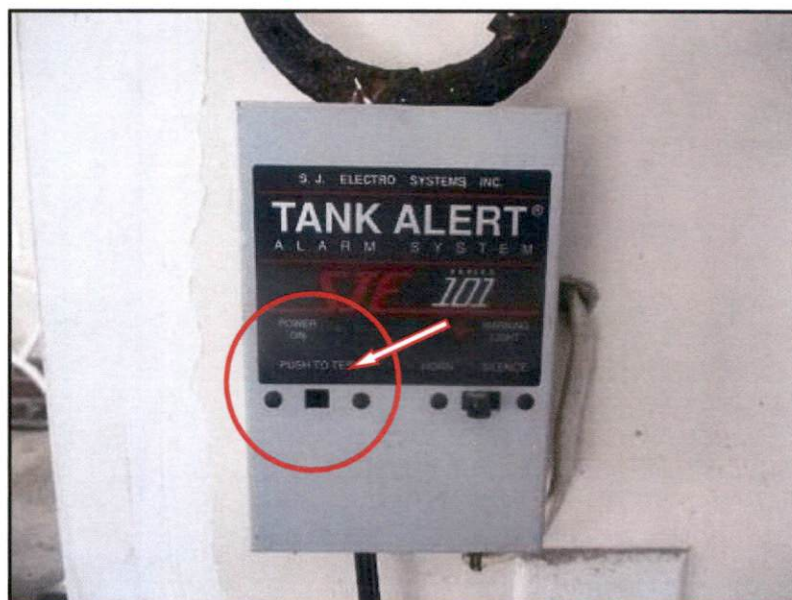
Example of Alarm (Test Switch):

- 6). Highwater alarm float should be functioning at all time. It is recommended that Service provider make the necessary repair to assure alarm is functioning (see page 13 for additional information and pictures).

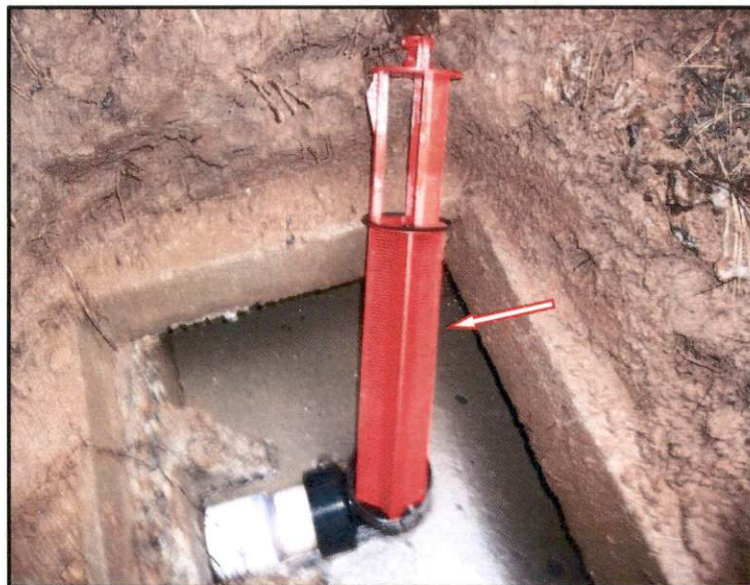
Example of Retro-fitted with PVC Sanitary Tee with Effluent Strainer:

- 7). Because of the age of system, consideration should be given to install a PVC sanitary baffle tee with an effluent strainer. This updated improvement is not uncommon in older systems and is highly recommended with pump systems. For your information, a sanitary tee with effluent strainer, prevents, sludge, mixed solids, scum, and in some cases non bio-degradable products, from exiting the tank and lodging in the pump tank, causing a blockage which can disrupt the flow of effluent to the soil absorption area beneath the lines (see page 14 for additional information and pictures).

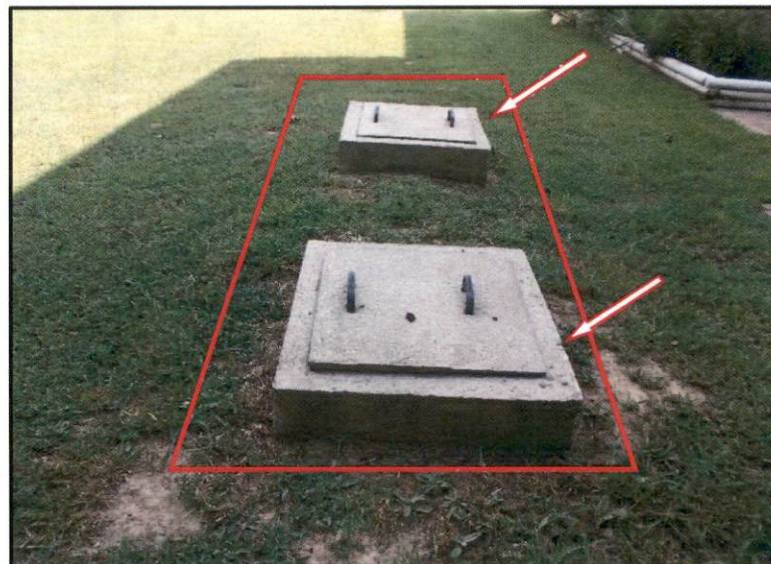
**Example of Risers:**

- 8). Considering the depth that tank is buried beneath the soil surface and the amount of time and difficulty in uncovering the inlet primary and outlet secondary chamber access openings to pump and clean the tank, it is recommended extending the risers to a minimum of 6 inches above finished grade (see page 15 for additional information and pictures).

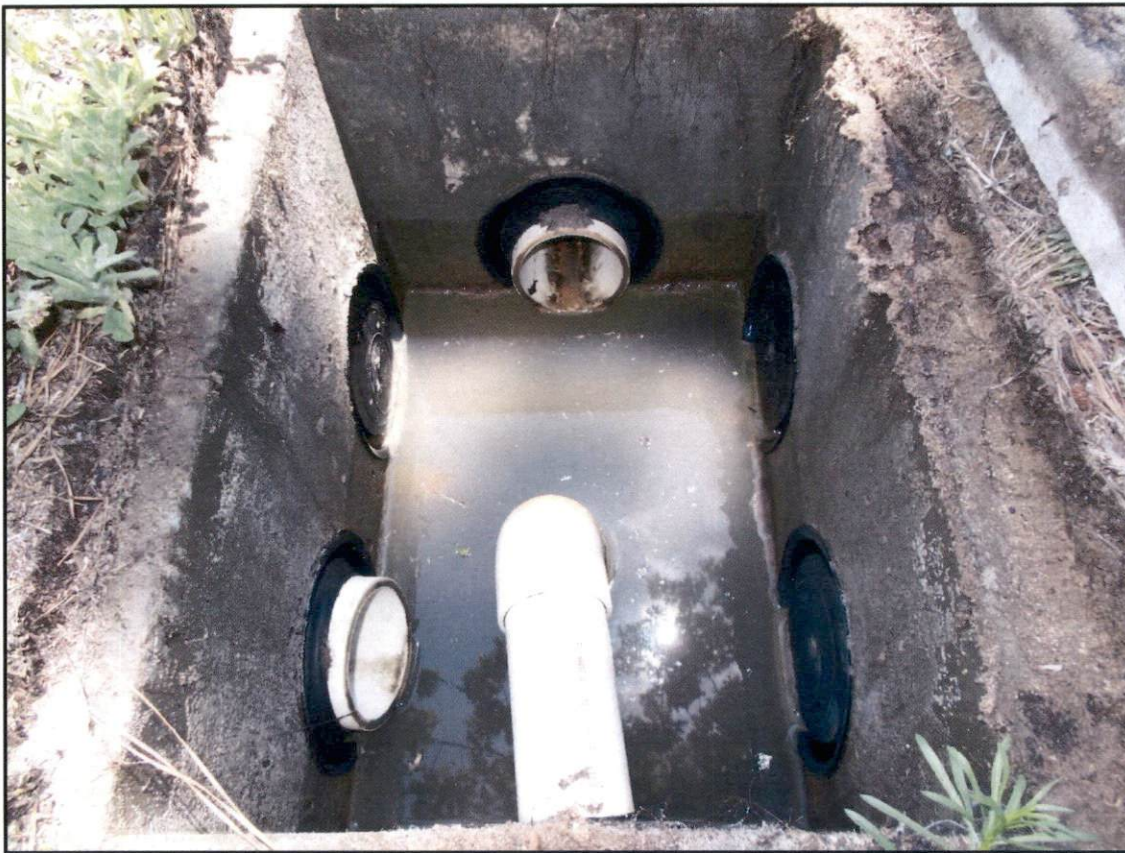
Example of Distribution Box with two (2) Lines:

At time of inspection distribution device could not be located. Therefore, the actual physical condition of distribution devices could not be determined. FYI: Septic systems of this age do not have outlet effluent strainer. Therefore, wastewater with suspended solids can settle in distribution device and in some cases create a layer of sludge. Accumulation of sludge and mixed solids can form a thicker than normal bio-mat, which can restrict the effluent from being absorbed into the surrounding soil absorption area. Periodic inspections of the located distribution devices are recommended so that any excessive accumulation of sand, sludge, or the infiltration of roots can be removed. FYI: It is not unusual to replace distribution boxes in systems of this age.
