Onsite Wastewater System Inspection

165 Buie Farm Road

09/26/2023, 08:30 AM

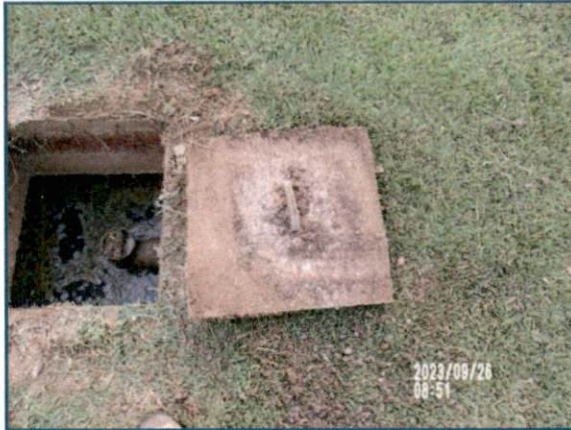
P7. Outlet Septic Tank Lid

The outlet compartment of the septic tank was measured to be twelve feet out from the front right corner of the house, contained a concrete access riser and was at grade level. The riser, riser lid and inner septic tank lid were all in satisfactory condition and they were sealed to

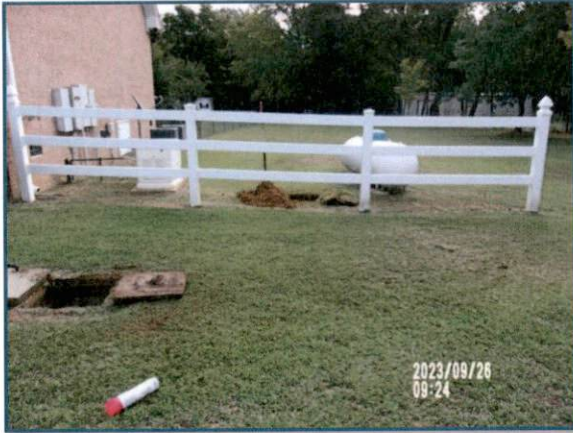
P23. Distribution Box Location

The distribution box was located and it measured four feet out to the right of the septic tank outlet and twelve feet back towards the right side of the house. I measured the box to be two feet on the opposite side of the fence than the septic tank, and twelve feet and six inches off the right hand side of the house. The distribution box and lid were severely deteriorated, and should be replaced at this time. When I first opened the lid I noticed that the water was standing above two of the outlets, and the water that was put inside the septic tank was only flowing out of the line closest to the front of the property.
