Application for Repair

Onsite Wastewater System Inspection

Inspection Title
2040 Arrowhead Road

Property Address
2040 Arrowhead Road
Dunn, N.C. 28334

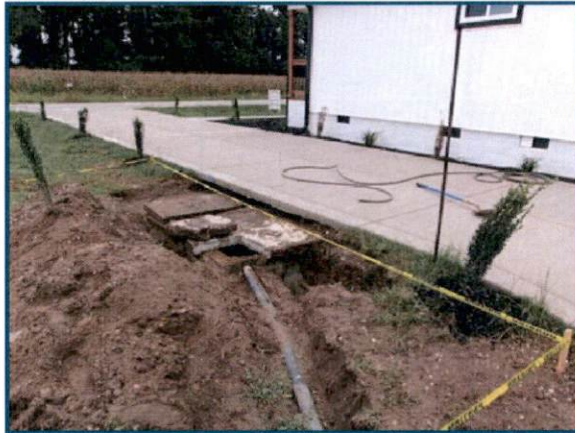
P3. Septic Tank Location

The septic tank was located thirteen feet and six inches to the right of the house, straight out from the white PVC cleanout by the foundation, and it was eight inches below grade. The property lines were not marked with readily observable property markers, so I was unable to measure the precise distance from the septic tank to the property line. I estimated the tank to be approximately eight feet to the left of the right property line. When this tank was installed, there were no setback requirements. The current set back requirement from property lines is at least ten feet. The entire left side of the septic tank is approximately six inches underneath the concrete driveway. This septic tank is not traffic rated, and should not be subjected to vehicular traffic. The septic tank is a single compartment septic tank, and the top of the tank was originally created using multiple slabs that are five feet wide and two feet long,

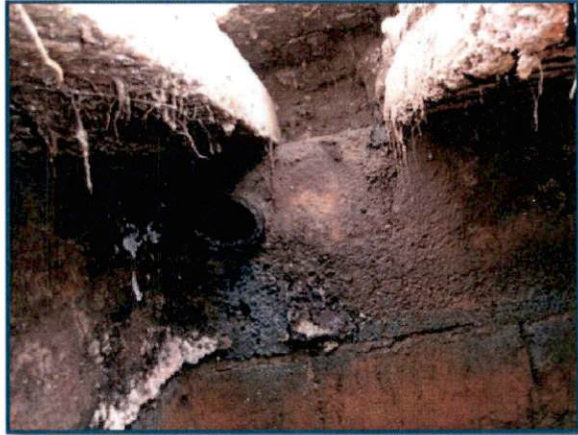
P10. Inlet Pipe & Tank Interior

8. There was an obstruction observed inside the inlet pipe, between the house and the septic tank. I measured the obstruction to be approximately seven to eight feet from the septic tank. The obstruction appears to be corrosion on the bottom of the cast iron pipe.

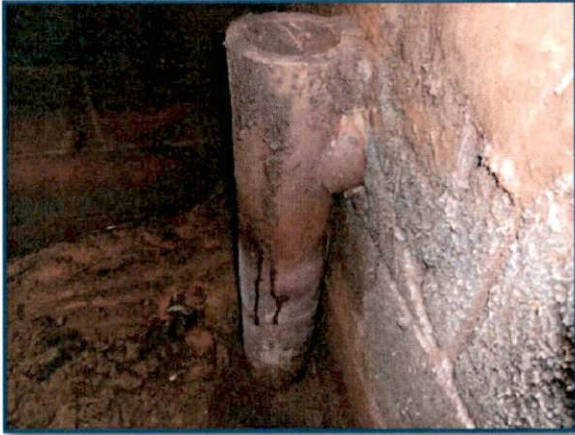
P17. Septic Tank Outlet Tee

was hitting was the transition from a smaller diameter cast iron pipe into the larger diameter ABS pipe that enters the tank. I managed to maneuver my camera past the transition, and I eventually encountered a true obstruction within the cast iron pipe itself, approximately seven to eight feet from the septic tank. The obstruction appears to be the corrosion of the cast iron. I was unable to push my camera beyond this obstruction. I noted that all of the cast iron underneath the house has been replaced with PVC pipe, so there is only a short section of cast iron remaining underneath the driveway. Next I observed the physical condition of the interior of the tank, above the contents, and I did not observe any signs of damage, cracks or excessive corrosion. Lastly, I observed the terracotta outlet tee, and it appeared to be in satisfactory physical condition.
