TYNDALL
ENGINEERING & DESIGN, P.A.

Reference: Engineering Services
Focht Residence
99 Curtis Dr.
Erwin, NC 28339
TE&D Project No.: DRB2201-0154_C

Reference: Engineering Services
Focht Residence
99 Curtis Dr.
Erwin, NC 28339
TE&D Project No.: DRB2201-0154_B

Reference: Engineering Services
Focht Residence
99 Curtis Dr.
Erwin, NC 28339
TE&D Project No.: DRB2201-0154_A

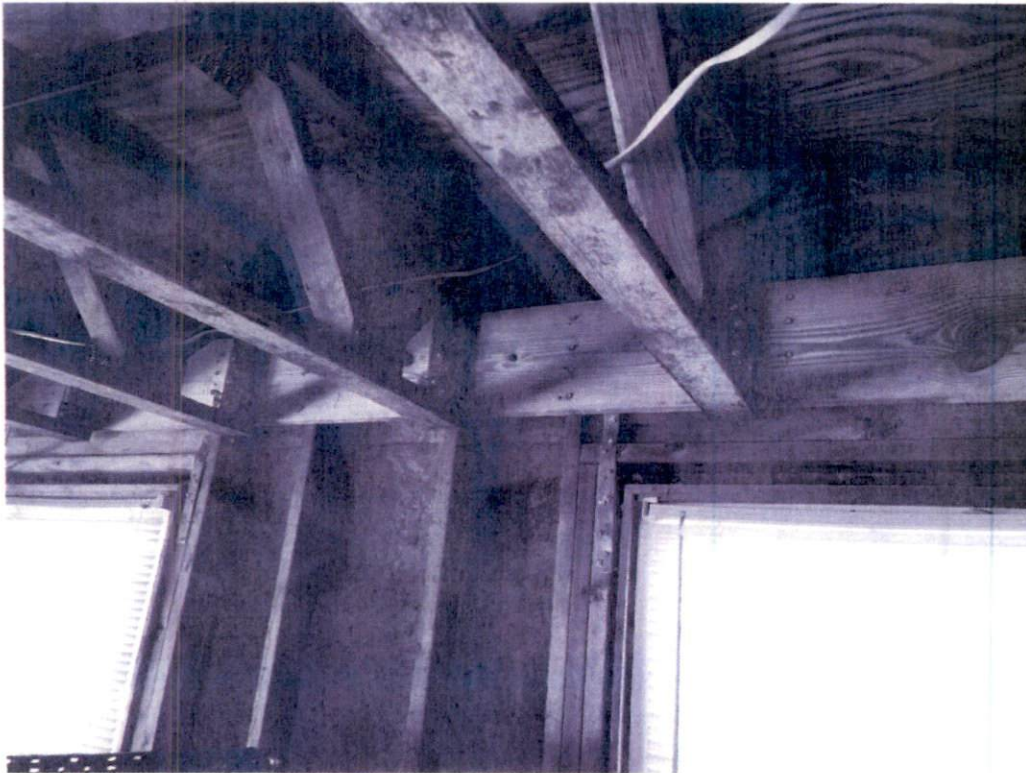
ML28Z Hanger Installed

1. The LSTA12 strap was installed to the plan specified (2) 2 x 4 stud column and the existing (2) 1-3/4" x 9-1/4" LVL header. No further modification is required.
2. The ML28Z was removed and re-installed tightly per the manufacturer's specifications to the beam. No further modifications are required.
