Roof Report

Robert Wiggins

Overview of the condition of the roof...

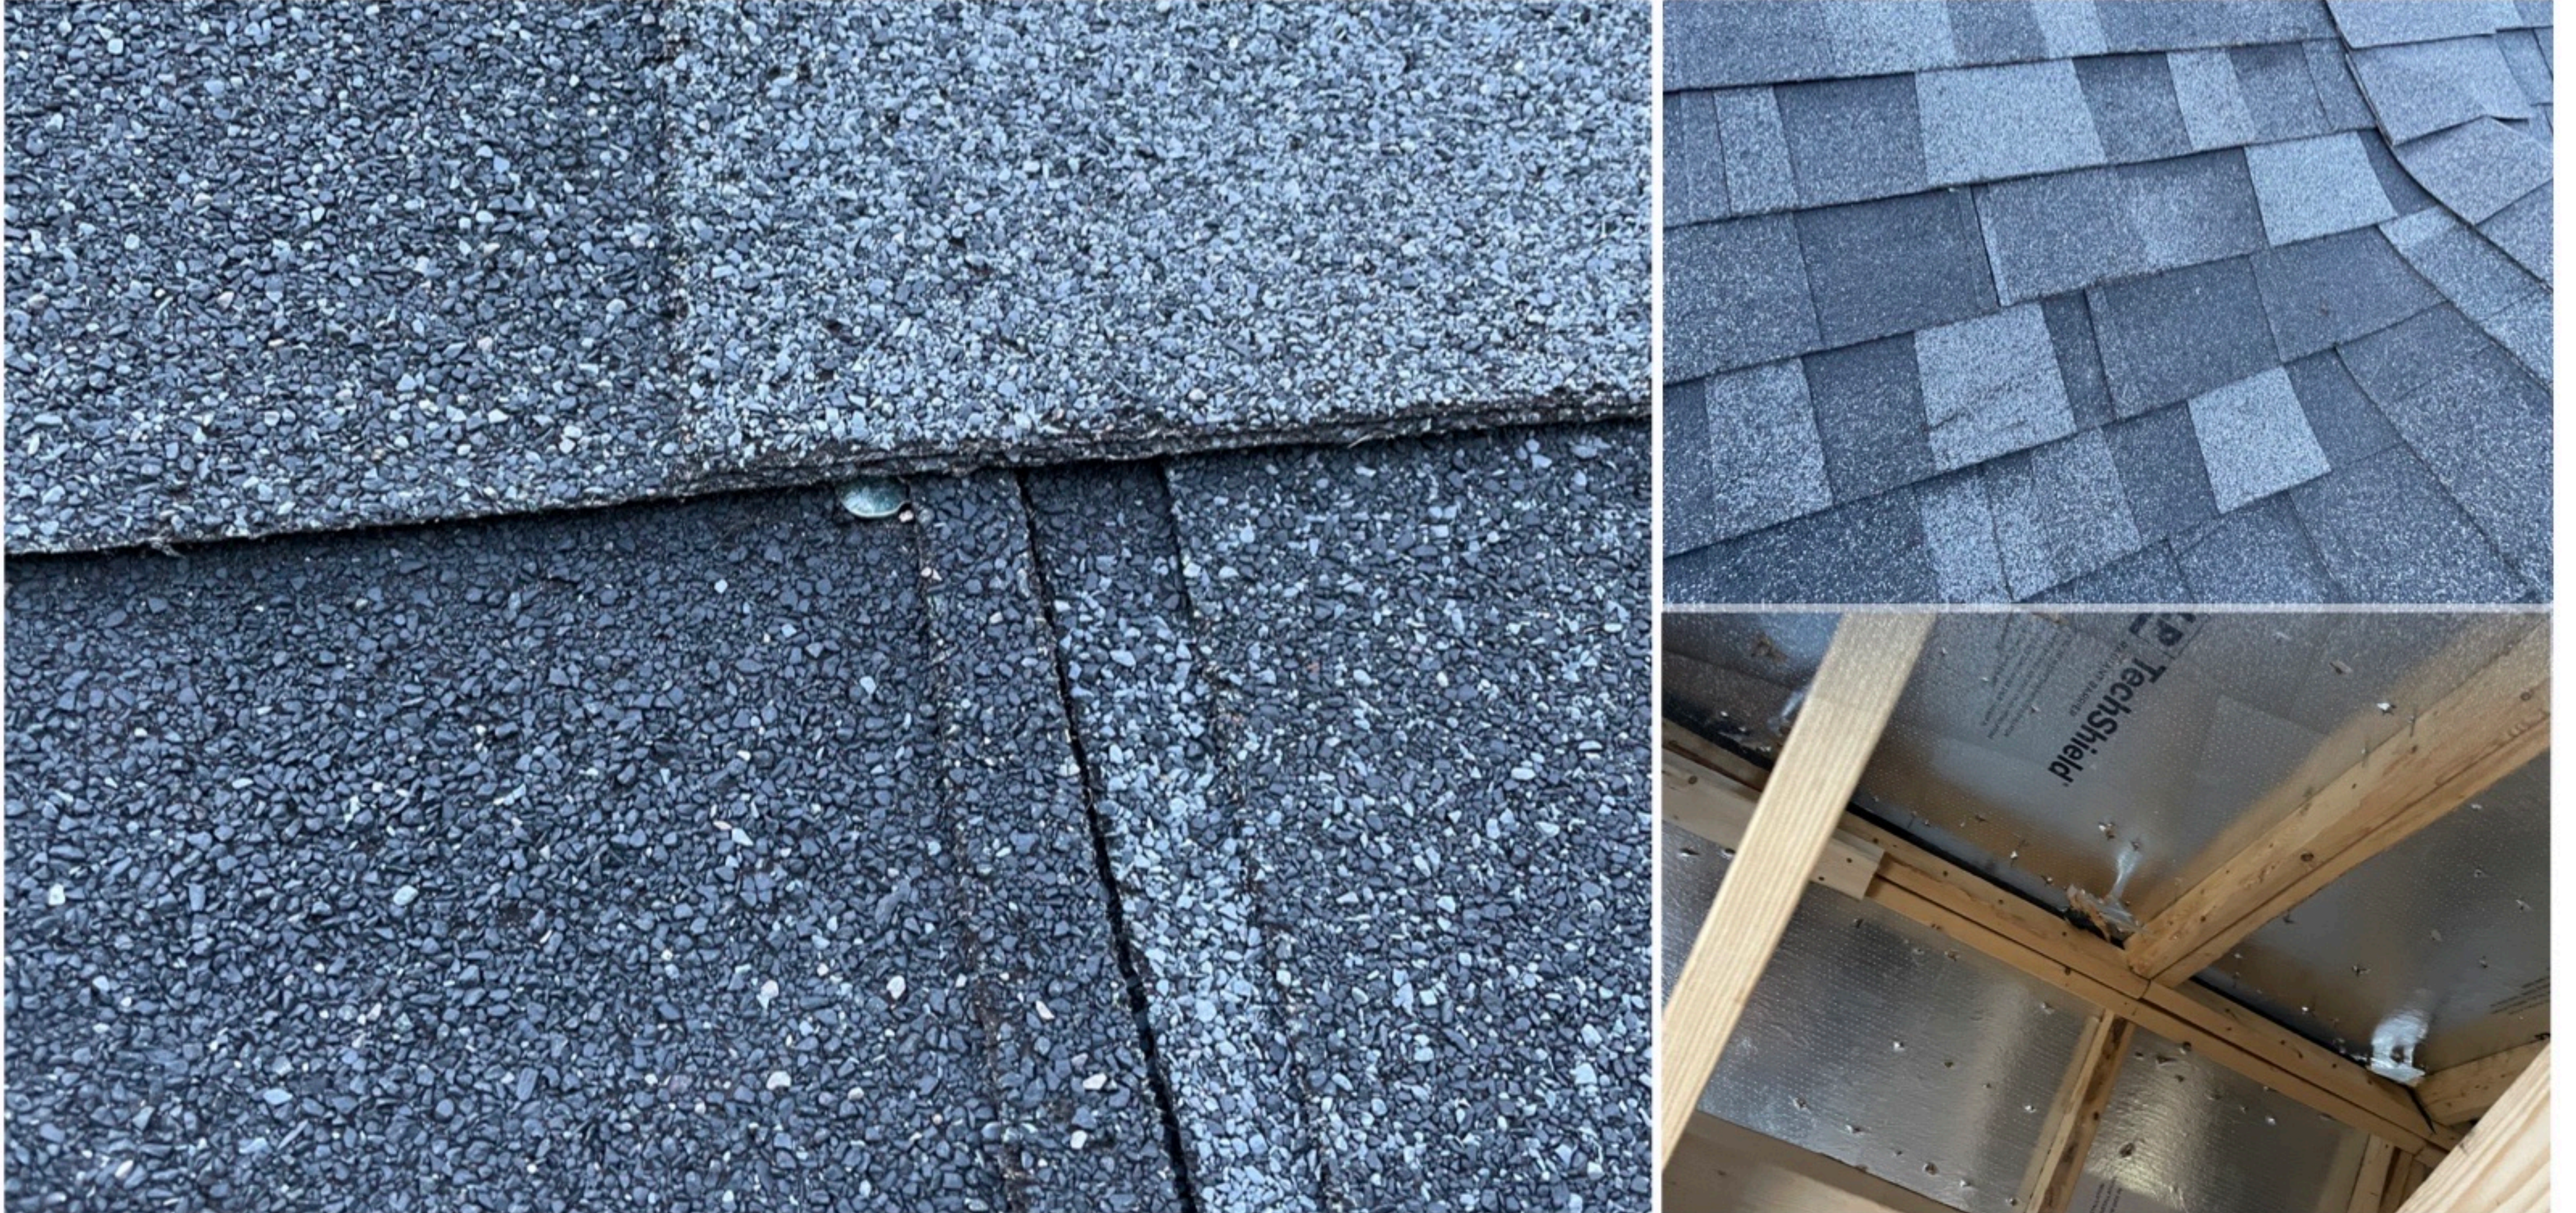
- Exposed fasteners due to improper install of shingles
- Several holes in the roof deck near the ridge line
- Ridge cap and ridge vents are spaced and installed improperly
 - Ridge caps on both ends of the roof are installed with too much exposure
- Severe granule loss on multiple areas of the roof due to heavy foot traffic
- Severe shingle creases around recent repaired areas
 - Shingle tears found near valleys and pitch transition to the patios
- Pipe boots installed incorrectly and will lead to leaks
- No kick out flashing as required by NC building code
- Future high risk of multiple leaks during heavy rain

Due to the many previous repairs on this new roof, and the extensive amount of current issues - a full replacement is suggested.
