**Date:** 12/19/2024

**Re:** **Drilled Bottom Plate**  
Location: Lot 6 Honeycutt Hills  
JDS Project No.: RDU2412497  
Date of Review: 12/19/24

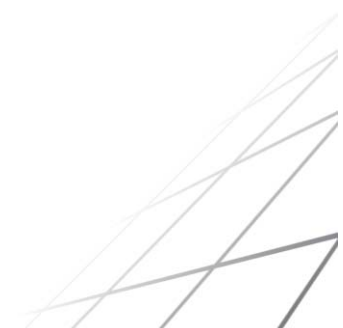
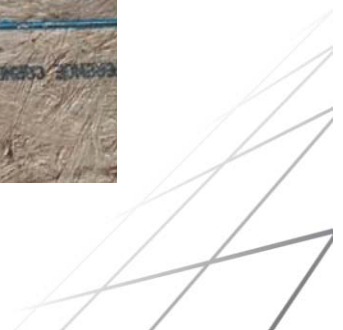
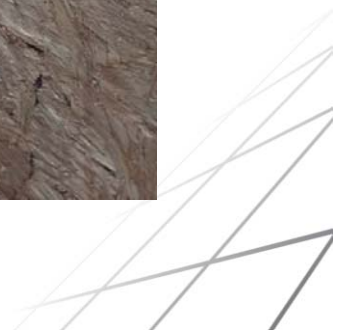
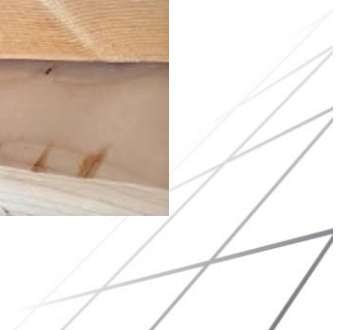
**PHOTO SET 1**

The client requests an evaluation of multiple sill plates that have up to 1" diameter holes drilled in the center. The client has provided pictures of damage (Photo set 1, pages 2 through 5) which have been fire foamed to seal the penetrations (Photo Set 2, Pages 6 through 8) in the following areas:

1. The left wall of the dining room.
2. Multiple holes drilled in the sill plates of the walls of the study.
3. Multiple holes drilled in the sill plates of the living room by the receptacle's wires.
4. The back bathroom rear wall of the first floor have multiple holes.

Based on our review of the client provided pictures, the holes that were drilled into the bottom plates in the areas listed above do not compromise the structural integrity of the members. The pictures provided by the client have been included in this report.
