Description: Joist 12(i14815)
 Loading: See attached BC Calc® Design Report
 Address: 202 Paper Birch Way
 City, St: Fuquay-Varina, NC
 Retailer: 84 Lumber
 Date: 2/24/25

Single 14" BCI® 6000s-1.8

BASE 2\Floor Joists\12(i14815) (Joist)

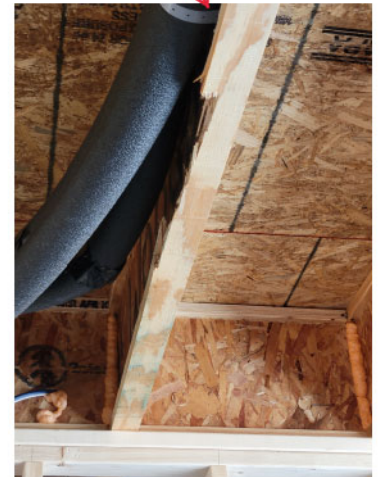
Tag	Description	Location	Pos. Mom. (ft-lbs)	Neg. Mom. (ft-lbs)	Shear (lbs)	Total Defl. (in)	Live Defl. (in)
L01	damage	20-00-12	0(NA)	-2759(1)	934(1)	-0.077(3)	-0.077(8)
