Client: New Homes, Inc.
Project: Smithfield - French Country GR
Address: 4524 Duncan Creek Road
Lillington, NC - 27546

Date: 4/22/2025
Input by: Hampton Horrocks
Job Name: 156 Duncan's Creek - 1st Floor EWP
Project #: J1024-5460

**FJ28-rear BLI 40 11.875" - No Repair Required
See User Note 1**

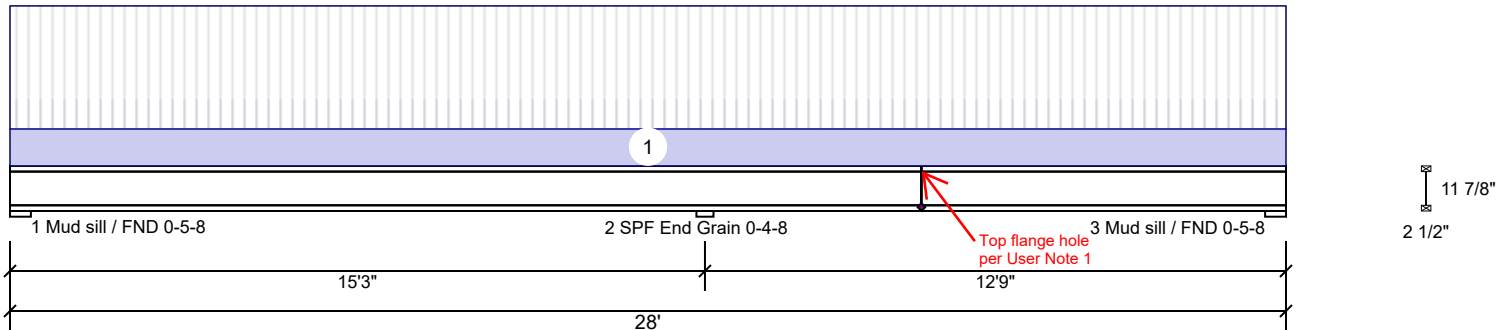
**FJ28-rear BLI 40 11.875" - No Repair Required
See User Note 1**

- Location Analysis represents ~1/2" diameter vertical hole going through one side of top flange. Hole is located against web, but does not appear to intrude into the web. This design based on scaling of provided photograph. No definitive cross-section dimensions of vertical top flange hole were provided. Stated cross-section dimensions of damage depicted in this calculation should be field-verified. No repair required.

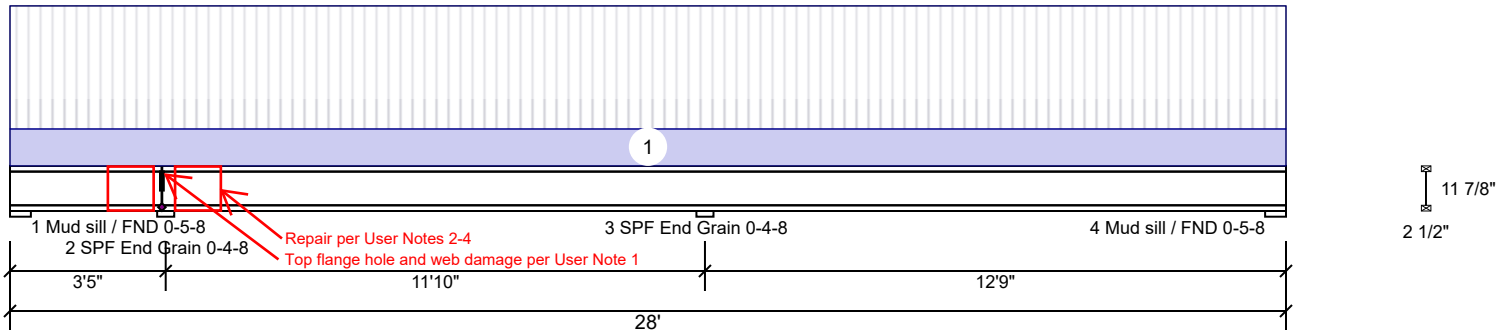
FJ28-front BLI 40 11.875" - Repair Required
See User Notes 1-4

- 1 Location Analysis represents ~1/2" diameter vertical hole going through one side of top flange. Hole is located against web. Web appears to be damaged below vertical hole as indicated in Hole Analysis table. This design based on scaling of provided photograph. No definitive cross-section dimensions of vertical top flange hole were provided. Stated cross-section dimensions of damage depicted in this calculation should be field-verified. Repair as follows.

- 2 Attach 23/32" x 11 7/8" high x 12" long APA 48/24 span-rated plywood (face grain horizontal) to top & bottom flanges on one face with 8d Sinker Nails (0.113 x 2 3/8") @ 3" o.c.
- 3 Use 1/4" bead of carpenter's wood glue on all contact surfaces.
- 4 Locate at both vertical edges of perpendicular blocking.

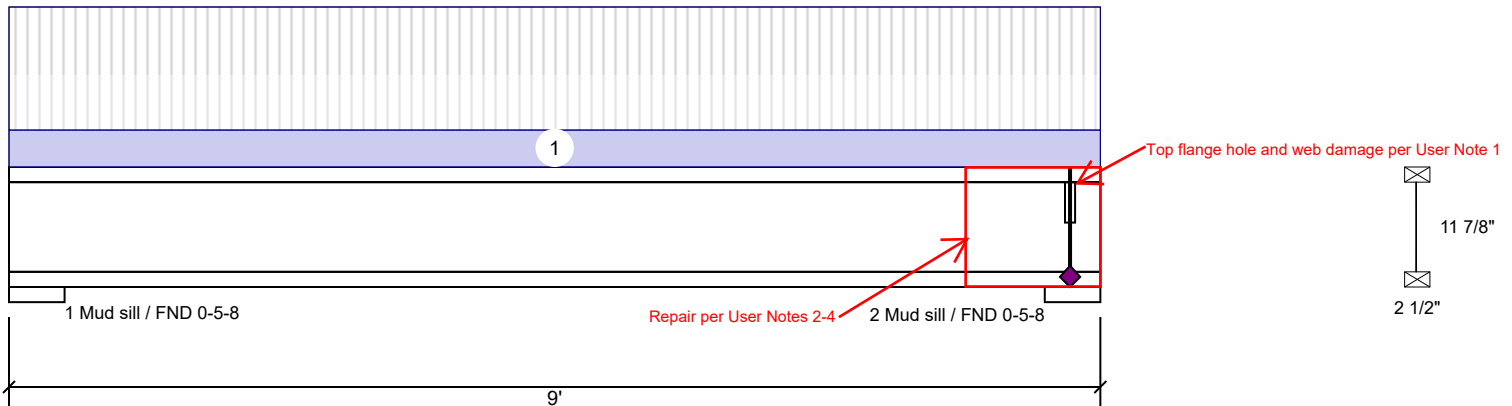
FJ9 BLI 40 11.875" - Repair Required
See User Notes 1-4

- 1 Location Analysis represents ~1/2" diameter vertical hole going through one side of top flange. Hole is located against web. Web appears to be damaged below vertical hole as indicated in Hole Analysis table. This design based on scaling of provided photograph. No definitive cross-section dimensions of vertical top flange hole were provided. Stated cross-section dimensions of damage depicted in this calculation should be field-verified. Repair as follows.
- 2 Attach 23/32" x 14" high x 12" long APA 48/24 span-rated plywood (face grain horizontal) to top & bottom flanges on opposite face from web damage with 8d Sinker Nails (0.113 x 2 3/8") @ 3" o.c.
- 3 Use 1/4" bead of carpenter's wood glue on all contact surfaces.
- 4 Locate end of gusset at right end of joist.
