MEMBER REPORT

1st Floor, FC1: J1 (i1464)

Job Notes TC 156058 544 DUNCAN CREEK ROAD LILLINGTON, NC, 27546 DUNCAN'S CREEK 155

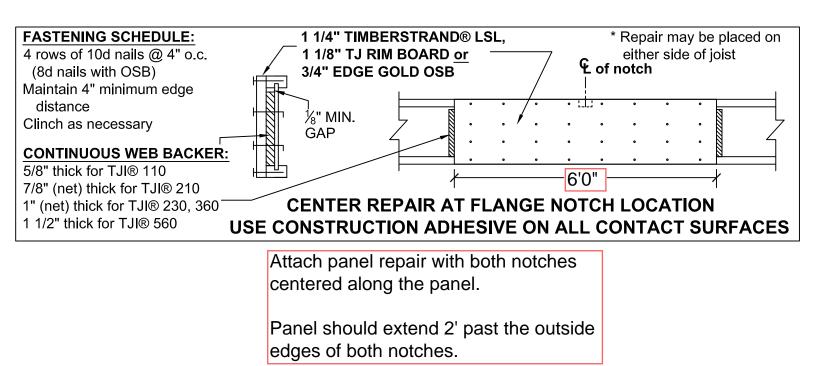
Member with damage as shown (and repaired if required) has adequate structural capacity for the design condition indicated. I have not reviewed the project plans or field conditions. The proper authority is to review the damage evaluation inputs and confirm they are consistent with the intent of the overall building design and field conditions. This damage evaluation is based on the information provided to Weyerhaeuser; if not consistent with the building design and field conditions, it should be rejected or returned to us to be corrected.
