SEPTIC SYSTEM EVALUATION

Date: February 26, 2019
Report for: Robert & Gail Howington
Inspection address: 345 Fieldstone Drive, Holly Springs, NC 27540
Realtor: Kristine Pryzgoda - Porchlight Real Estate
System Design: 2008

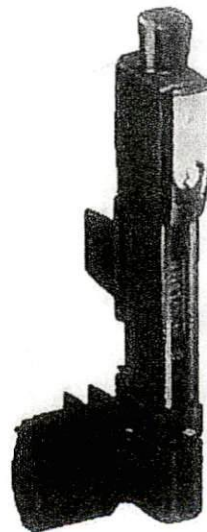
Rising Sun Pools uses Magna Latch for our gate closures. It will be installed 54" above grade.

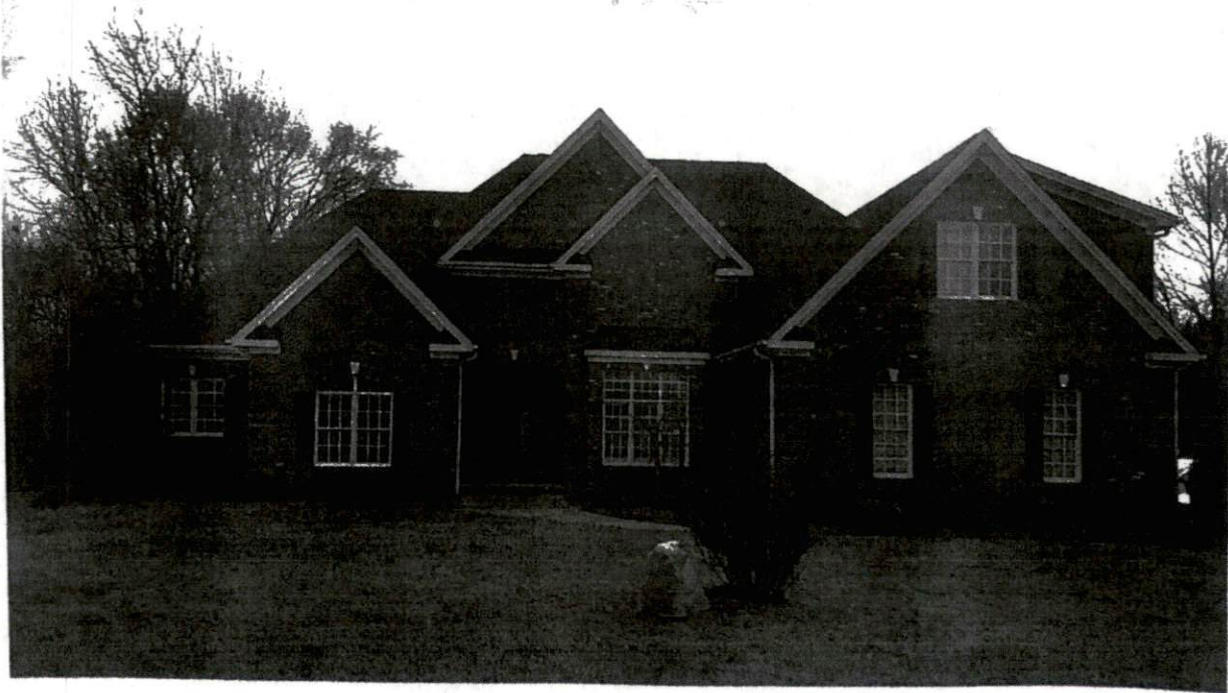
System Type: Conventional Pump to Gravity – Gravity feed distribution systems are the most commonly found/used septic systems and utilizes gravity alone to pass waste water effluent from the septic tank to the drain field.

System Design: Four bedrooms – The home currently has 3 bedrooms. The permit indicates that the system is designed to service four bedrooms.
