Reference: Engineering Services  
7934 NC-210  
Bunnlevel, NC 28323  
TE&D Project No.: 2301-020499

As requested by the client, a representative of Tyndall Engineering & Design, PA (TE&D) was on-site to inspect and observe the existing footing and foundation. We understand the previous home was severely damaged by a fire (as well as the subsequent fire suppression) and was completely removed from the lot. We inspected and observed the following:

**Site of Inspection**

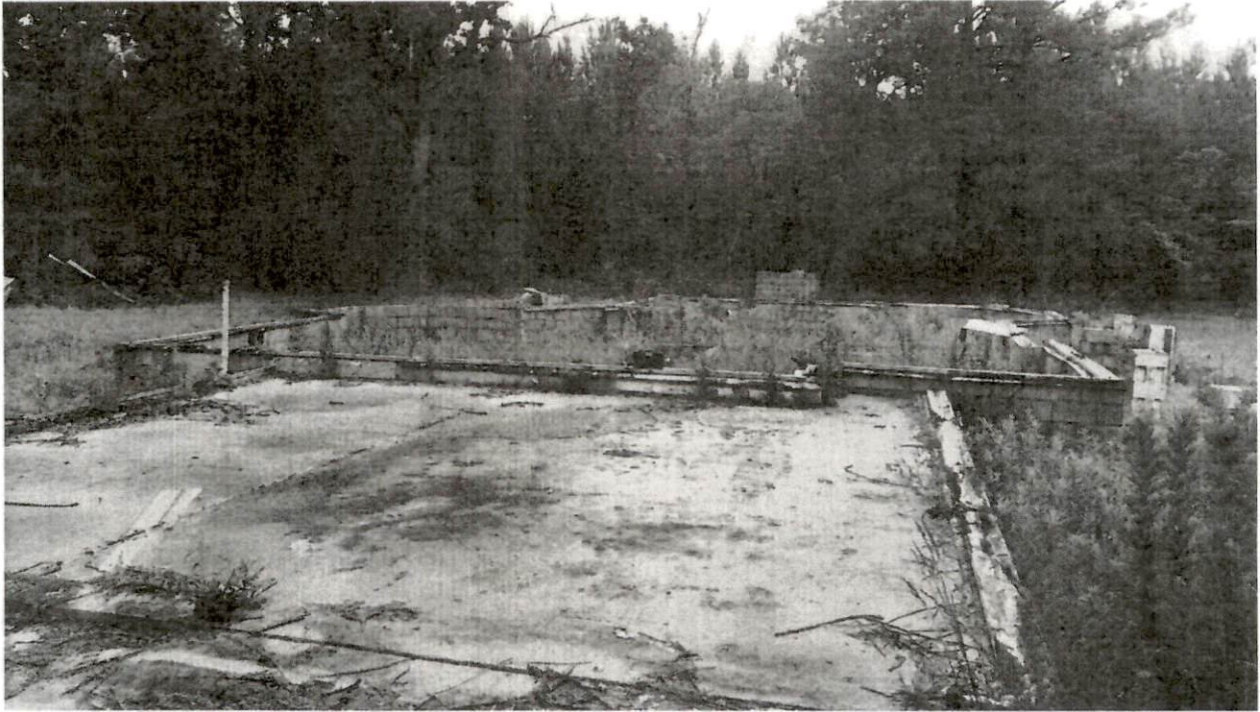
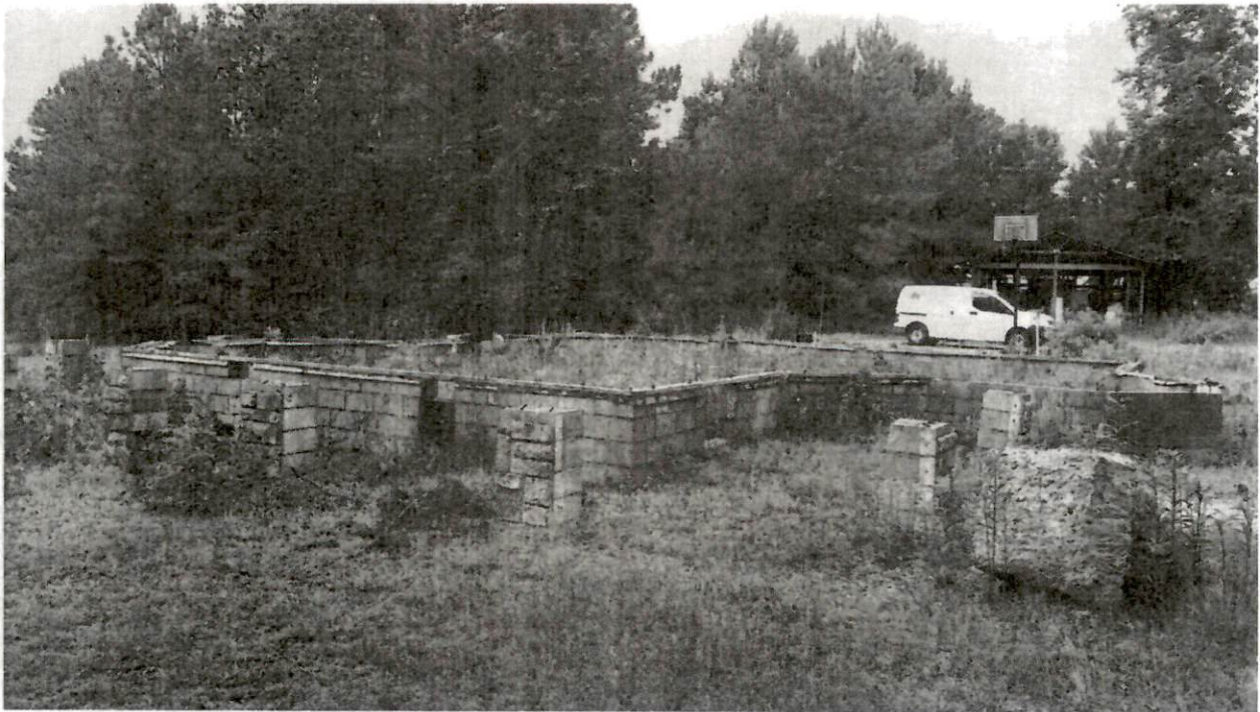
Drive way

New Backed Entrance  
TO NEW MAJOR PM  
INSTALLED 7/5/2023

Proposed  
GARAGE  
24' X 30'  
ON EXISTING SLAB  
4 windows  
1 main door  
1 overhead door.

EXISTING  
parking  
SLAB  
24' X 30'

EXISTING  
CRAWL  
SPA

STICK FRAME ROOF 2" OC 2 1/2 pitch

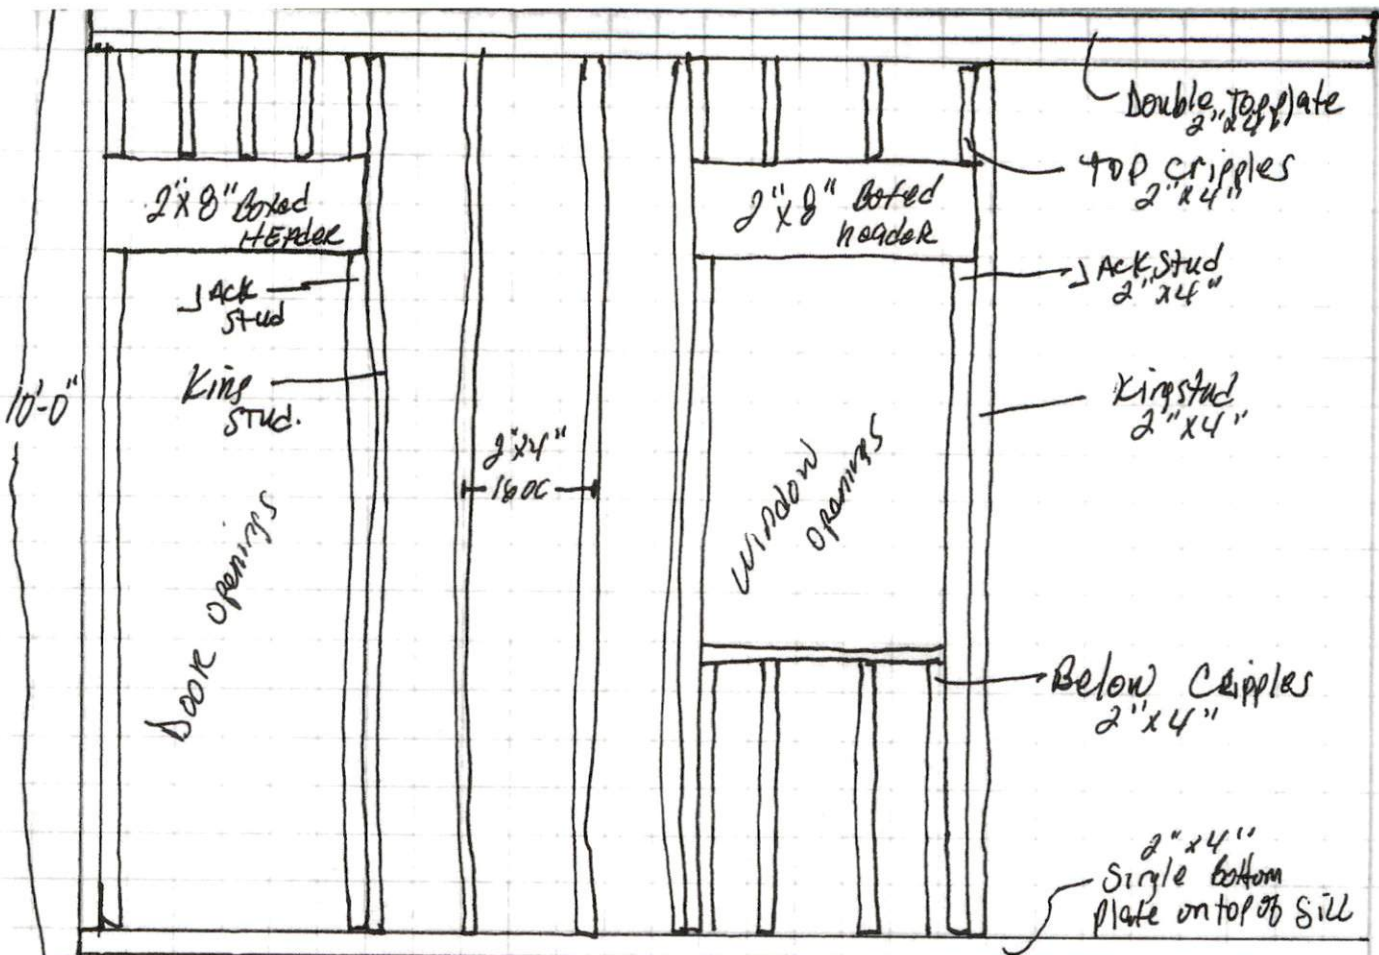
\* 1-10' wide Garage Door on Gable End Header will be 126" To Accomodate 2 JACK STUDS ON EACH SIDE

4 Windows @ 34" x 49" Double Hung.  
 Headers will be 37" wide To Accomodate JACK studs.  
 1 Door @ 36" Header will be 39" To Accomodate JACK studs.

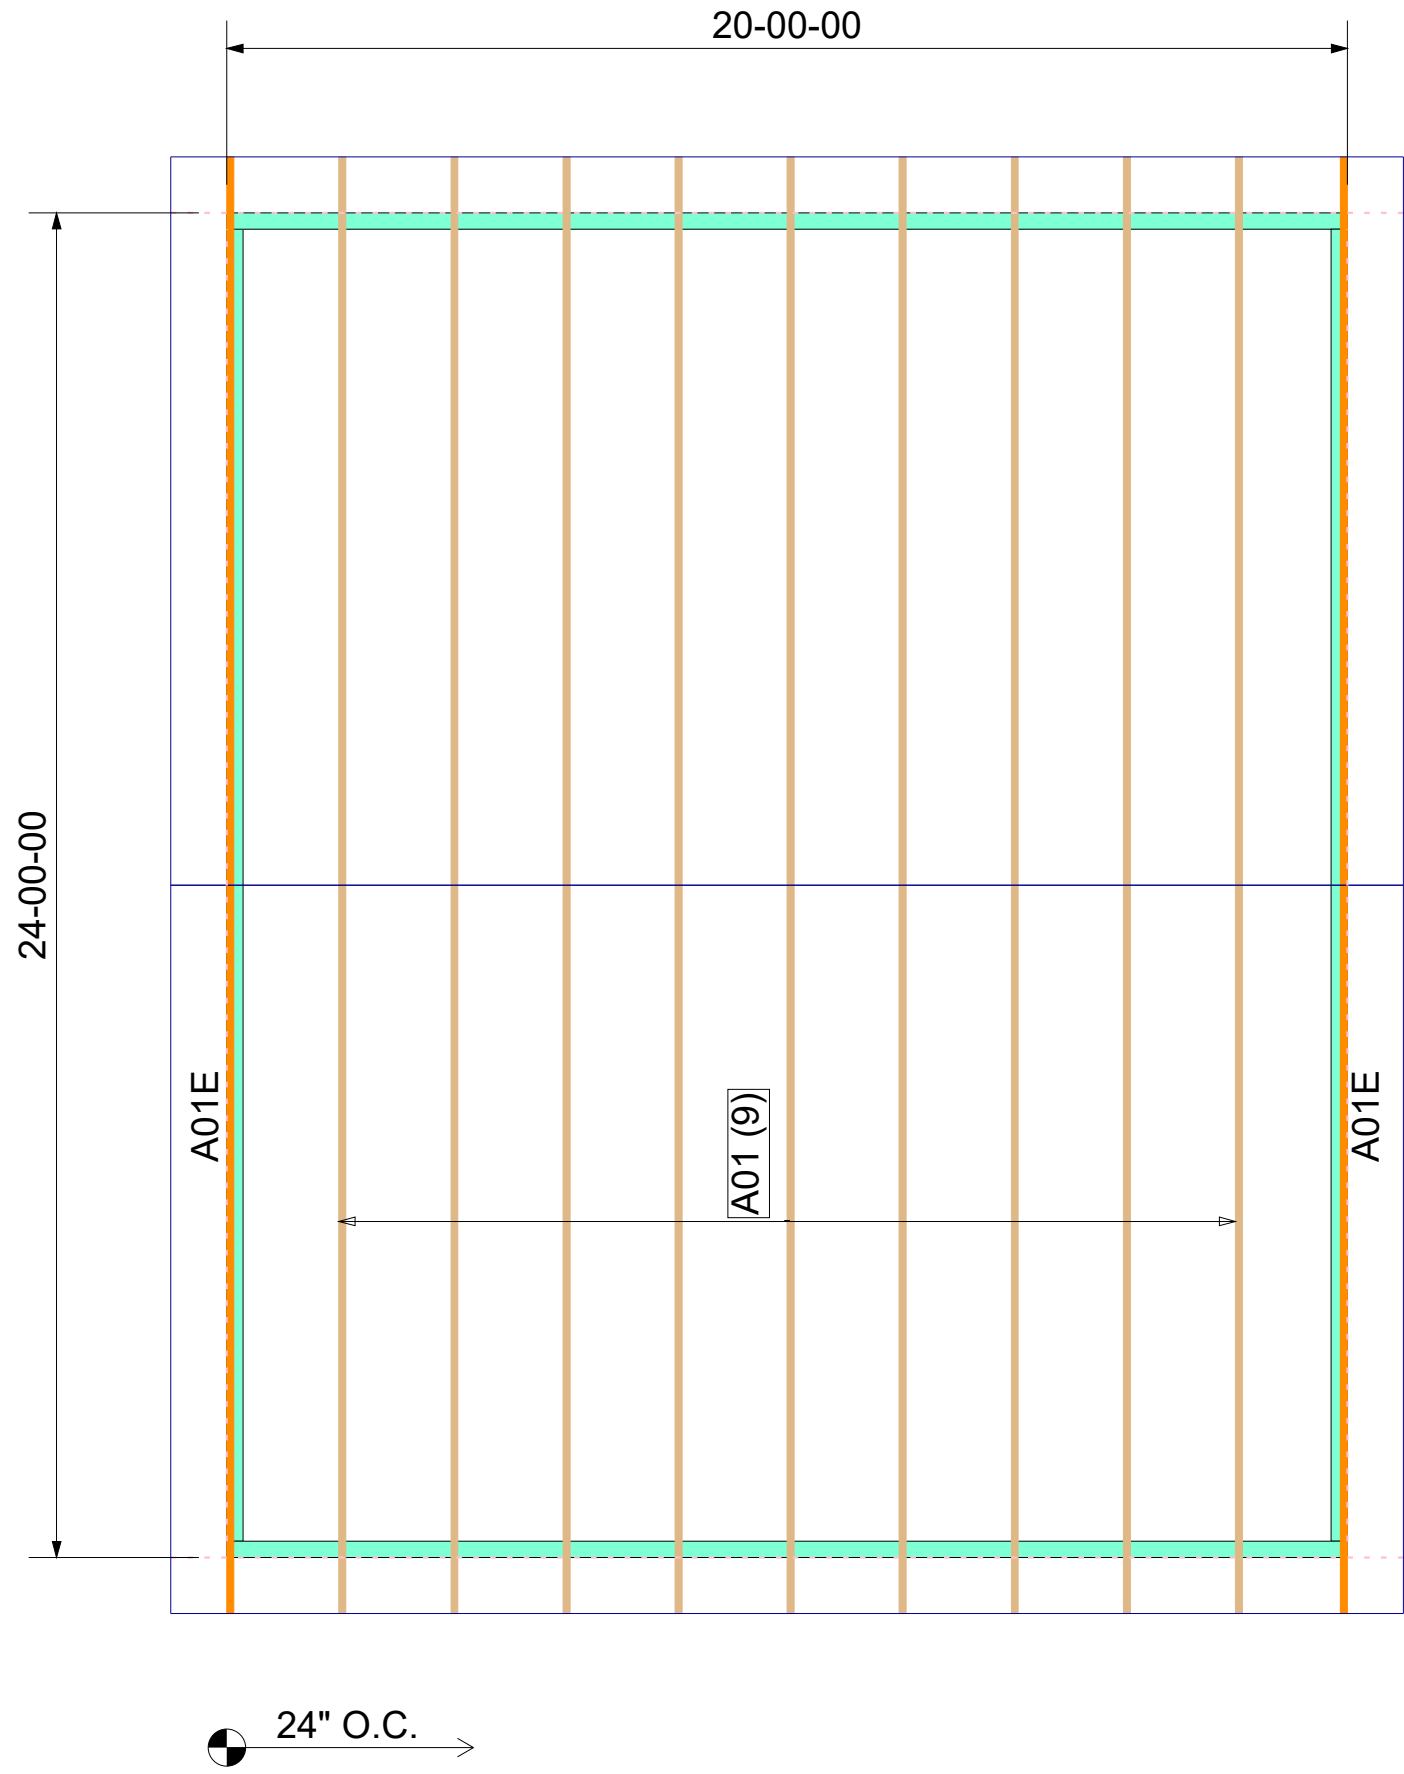
Truss to bearing connections if shown on this layout are suggested by Truswood based solely on the uplift reactions and considerations for the truss component. All truss to bearing connections must be specified or approved by the Building Designer to adequately transfer all loads to the building system and foundation. Consult hardware manufacturer's specifications for all installation requirements.
