STRUCTURAL DESIGN LETTER

470 Mill Bend Drive
Fuquay-Varina, NC

At your request, the structural design of a new platform to be installed above a garage in the excess ceiling space was performed.

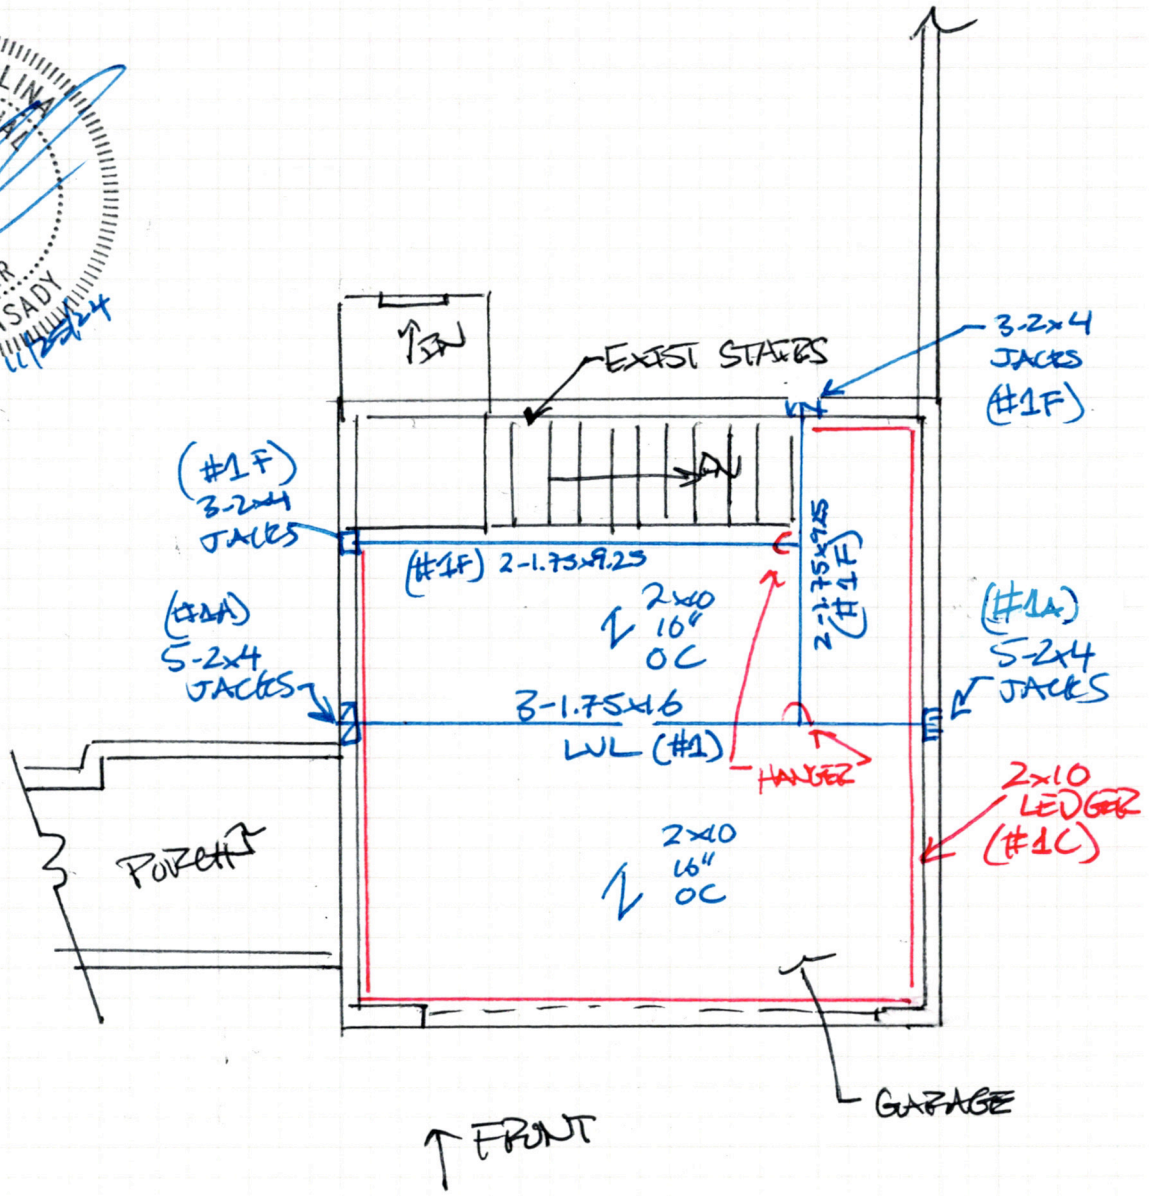
2ND FLOOR GARAGE AREA

SCALE: NTS

Foundation and Floor Framing (see attached sketch)

1. Provide 3-1.75"x16" LVL central beam (spanning left to right) across the garage space approximately 20 feet. Connect the LVL plies with (4) rows of 4" Simpson SDWS screws at 24" on-center from each side.
 - a) Support the LVL on 5-2x4 jack studs on each end, extending down to the foundation wall sections at each end.
 - b) The new beam shall be located in the middle third of the garage, such that the floor joist span does not exceed 14-feet.
 - c) Provide a 2x10 ledger board around the perimeter of the garage where the new storage

space is to be located. Connect the ledger to the wall studs with (3) 4" long Simpson SDWS screws at each stud or 16" on-center max.

- d) Provide new 2x10 floor joists, at 16" on-center, spanning front to back. Connect the floor joists to the ledger with Simpson LUS joist hangers.
- e) Provide ¾" tongue and groove floor sheathing attached to the floor framing with 10d nails at 6" on-center on the edges and 12" on-center in the field.
- f) At the stair boxout, provide 2-1.75x9.25" LVL beams. Connect the beams at their intersection and at the intersection with the 3-1.75"x16" LVL beam by a Simpson HUS410 hanger. Support the beam ends at the garage walls on 3-2x4 jack studs. Connect the plies of the beams together with (4) 16d nails at 16" on-center.
