STRUCTURAL DESIGN LETTER

470 Mill Bend Drive Fuquay-Varina, NC

At your request, the structural design of a new platform to be installed above a garage in the excess ceiling space was performed.

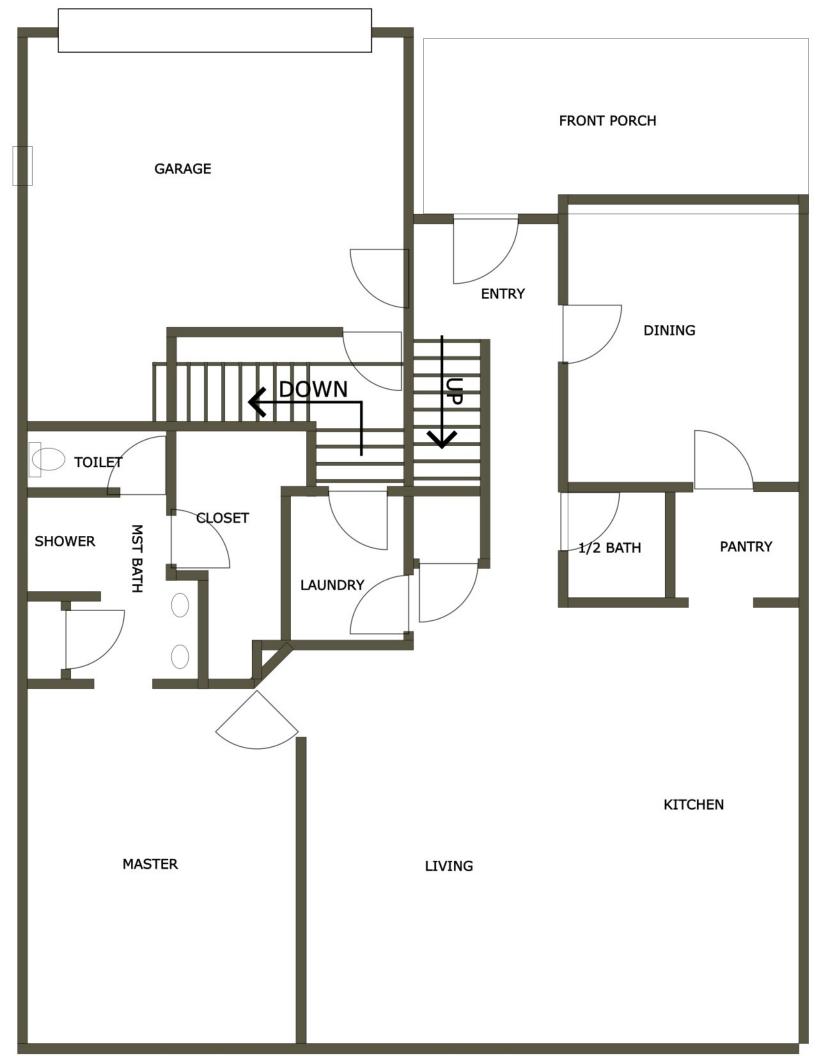
SEAL OSZ311 SEAN R. CASA AMARINI HILITIC 3.2×4 JACKS (#1F) 13 EXAST STATES (#1F) 3.244 JAUES (ALA) 5-2×4 JACES STREET-2 (#4F) 2-1.73,9.23 1 10° 0C JACKS 3-1.75×16 WL (#1) HANDER Porett 2×10 1 00 GAZAGE TERNT 2ND FLOOR GARAGE ASEA SCACE:NTS

Foundation and Floor Framing (see attached sketch)

- 1. Provide 3-1.75"x16" LVL central beam (spanning left to right) across the garage space approximately 20 feet. Connect the LVL plies with (4) rows of 4" Simpson SDWS screws at 24" on-center from each side.
 - a) Support the LVL on 5-2x4 jack studs on each end, extending down to the foundation wall sections at each end.
 - b) The new beam shall be located in the middle third of the garage, such that the floor joist span does not exceed 14-feet.
 - c) Provide a 2x10 ledger board around the perimeter of the garage where the new storage

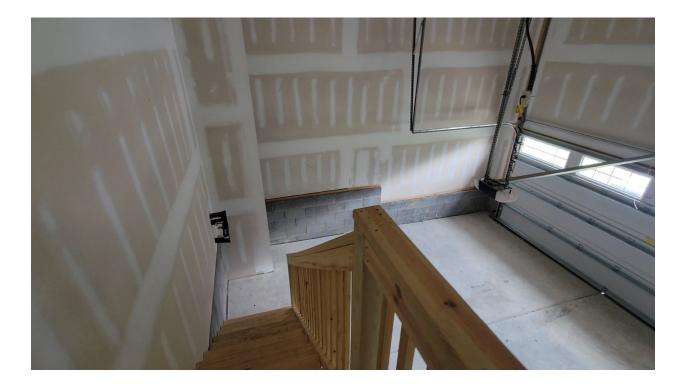
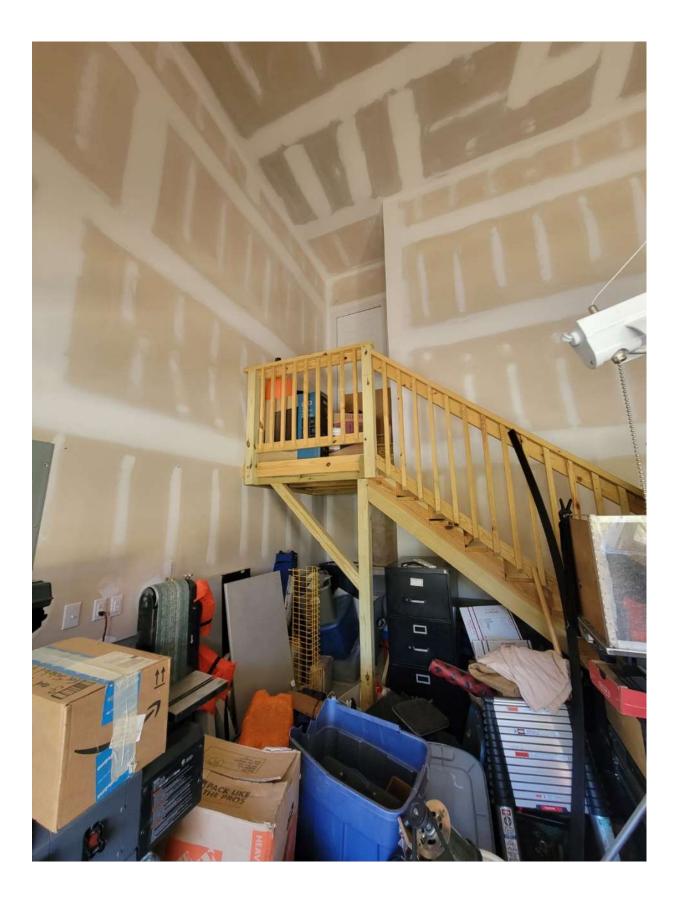
- Need a floor plan with room labelled
 - Existing and Proposed floor plans attached
- Staircase shall be fire separated from garage
 - Walled in staircase with 5/8" 'X' drywall
- Egress from stairs shall be into the house, or directly to the exterior without passing through garage
 - Added egress door direct to interior
- If a door is located in firewall between stairs and garage, it shall be a solid residential door without glazing
 - Added door from garage stairs to new space
- Must have a code complaint egress window from space created to exterior
 Added egress window to new space far wall
- Ceiling heights shall be code compliant.
 - Ceiling height in new space will be 9'.
 - Ceiling height in garage below will be
 - 7'8" under main beam
 - 8'6" everywhere else
