STRUCTURAL DESIGN LETTER

470 Mill Bend Drive
Fuquay-Varina, NC

SCOPE/BACKGROUND

At your request, the structural design of a new platform to be installed above a garage in the excess ceiling space was performed.

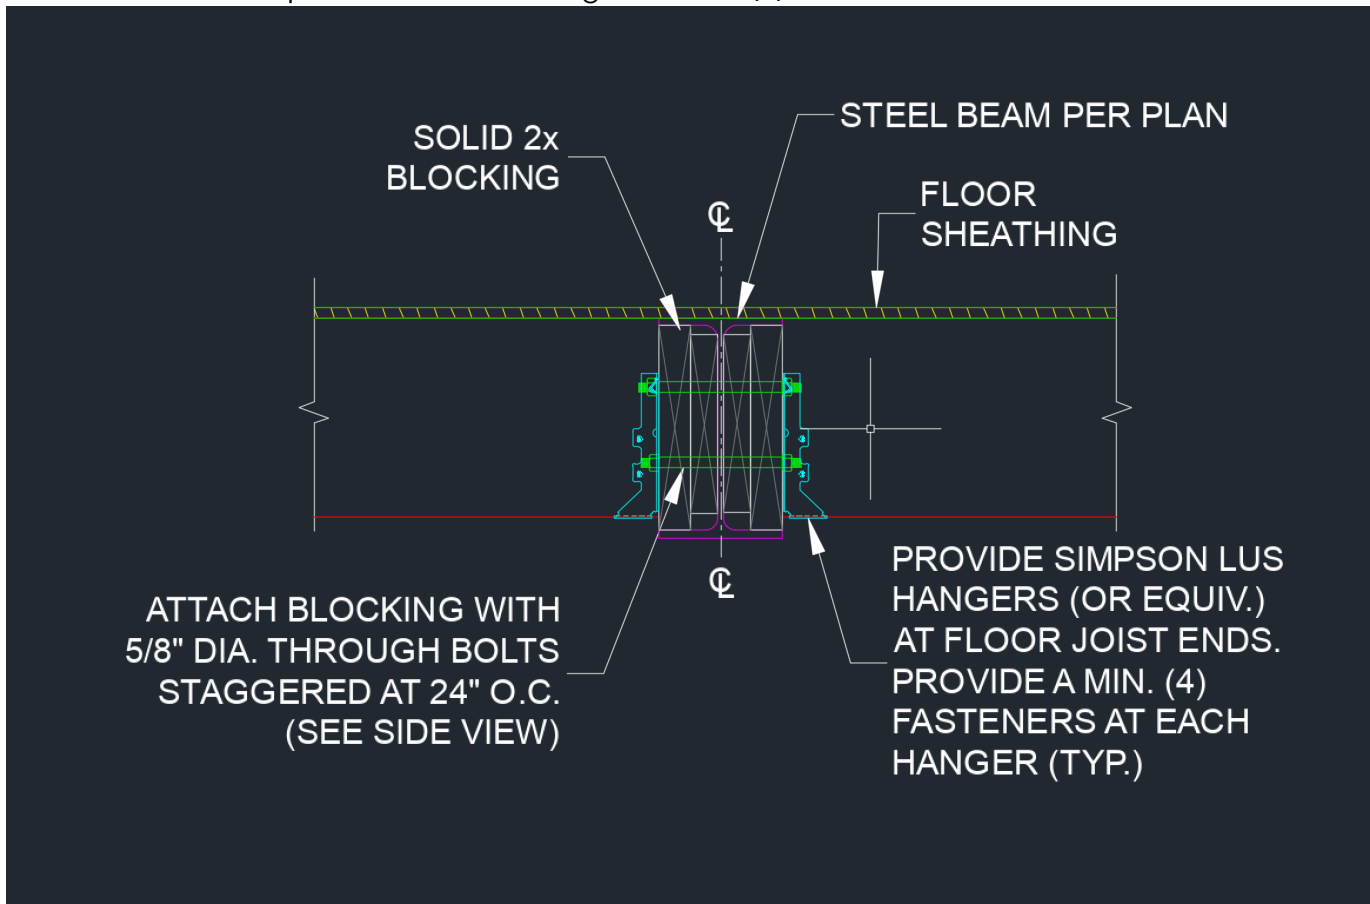
Figure 1 – Flush framing detail

1. Provide W10x22 (A992, grade 50) central beam (spanning left to right) across the garage space approximately 20 feet. Flush connect the framing to the beam per the below detail.
 - a) Support the beam on 5-2x4 jack studs on each end, extending down to the foundation wall sections at each end.
 - b) The new beam shall be located in the middle third of the garage, such that the floor joist span does not exceed 14-feet.
 - c) Provide a 2x10 ledger board around the perimeter of the garage where the new storage space is to be located. Connect the ledger to the wall studs with (3) 4" long Simpson SDWS
