SOUTHEASTERN SOIL & ENVIRONMENTAL ASSOC., INC.

PROPOSED SUBSURFACE WASTE DISPOSAL SYSTEM DETAIL SHEET

SUBDIVISION: Elyse Meadows  
INITIAL SYSTEM: Accepted 25% Reduction  
DISTRIBUTION: Gravity Serial  
BENCHMARK: 100.0  
NO. BEDROOMS: 4  
SEPTIC TANK SIZE 1000 Gallons

LOT 72  
REPAIR: Accepted 25% Reduction  
DISTRIBUTION Pressure Manifold  
LOCATION RC 72/73  
LTAR 0.30 gpd/ft2  
PUMP TANK SIZE N/A

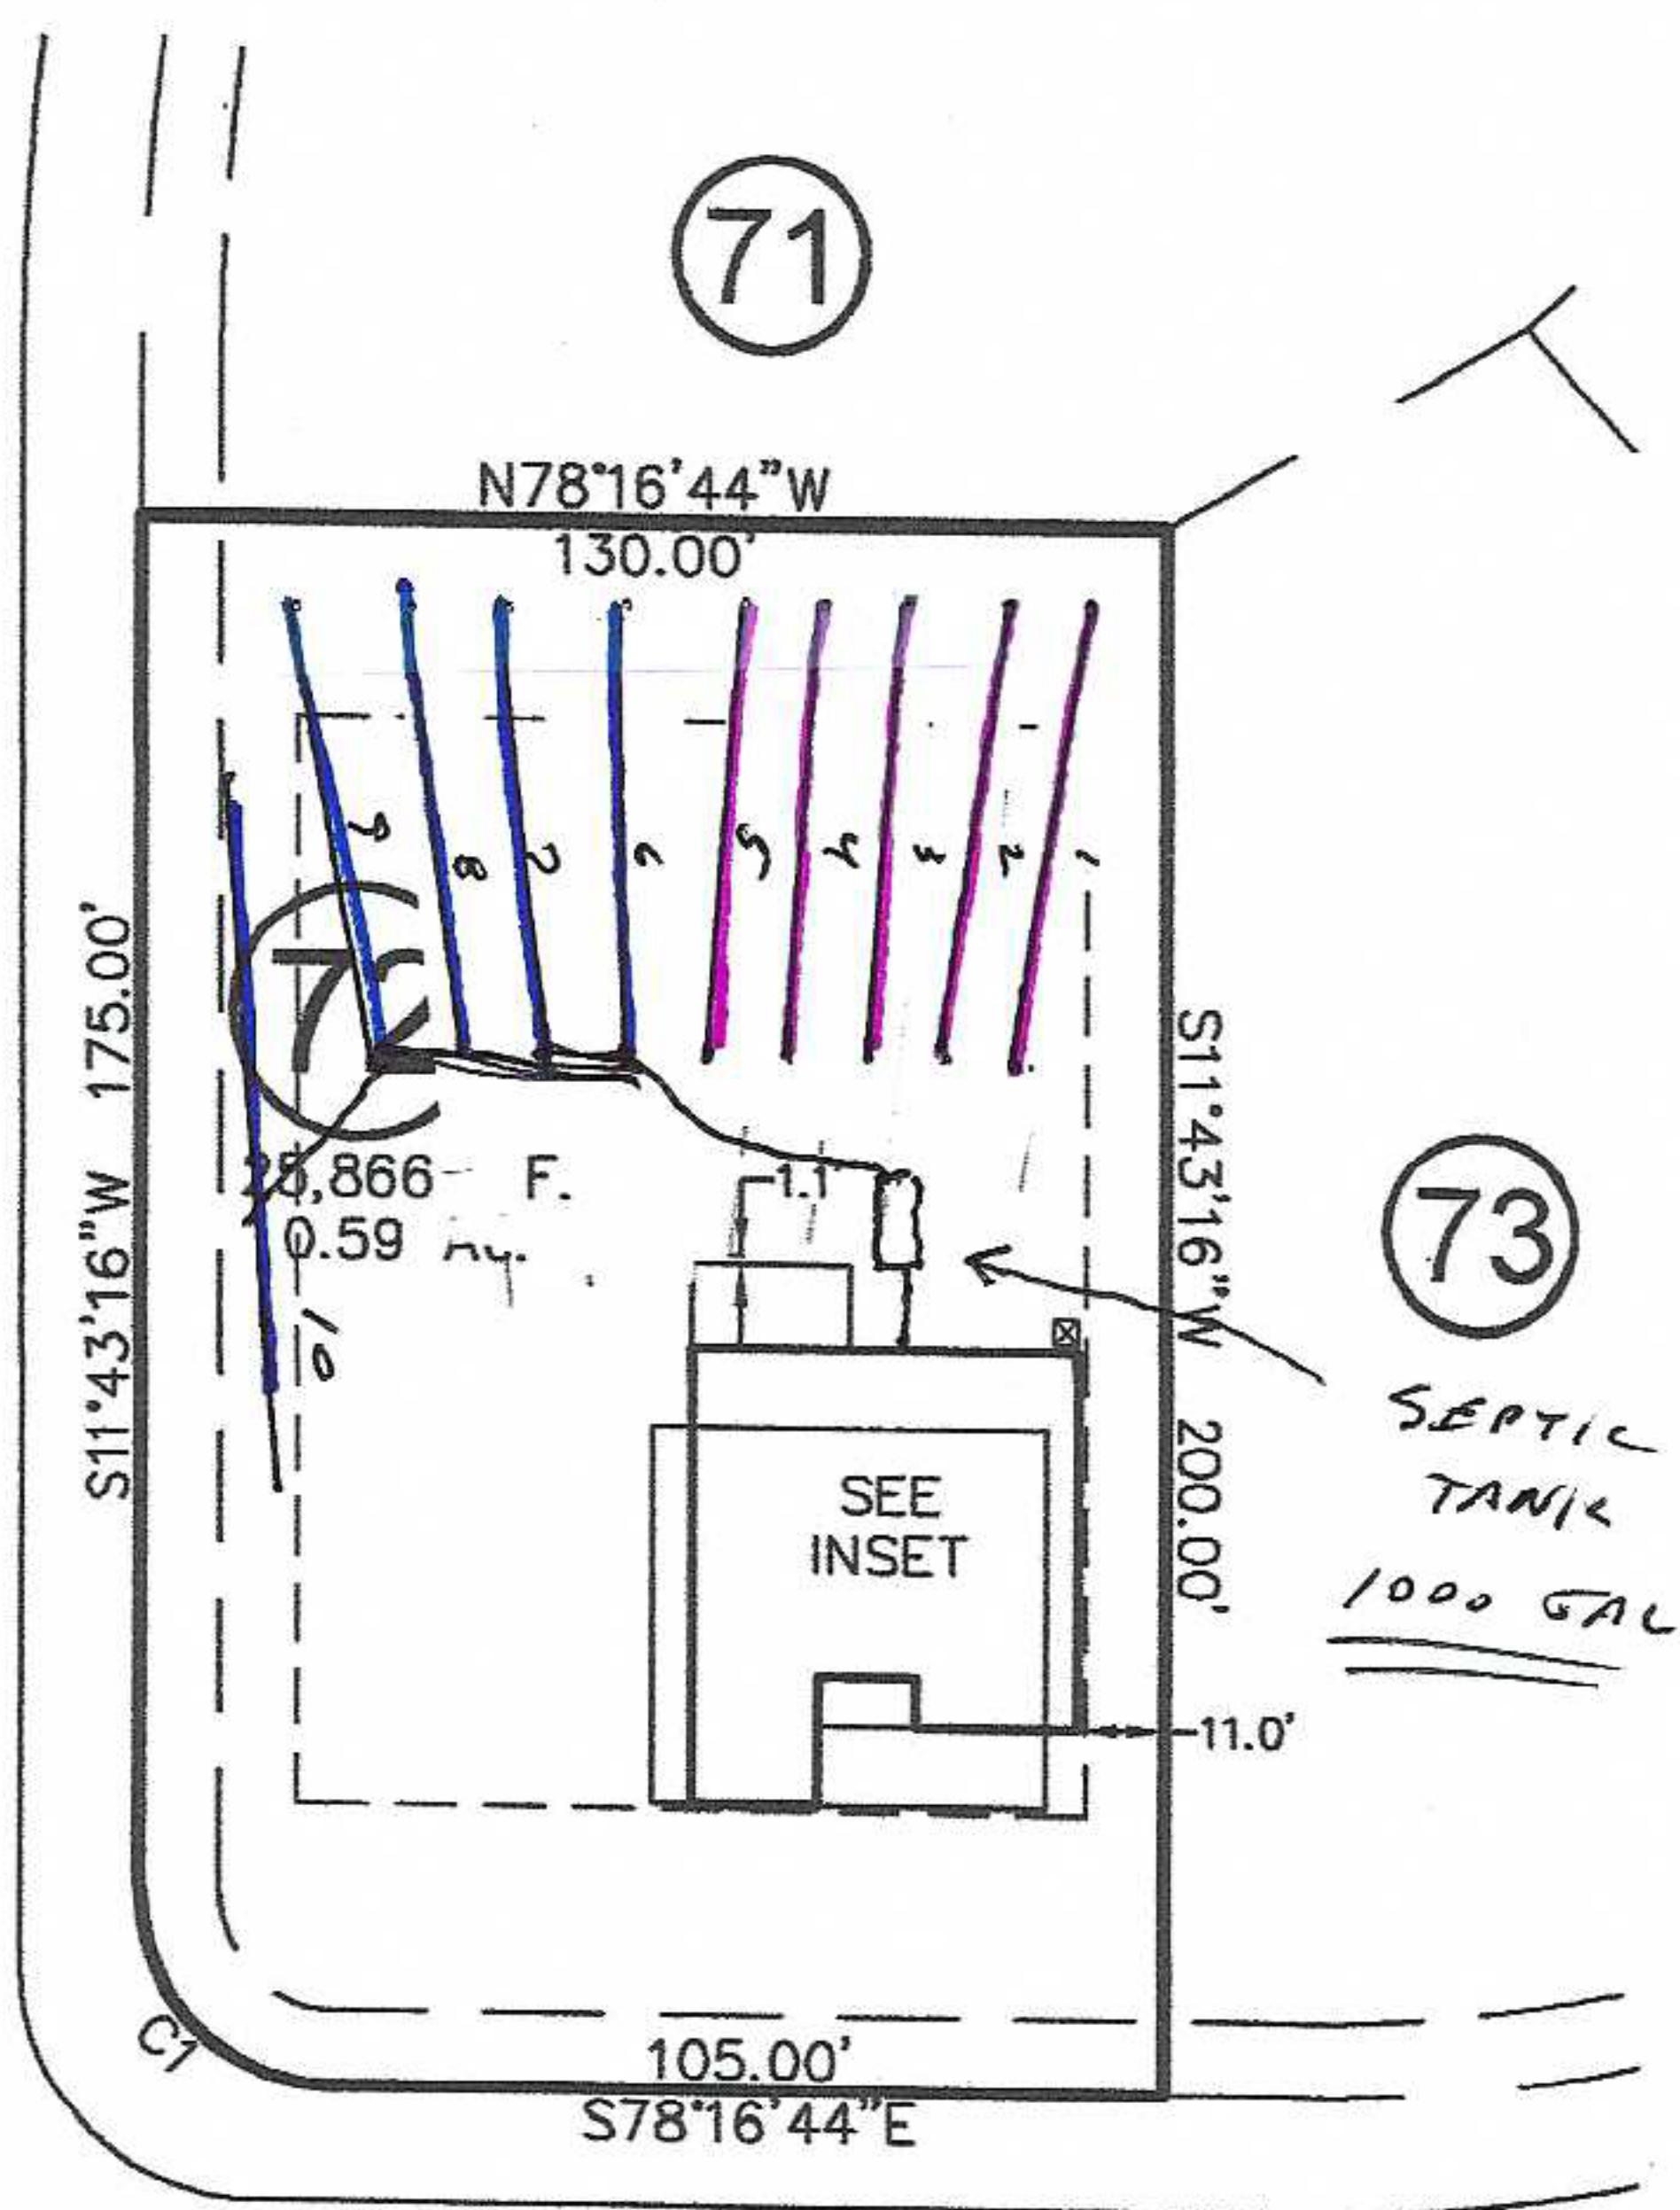
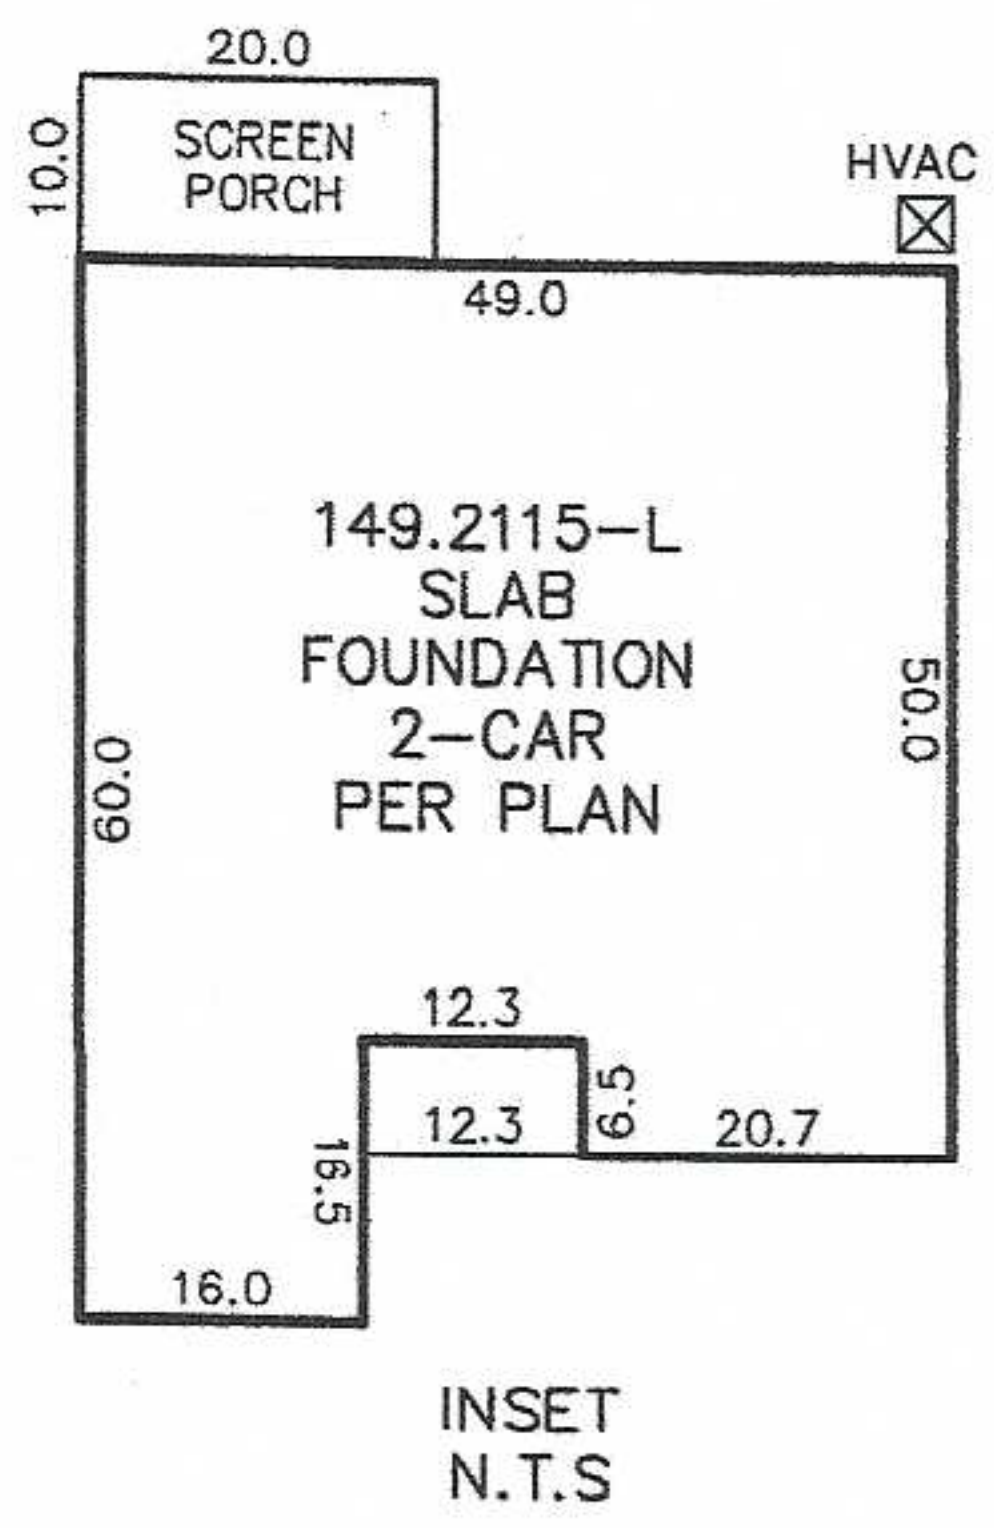
TYPICAL PROFILE  
0-10 LS/SL VFr/Fr/Gr  
10-40+ SCL Fi/SBk  
CR2/P+ >36"

THERE SHALL BE NO GRADING,  
CUTTING, LOGGING OR OTHER SOIL  
DISTURBANCE IN SEPTIC AREA

0-10 LS/SL VFr/Fr/Gr  
10-40+ SCL/SC Fi/SBk  
CR2/P+ >34"
