PAD TOP CHORD TO MATCH ROOF PLANE

MII-REP11B

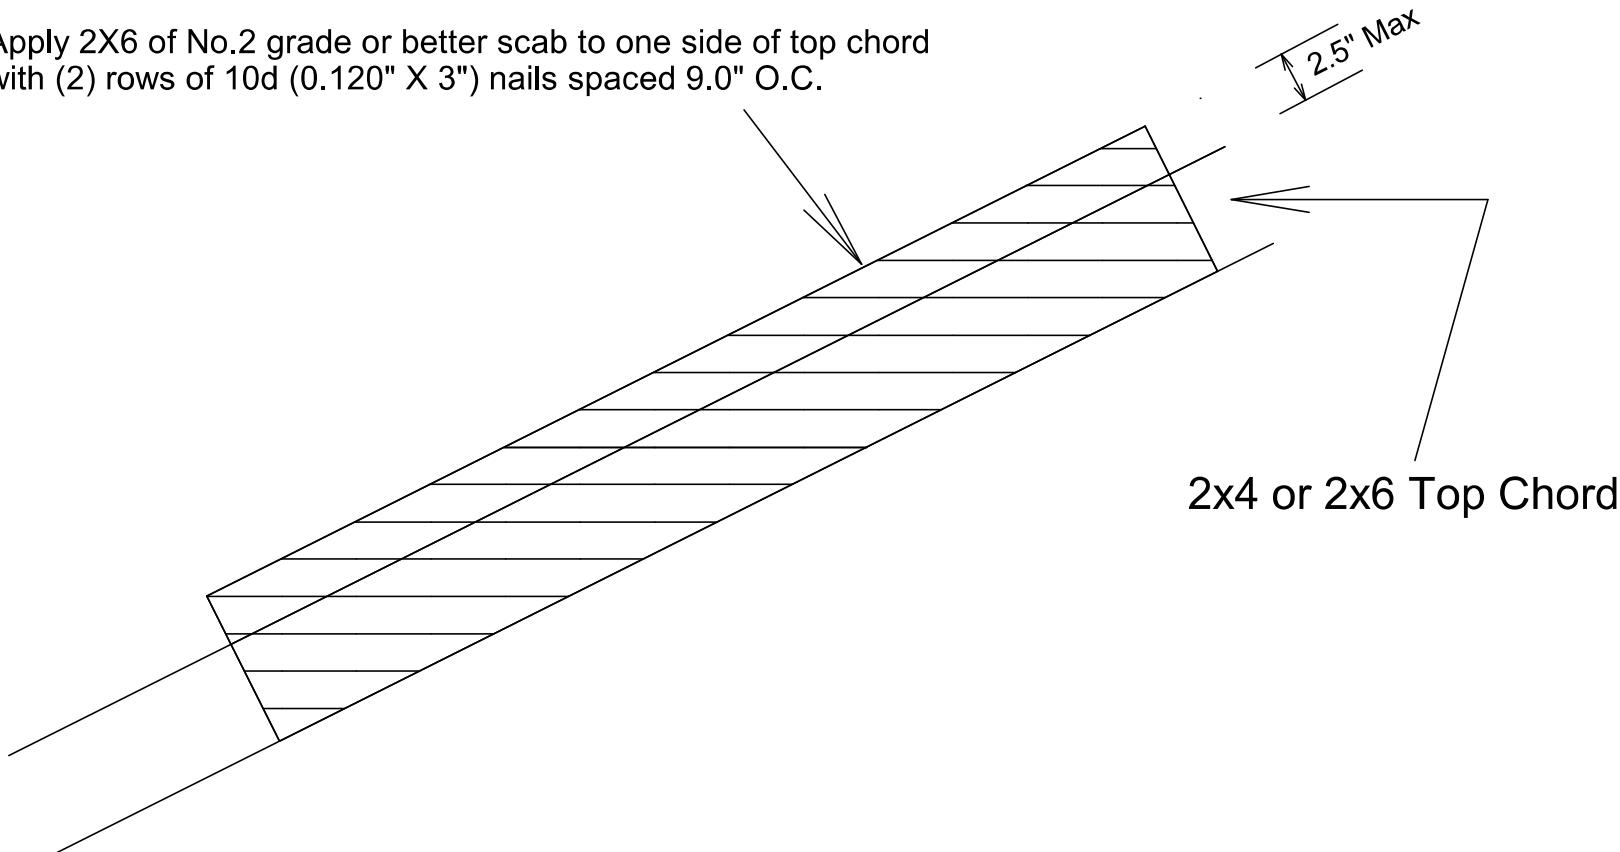
Apply 2X6 of No.2 grade or better scab to one side of top chord with (2) rows of 10d (0.120" X 3") nails spaced 9.0" O.C.

This repair to be used only with trusses (spans less than 40') spaced 24" o.c. maximum and having pitches between 5/12 and 10/12 and total top chord loads less than 50 psf.
