**FIELD REPORT**

Project: Serenity Amenity Client: TriPointe Date: 01/22/26  
 City: Fuquay Forman: Austin Contractor: Inland  
 Temperature: 57 Weather Conditions: Overcast Number of Trips: 1  
 Personnel: Austin G Notified Austin of Inland of results  
 1<sup>st</sup> Trip Arrived: 1:00 pm Left: 4:30 pm 2<sup>nd</sup> Trip Arrived: \_\_\_\_\_ Left: \_\_\_\_\_

FIELD REPORT ATTACHMENTS

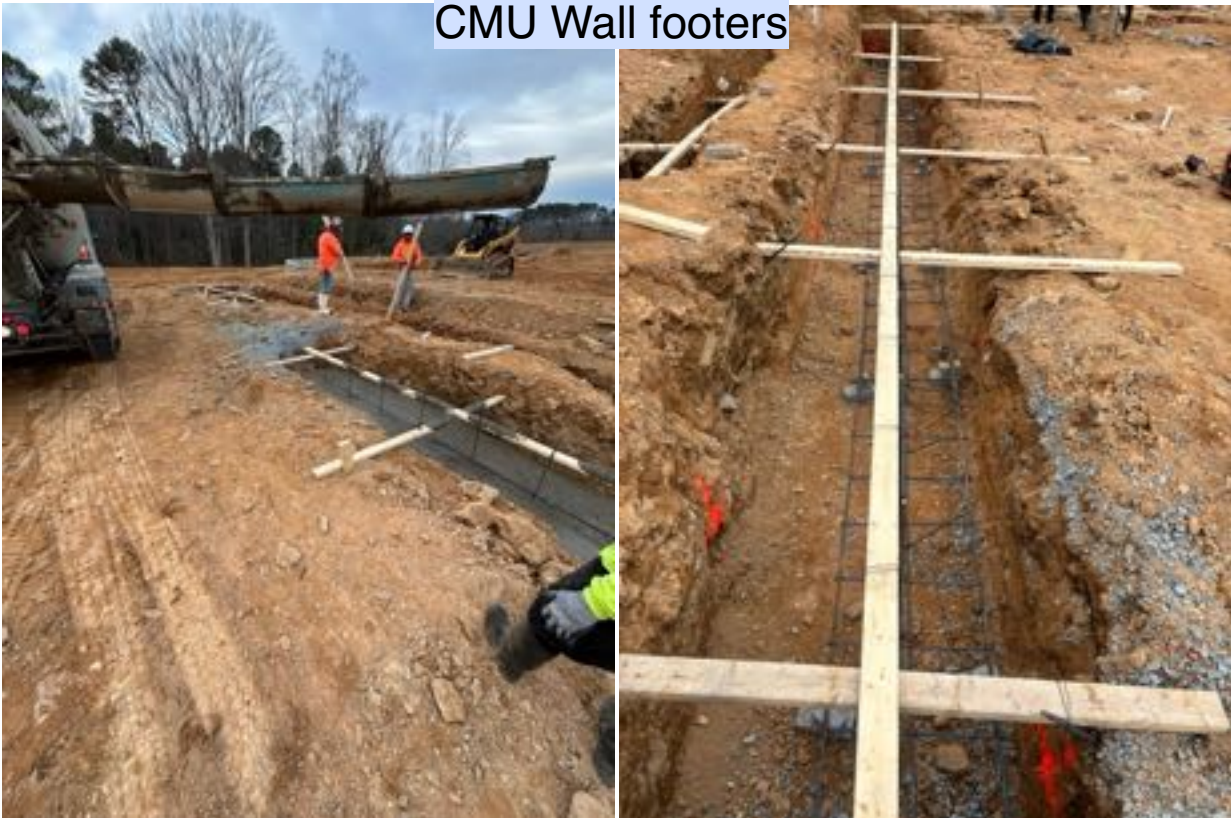
**CMU Wall footers**

TME personnel arrived on site as requested by the contractor. Austin from Inland Construction was on site. Tech evaluated Cantilevered Retaining Wall footers subgrade via half inch probe rod. Tech observed subgrade to be firm bearing. Tech evaluated mail kiosk subgrade for mud mat and observed subgrade to be firm bearing. Tech sampled concrete, testing for approximate air %, slump, and sample cylinders. Tech created 5 cylinders and stored them in cure box. Tech will return following day to take cylinder samples to lab once they have cured.

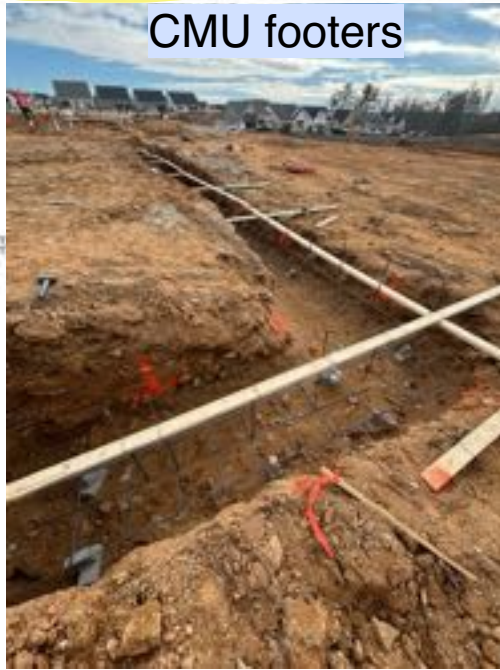
Truck ticket

Truck No.	Batch Time	Plant No.	Ticket No.	Size of Load	Sample	Slump (in)	Air %	Unit Wt. (pcf)	H2O Added (gallons)	Concrete Temp.	No. of Test Samples	Daily Set No.
3,806	14:03	1	237004594	10.00	15:15	3.9	3.00	144.91	0.00	61	5	1
